## **AIRWORTHINESS GROUP FACTUAL REPORT**

**NTSB No. ERA21FA130**

**Rolls-Royce Materials Evaluation Report No. 21FAE-025-PR  
(111 pages)**

| <b>TITLE</b><br><br><b>METALLURGICAL INVESTIGATION OF COMPRESSOR COMPONENTS REMOVED FROM AN M250-C20B, ENGINE S/N CAE833459, OPERATED BY CARIBBEAN BUZZ HELICOPTER</b> | | <b>PREPARED</b><br>Signatures on File | | |

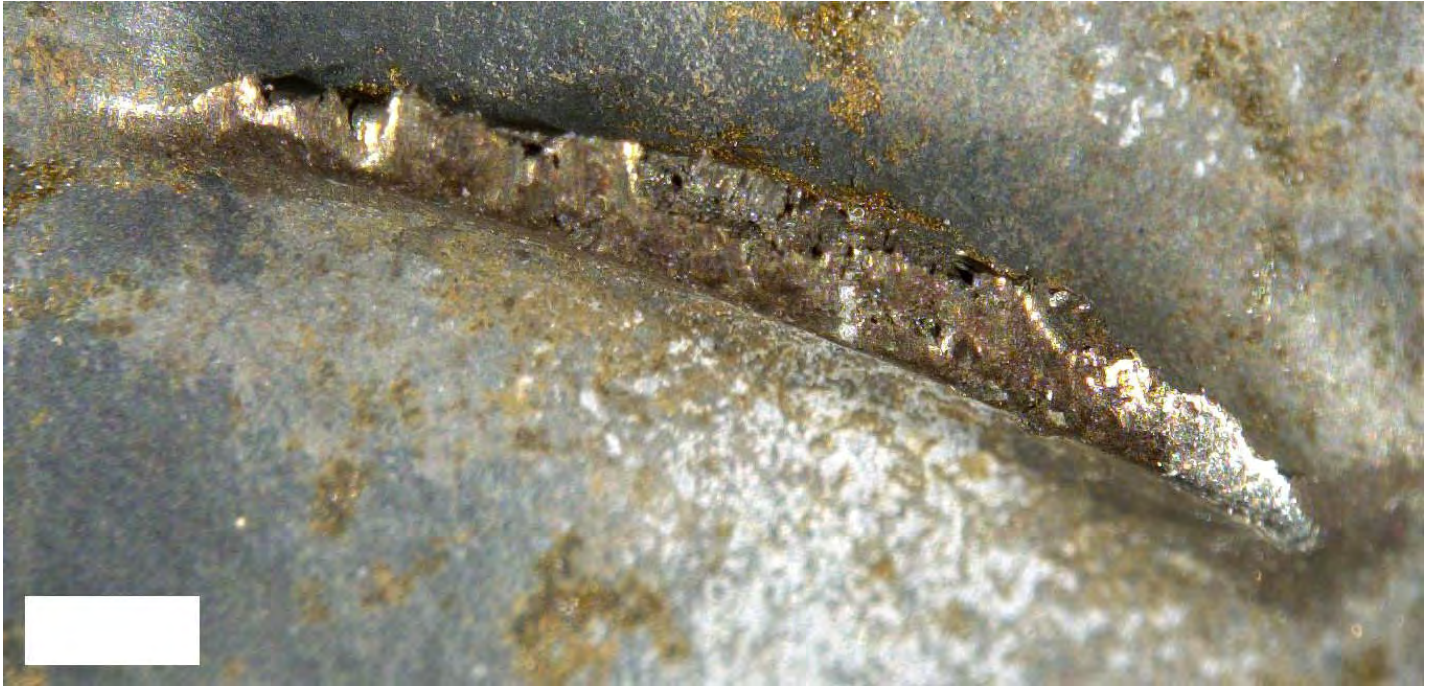
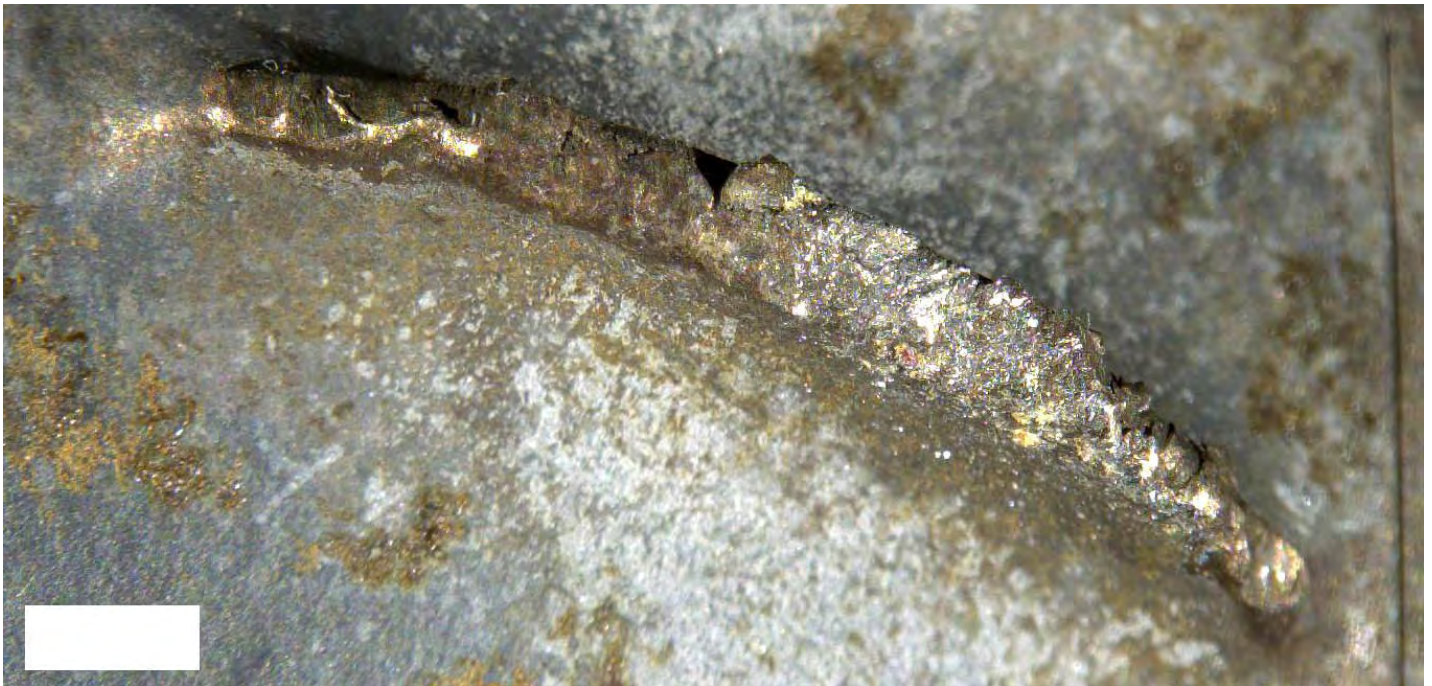
**Figure 39. Detailed views of two stage 4 blade fracture surfaces. No fatigue fracture features were present on either of the fracture surfaces.**

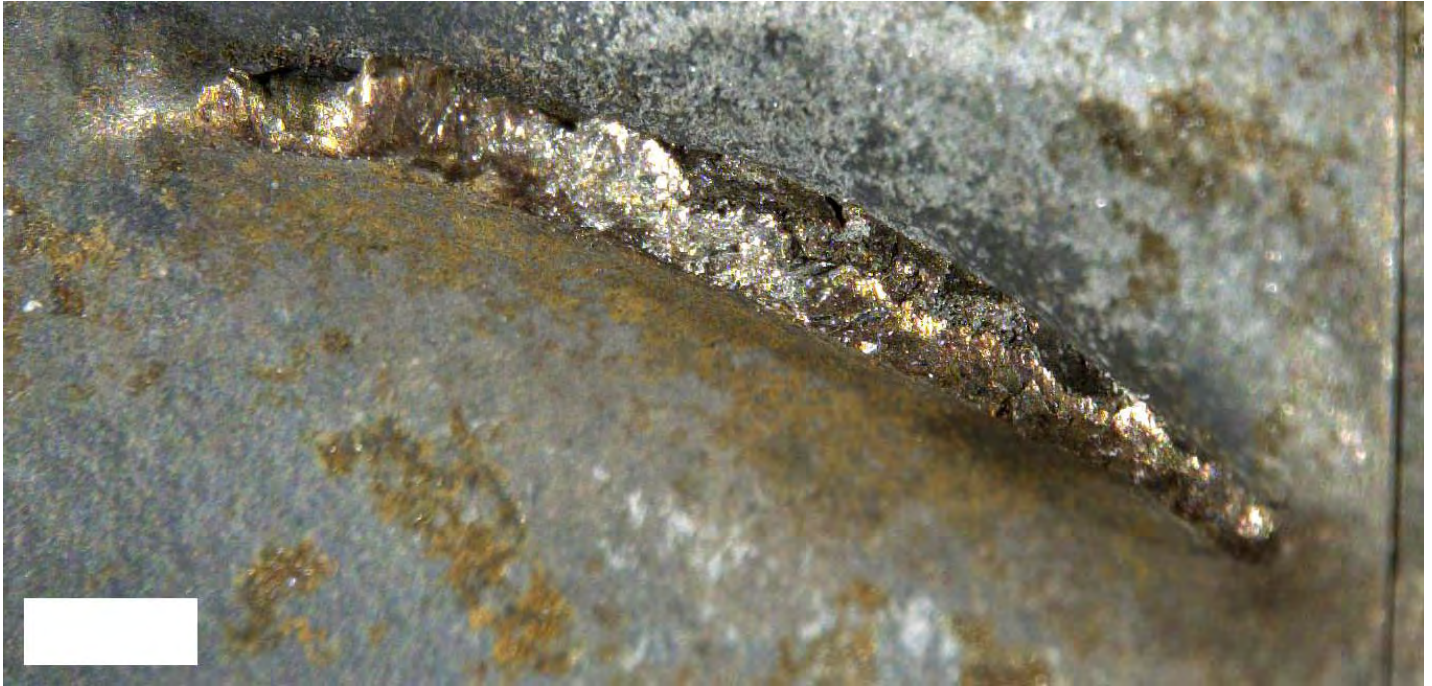
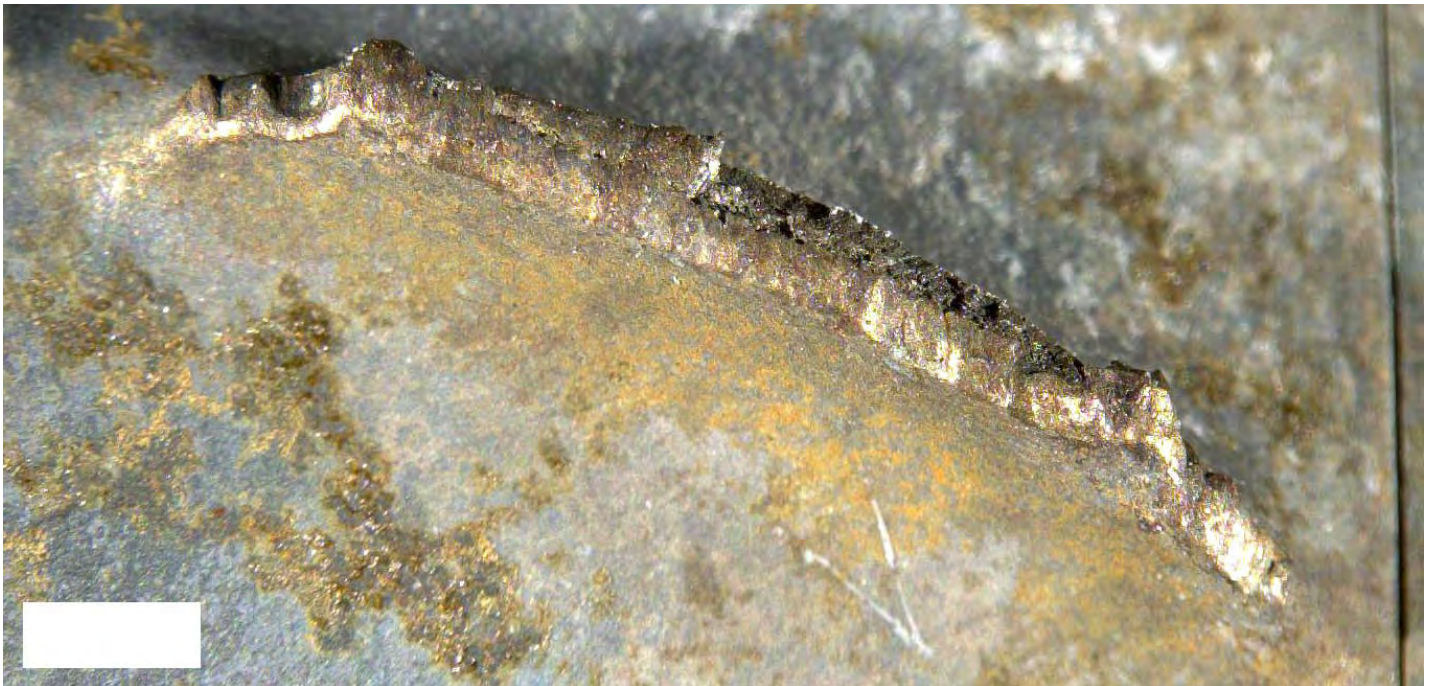
**Figure 40. Detailed views of two stage 4 blade fracture surfaces. No fatigue fracture features were present on either of the fracture surfaces.**

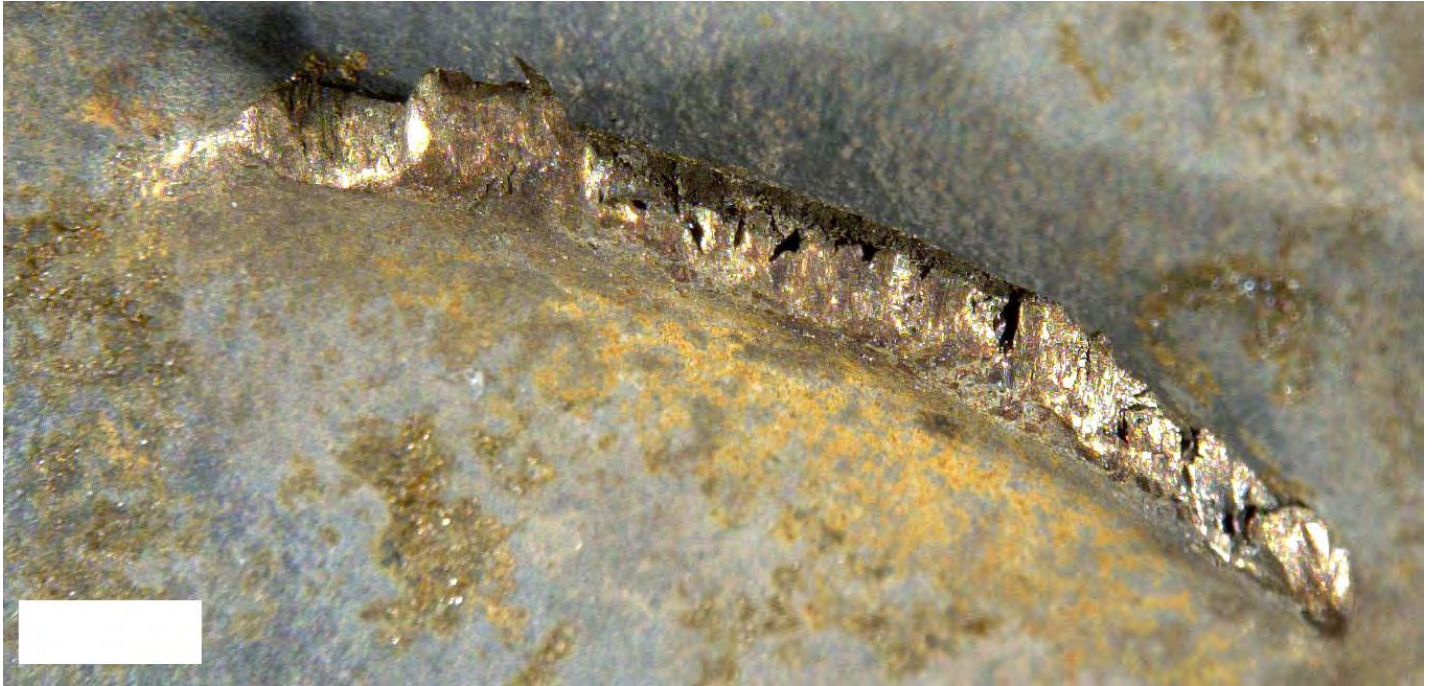
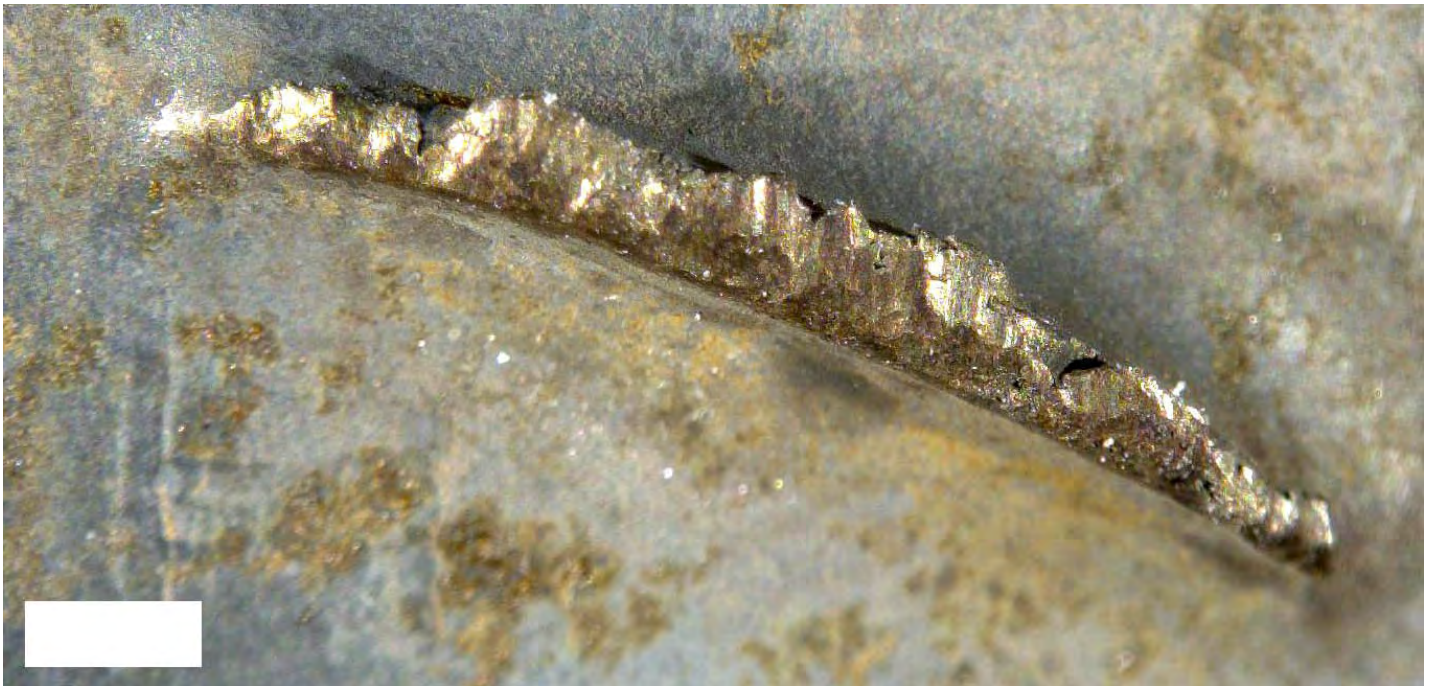
**Figure 41. Detailed views of two stage 4 blade fracture surfaces. No fatigue fracture features were present on either of the fracture surfaces.**

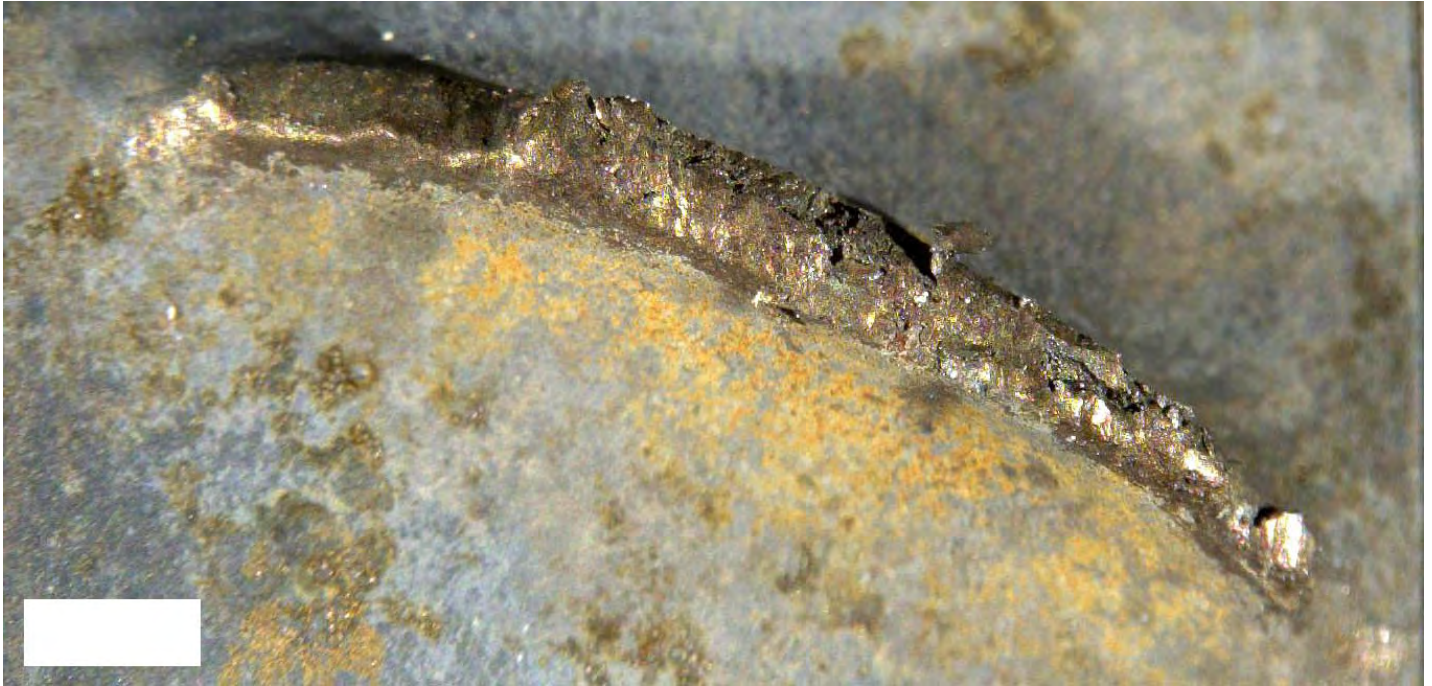
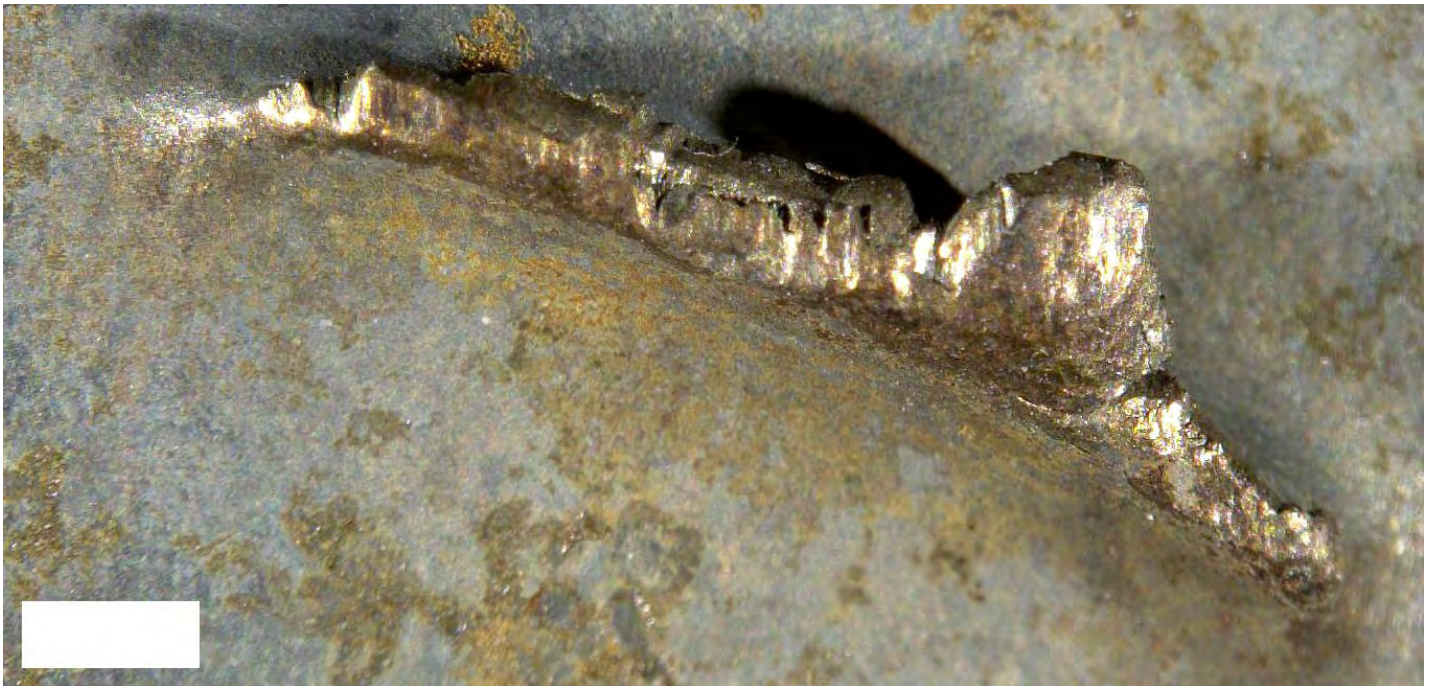
**Figure 42. Detailed views of two stage 4 blade fracture surfaces. No fatigue fracture features were present on either of the fracture surfaces.**

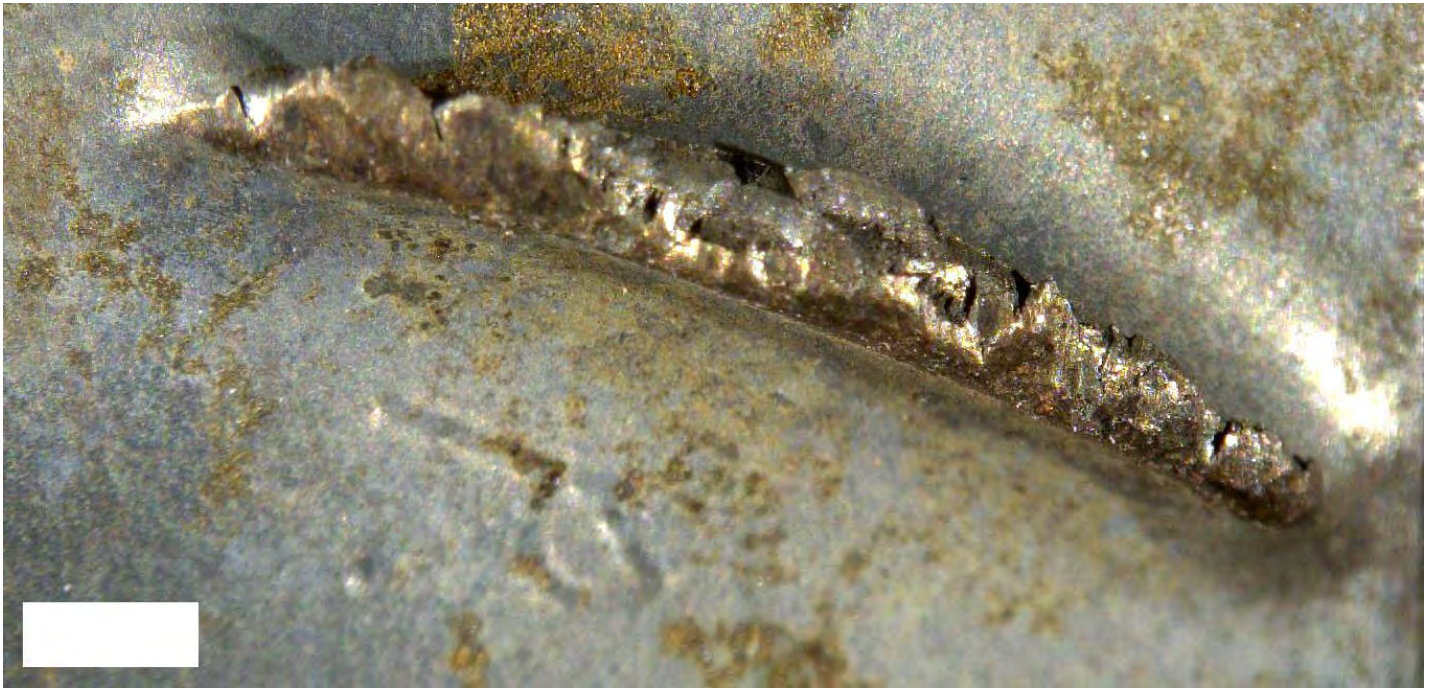
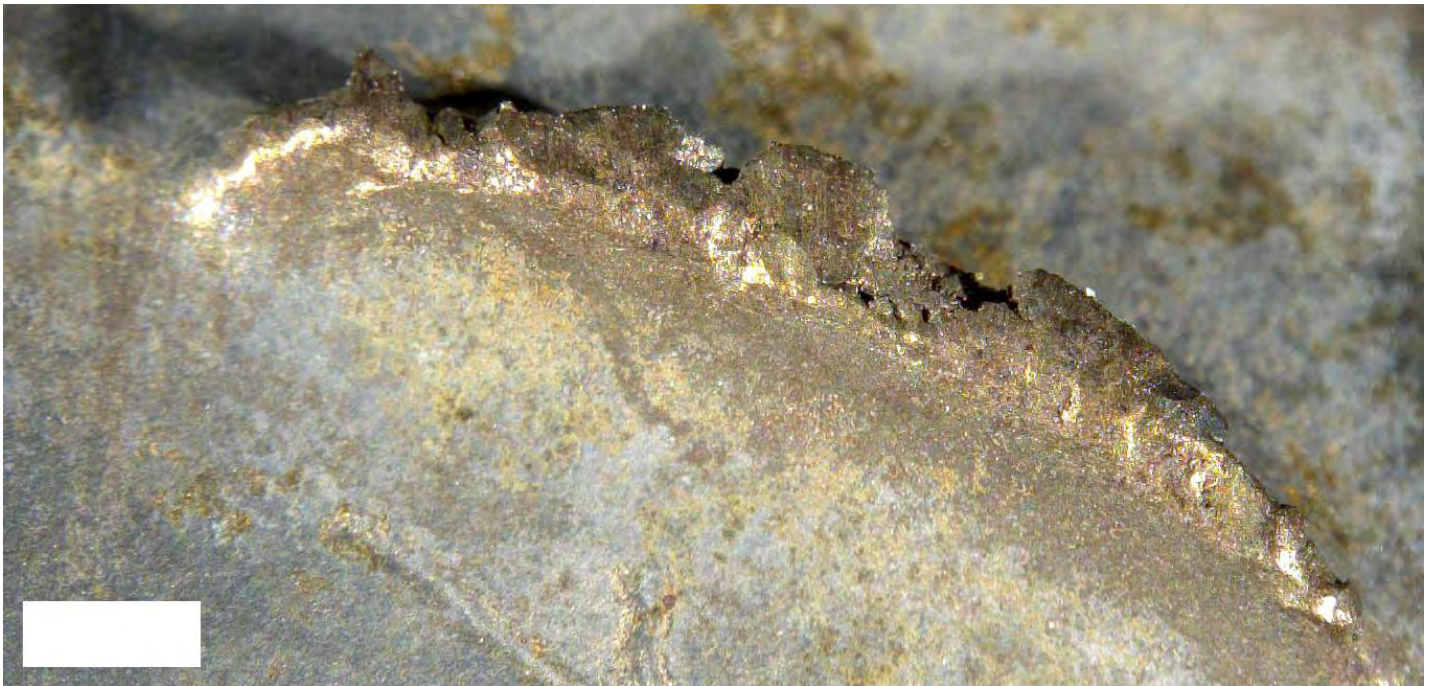
**Figure 43. Detailed views of two stage 4 blade fracture surfaces. No fatigue fracture features were present on either of the fracture surfaces.**

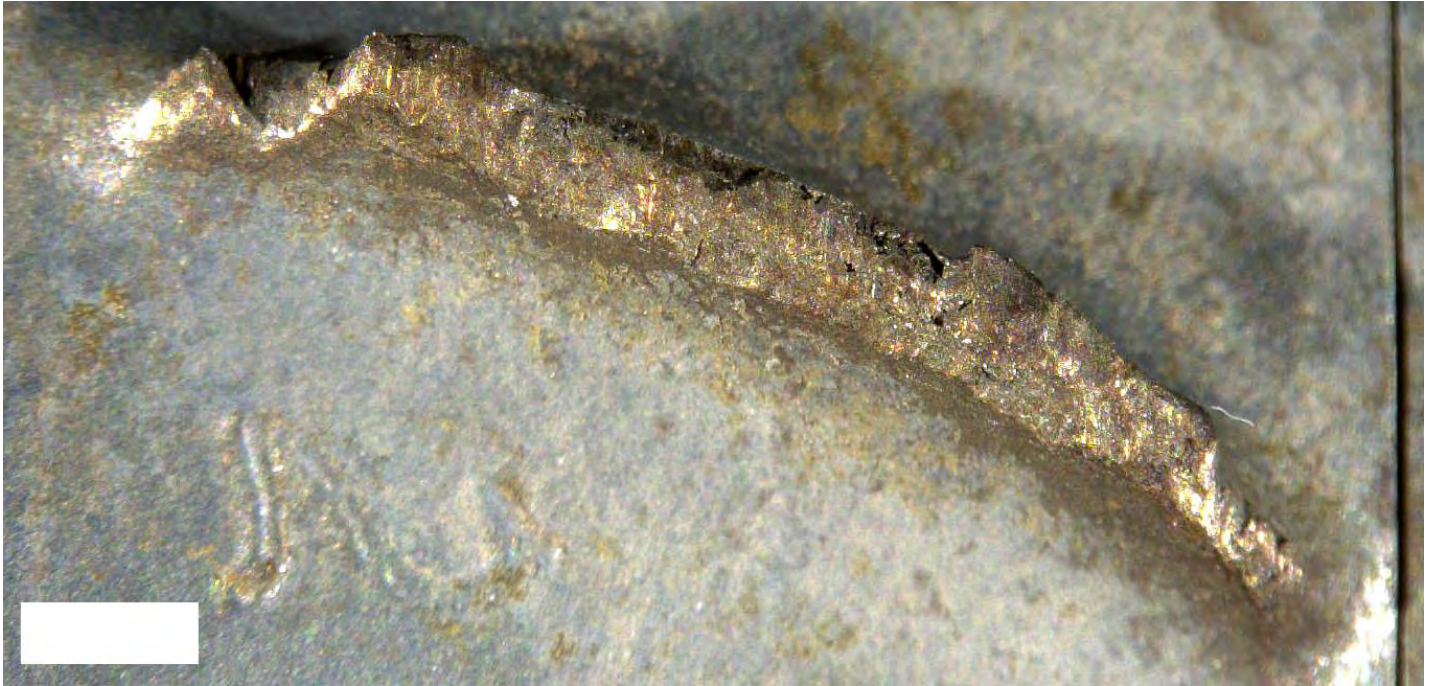
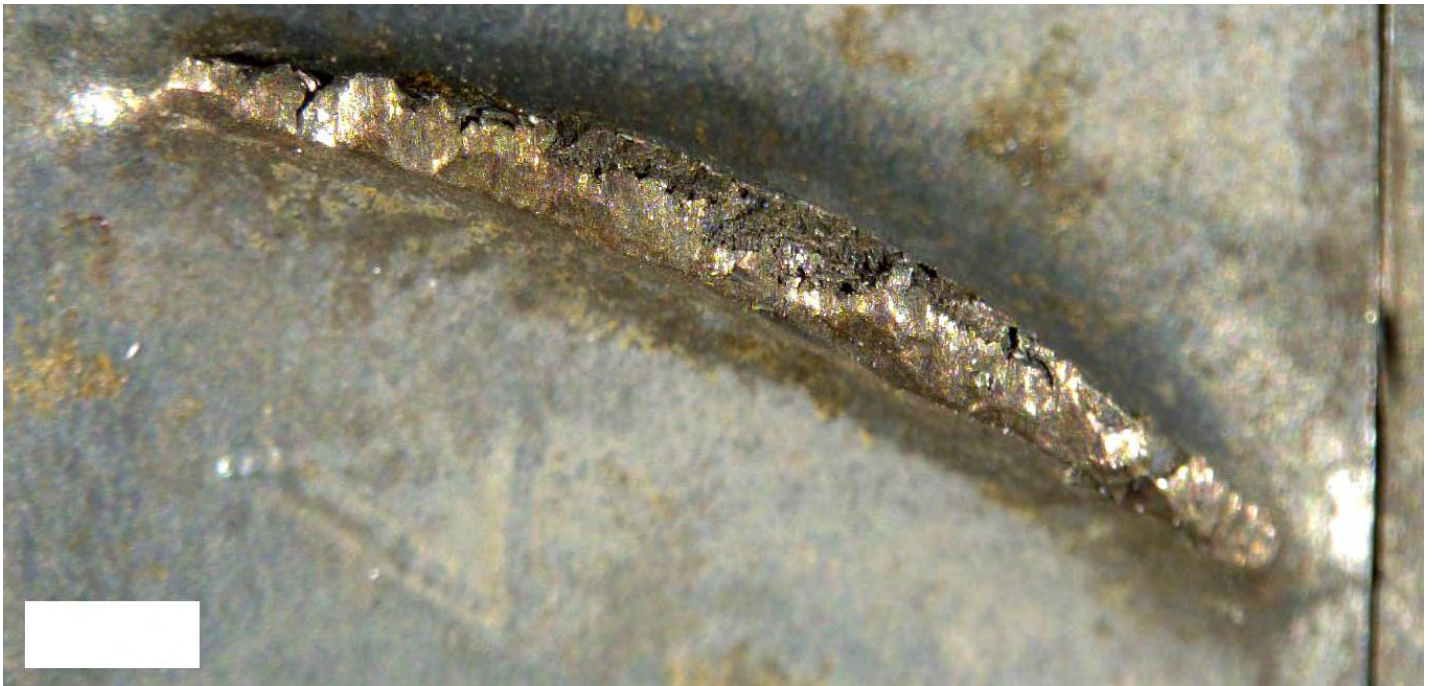
**Figure 44. Detailed views of two stage 4 blade fracture surfaces. No fatigue fracture features were present on either of the fracture surfaces.**

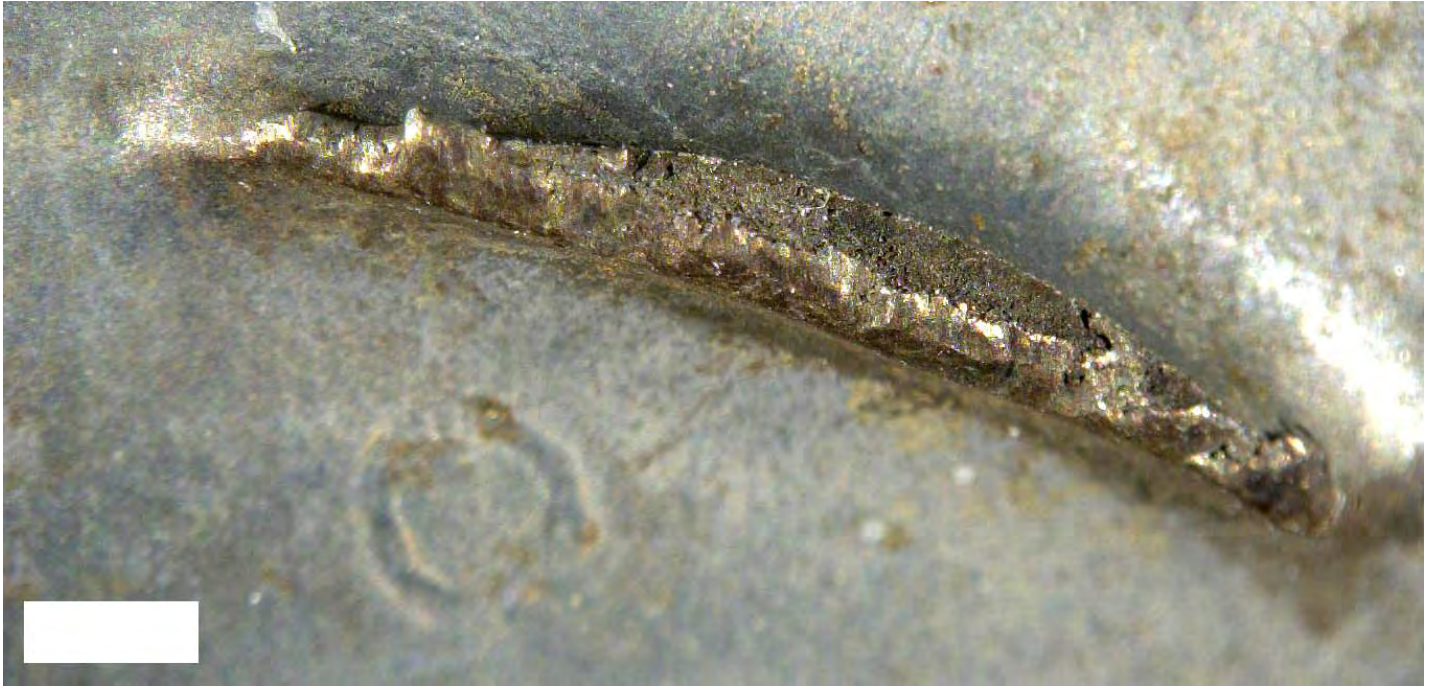
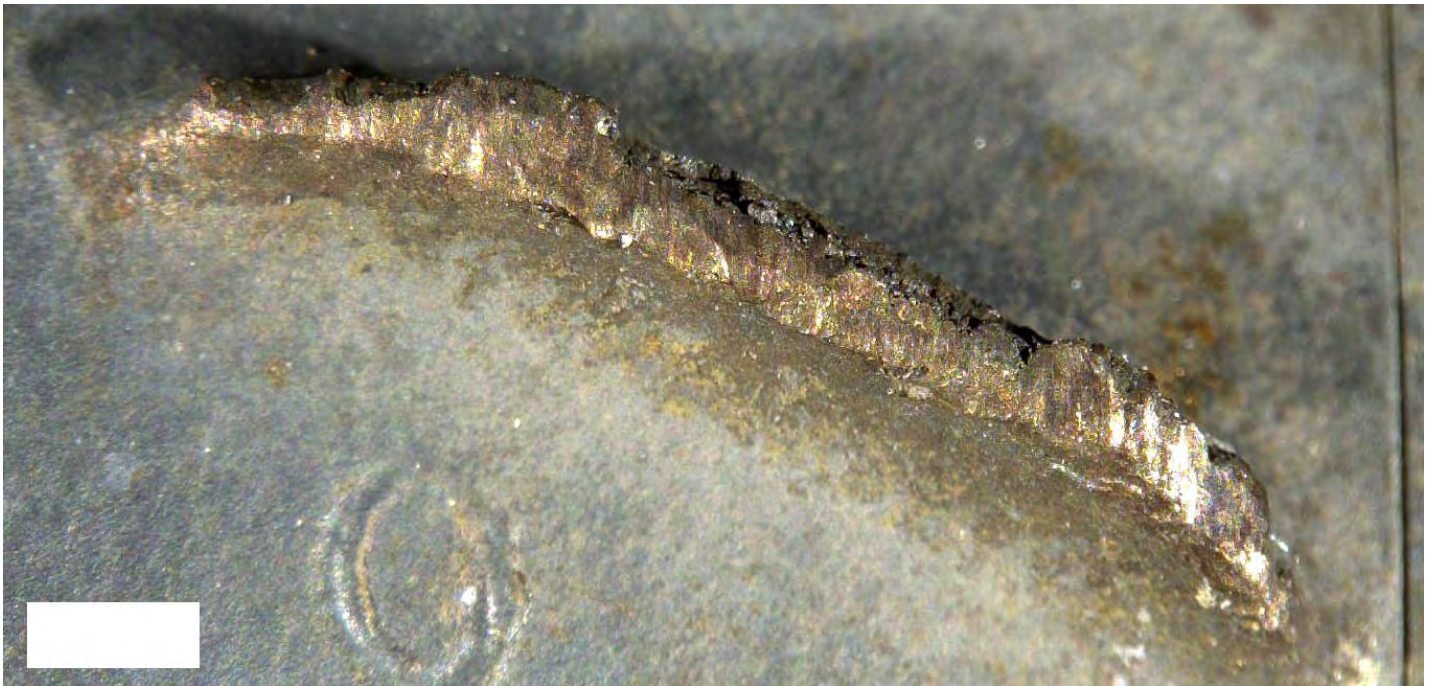
**Figure 45. Detailed views of two stage 4 blade fracture surfaces. No fatigue fracture features were present on either of the fracture surfaces.**

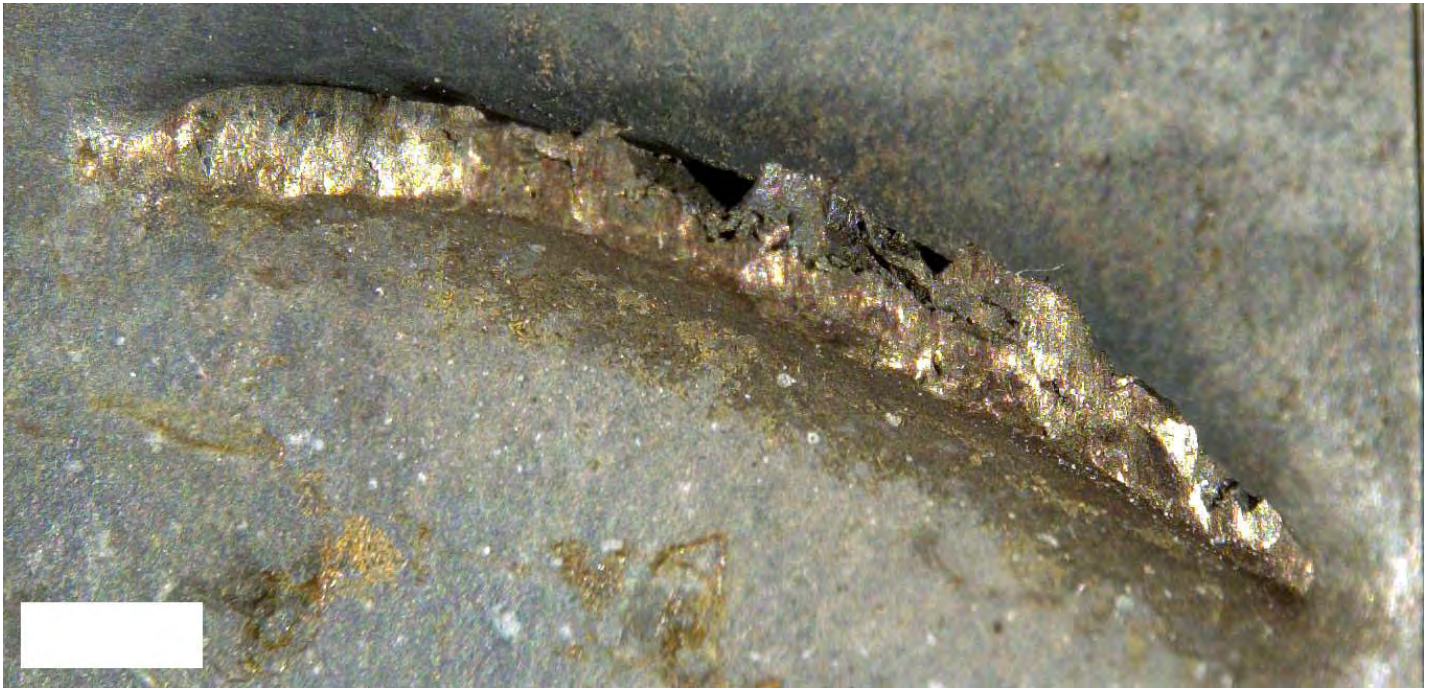
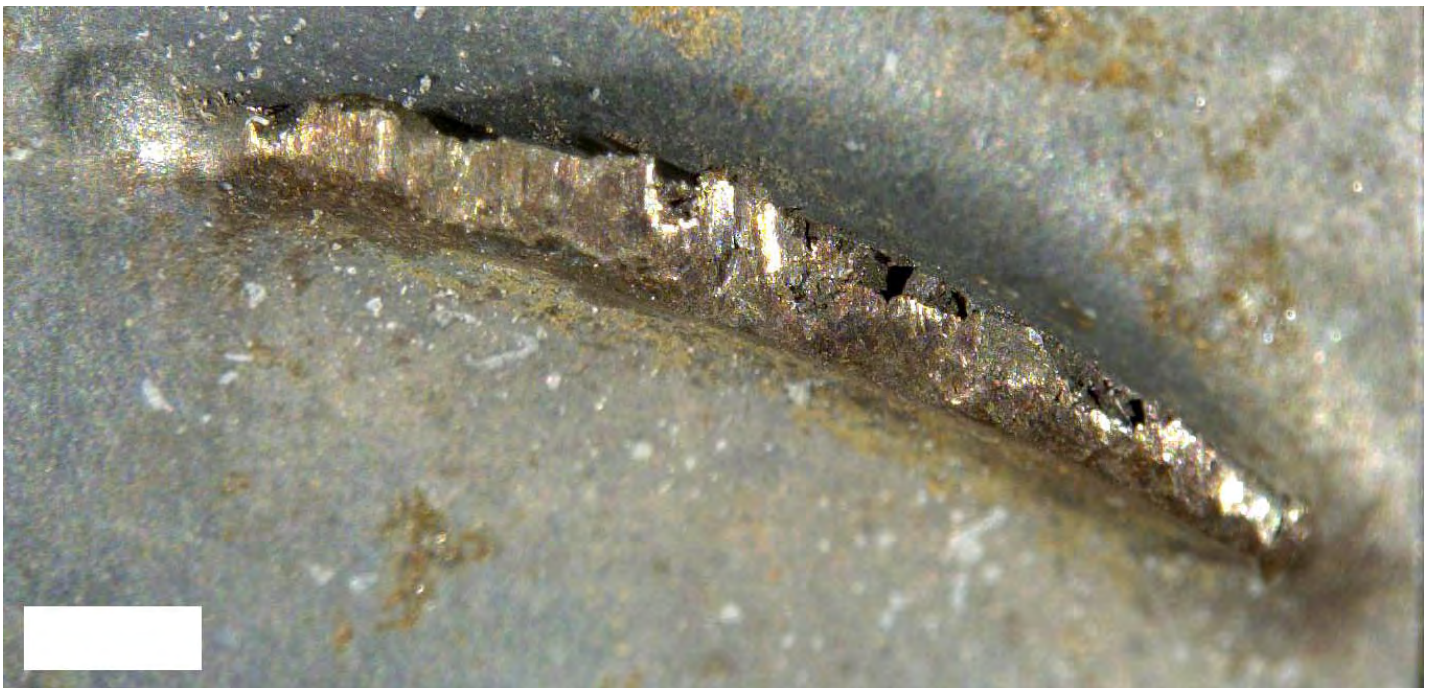
**Figure 46. Detailed views of two stage 4 blade fracture surfaces. No fatigue fracture features were present on either of the fracture surfaces.**

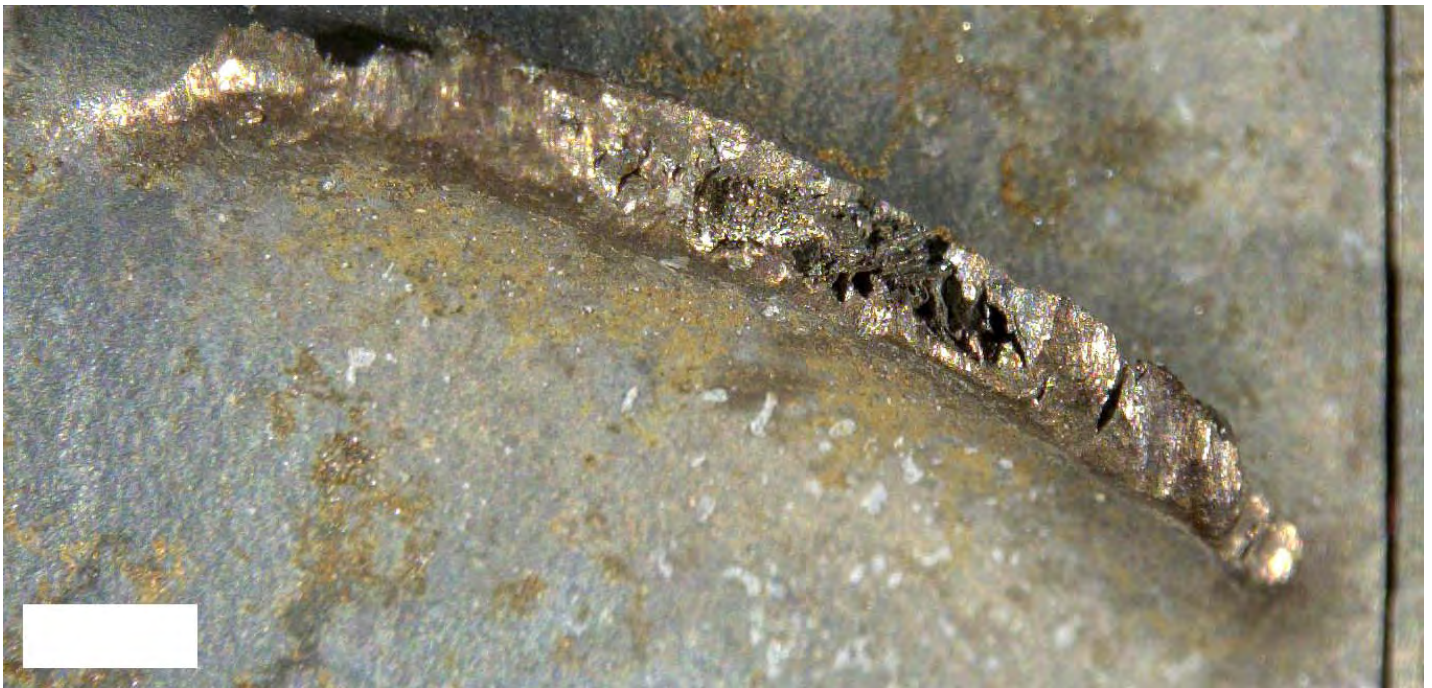
**Figure 47. Detailed views of one stage 4 blade fracture surface. No fatigue fracture features were present on either of the fracture surfaces.**

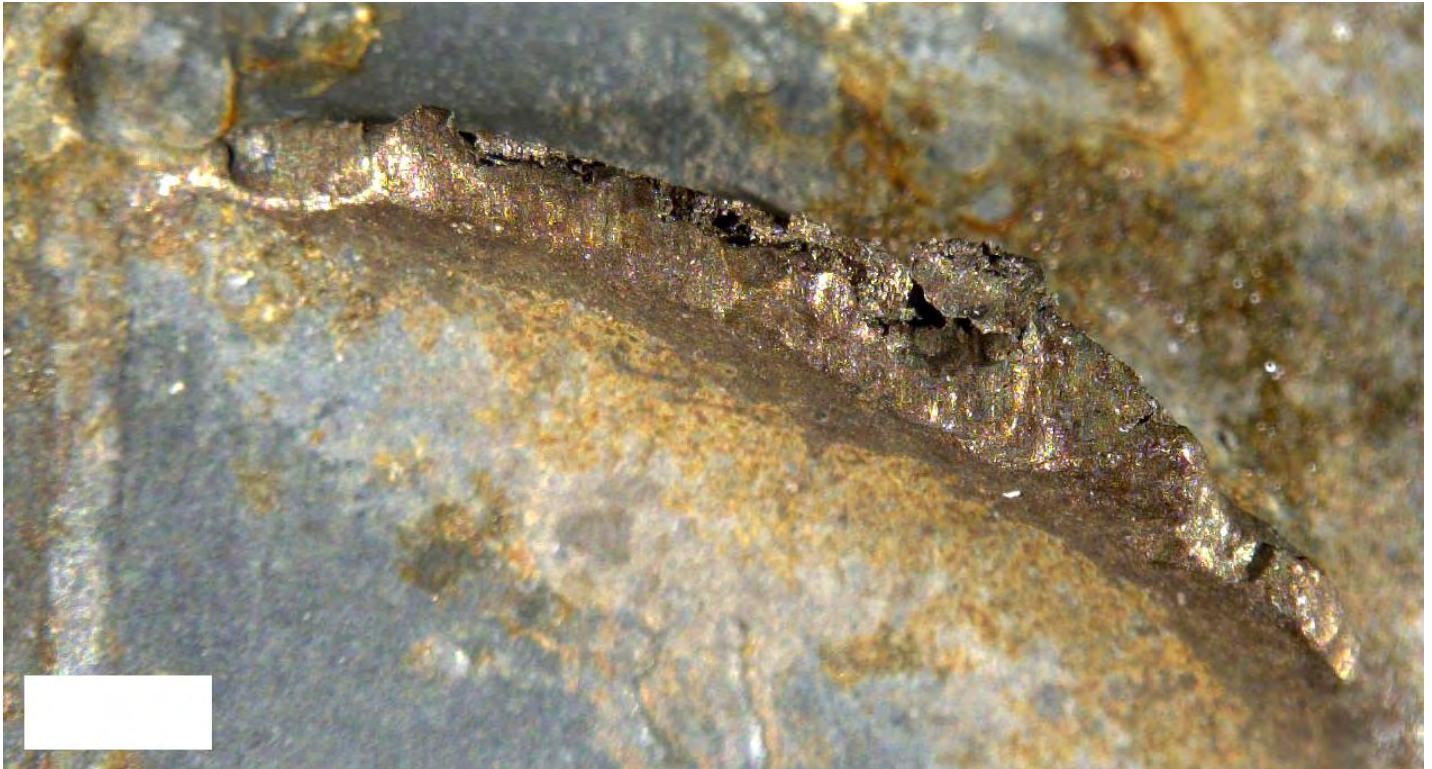
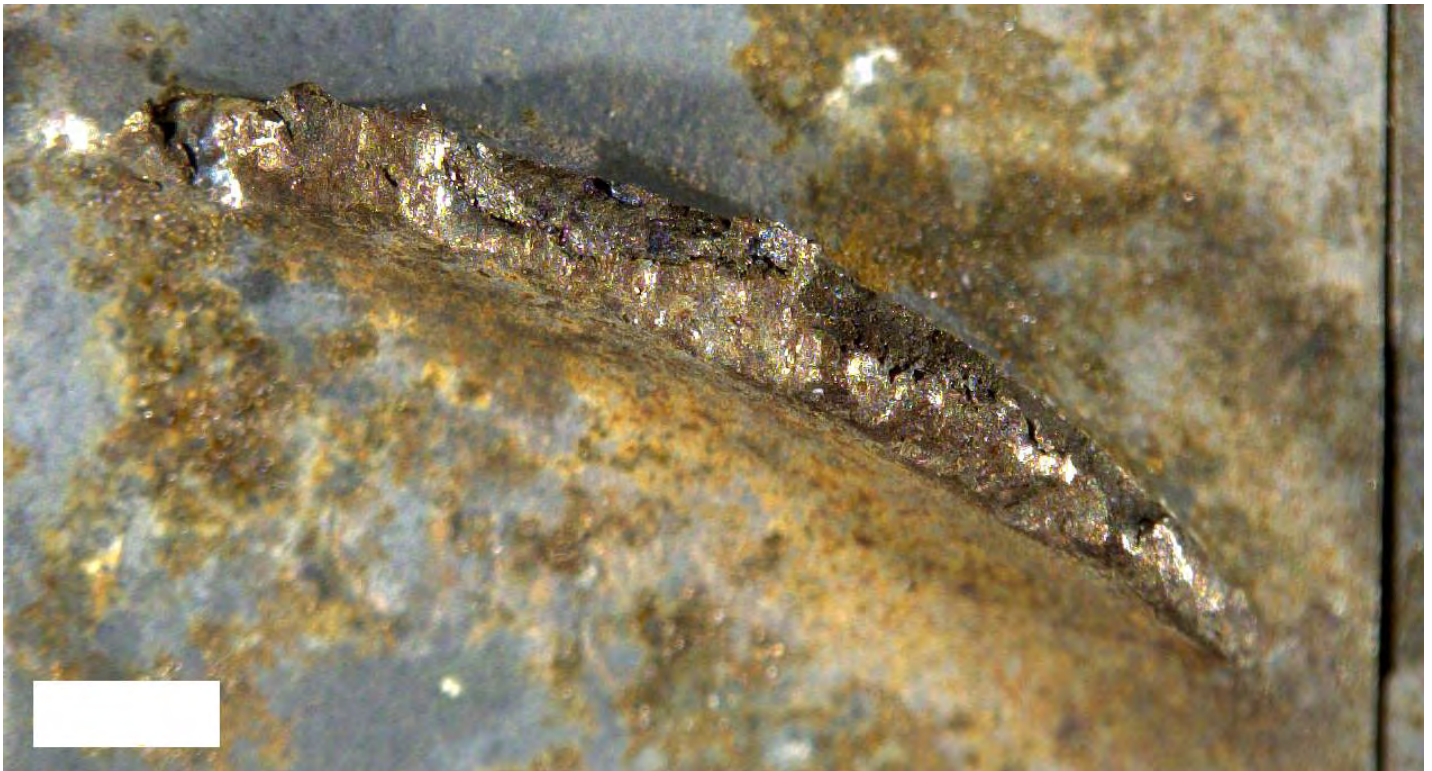
**Figure 52. Detailed views of two stage 5 blade fracture surfaces. No fatigue fracture features were present on either of the fracture surfaces.**

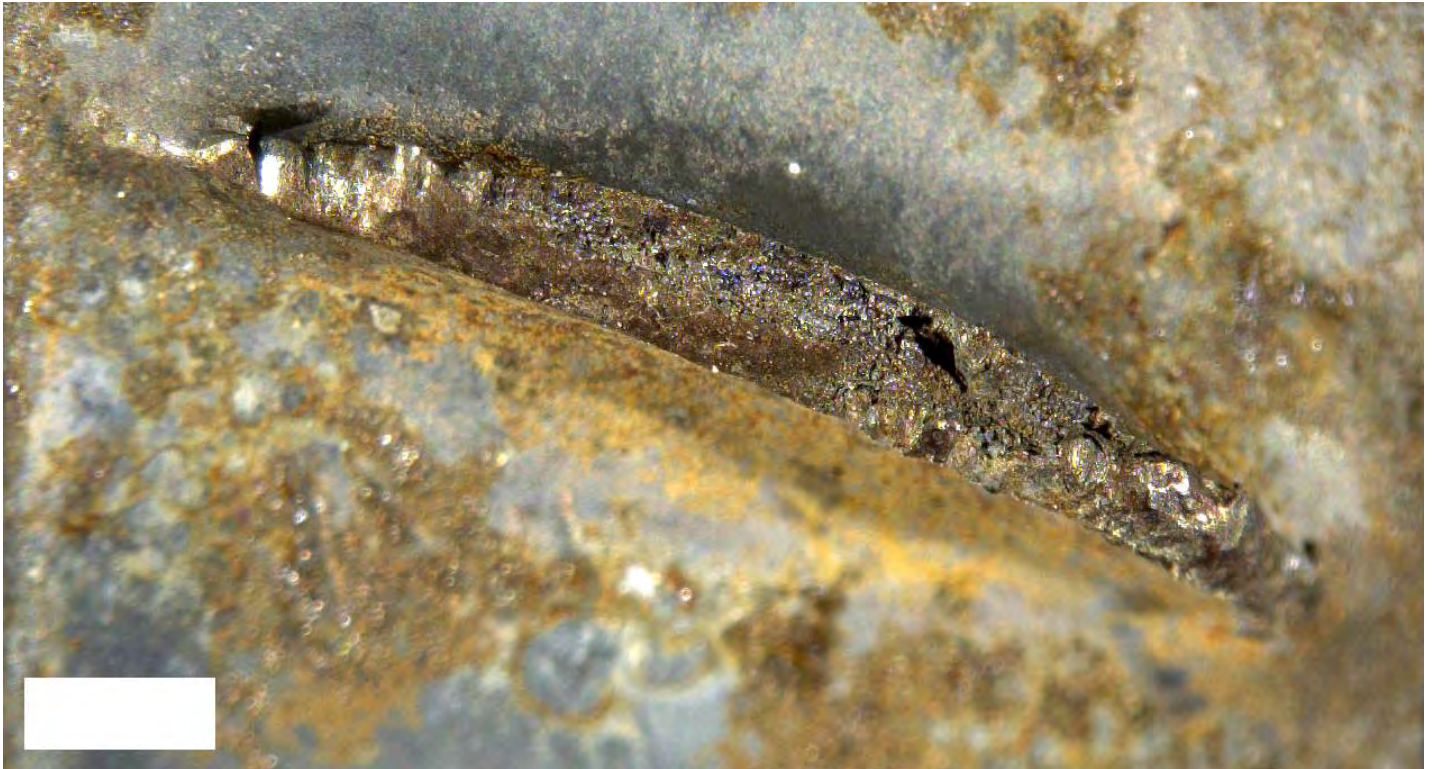
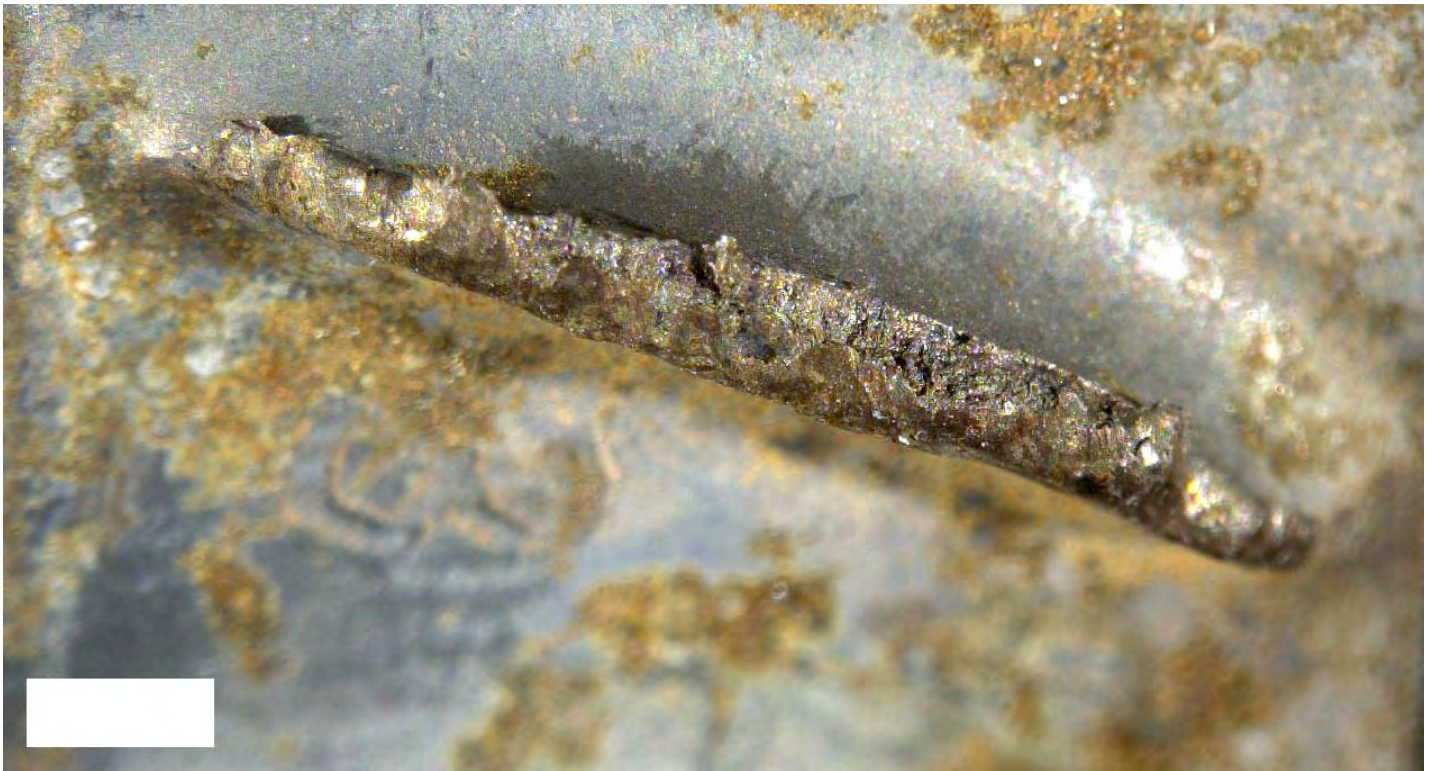
**Figure 53. Detailed views of two stage 5 blade fracture surfaces. No fatigue fracture features were present on either of the fracture surfaces.**
