## **AIRWORTHINESS GROUP FACTUAL REPORT**

**NTSB No. ERA21FA130**

**Rolls-Royce Materials Evaluation Report No. 21FAE-025-PR  
(111 pages)**

| <b>TITLE</b><br><br><b>METALLURGICAL INVESTIGATION OF COMPRESSOR COMPONENTS REMOVED FROM AN M250-C20B, ENGINE S/N CAE833459, OPERATED BY CARIBBEAN BUZZ HELICOPTER</b> | | <b>PREPARED</b><br>Signatures on File | | |

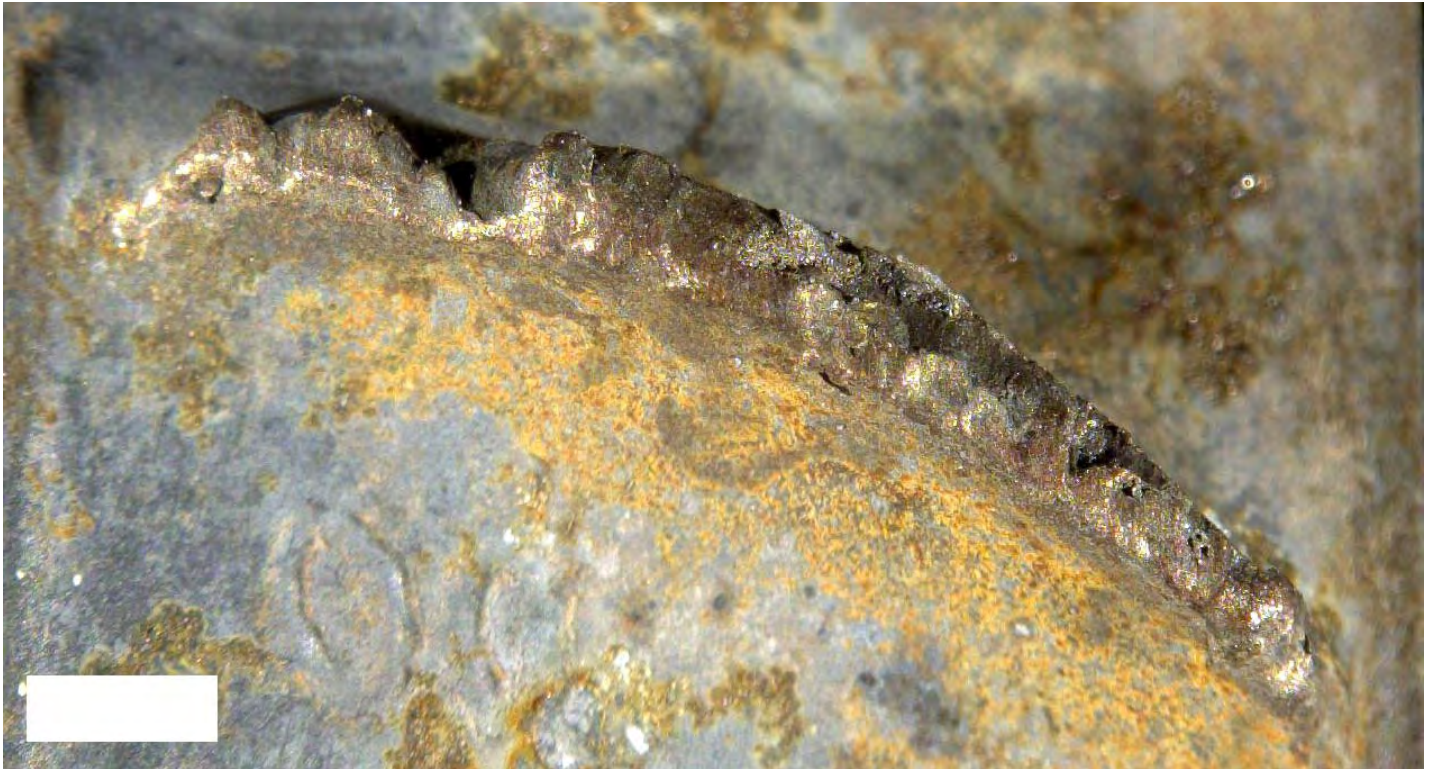
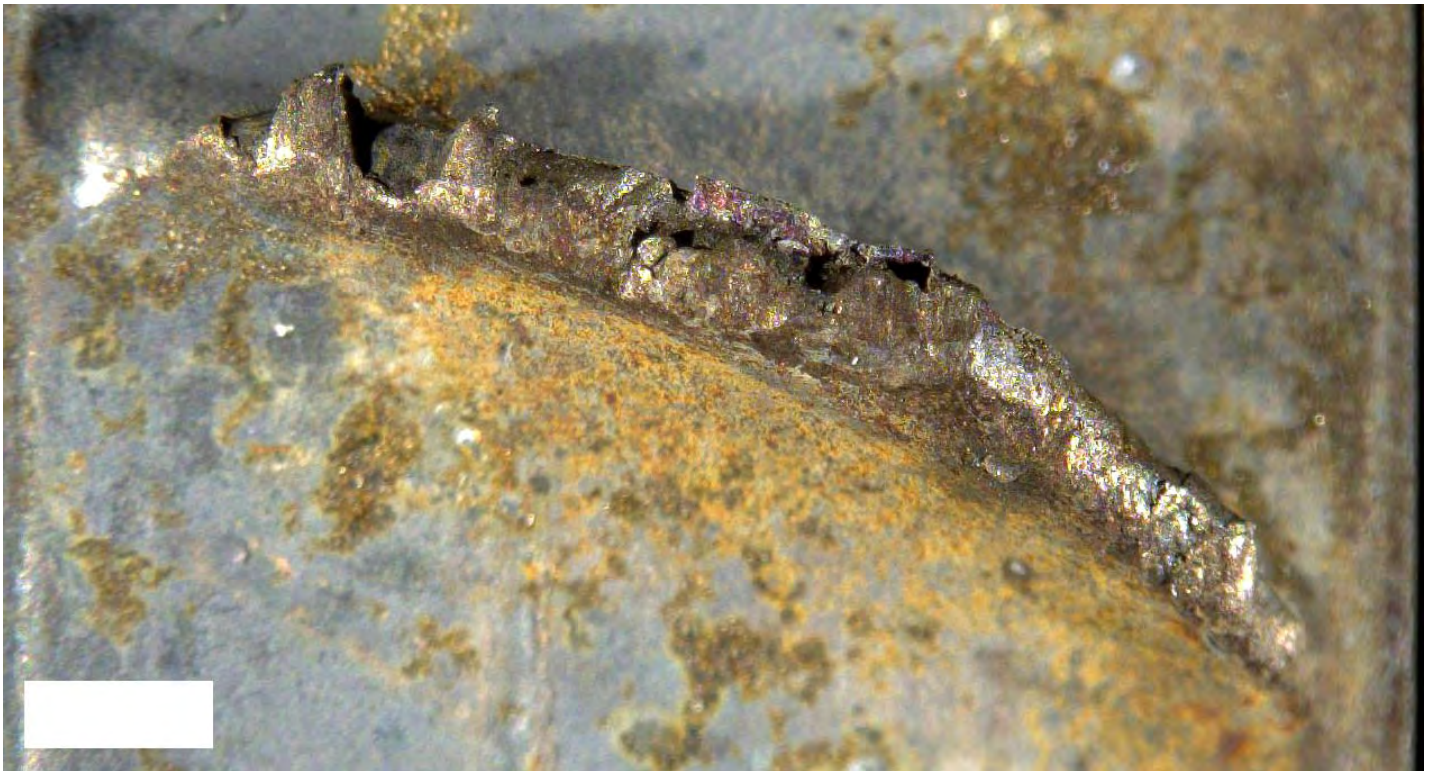
**Figure 54. Detailed views of two stage 5 blade fracture surfaces. No fatigue fracture features were present on either of the fracture surfaces.**

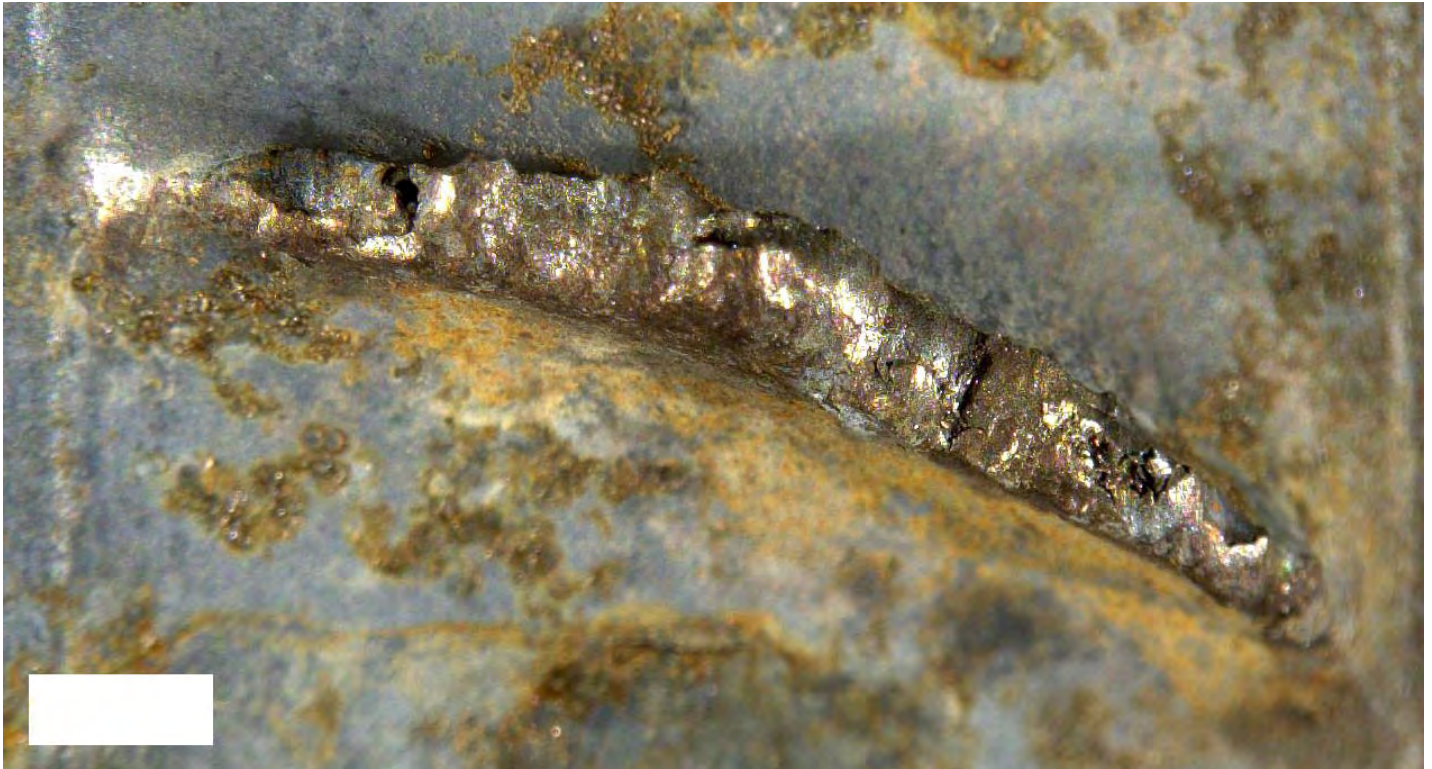
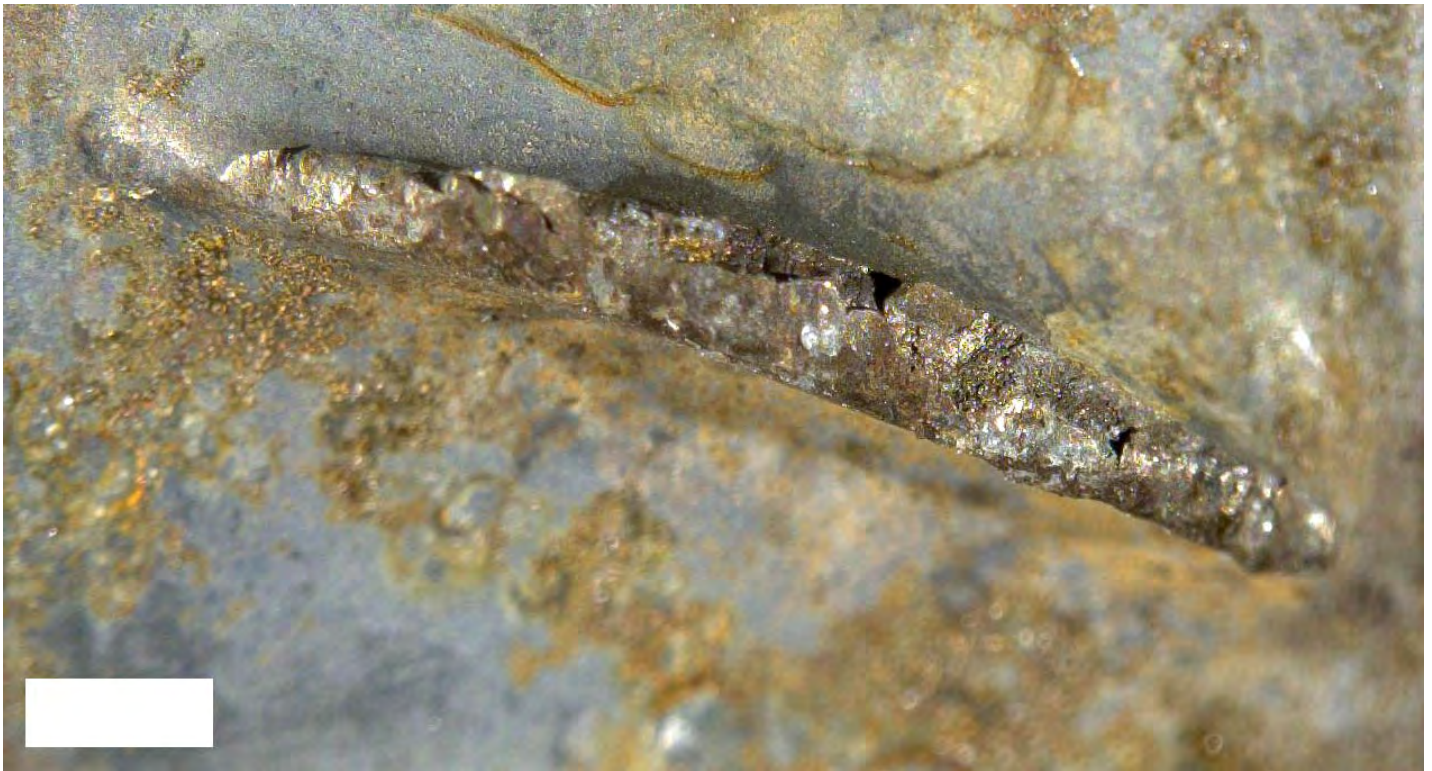
**Figure 55. Detailed views of two stage 5 blade fracture surfaces. No fatigue fracture features were present on either of the fracture surfaces.**

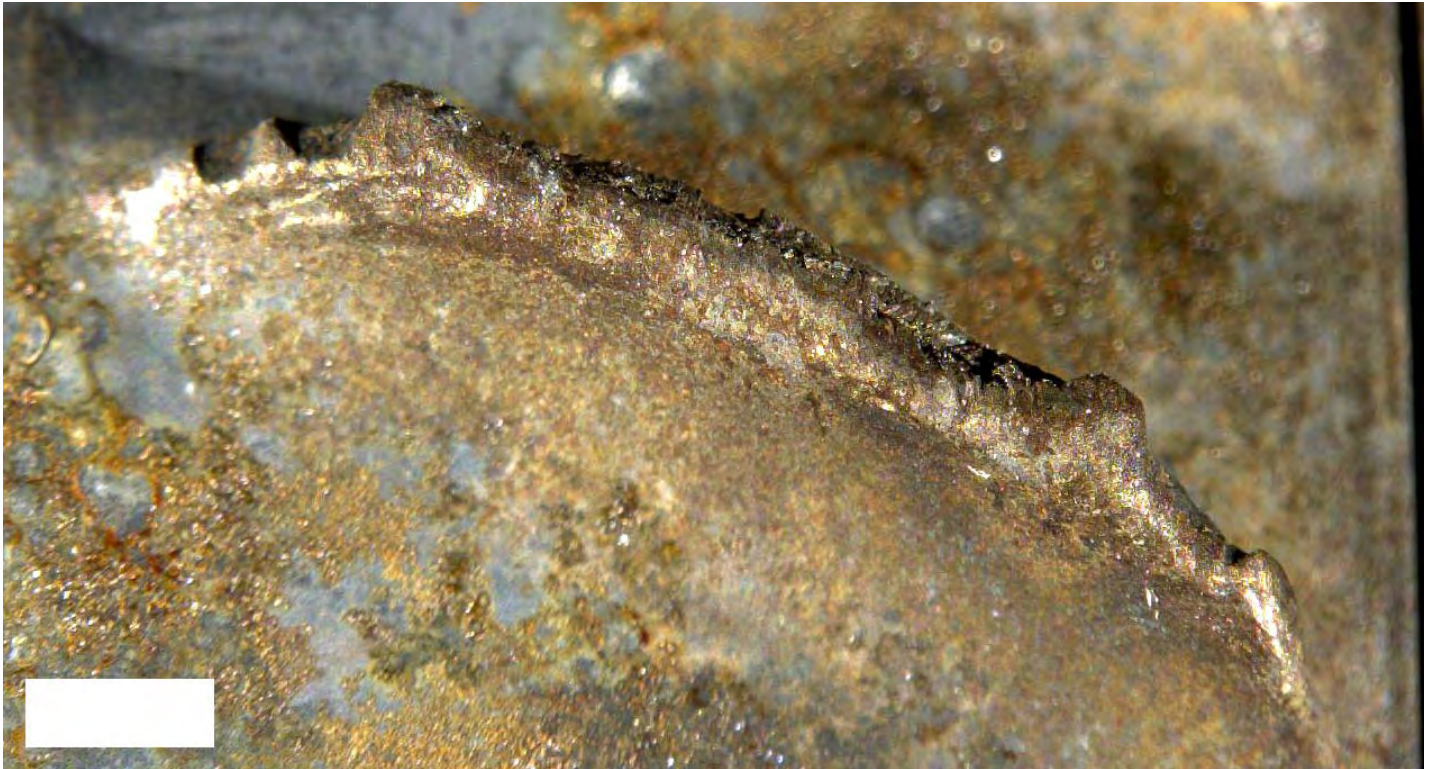
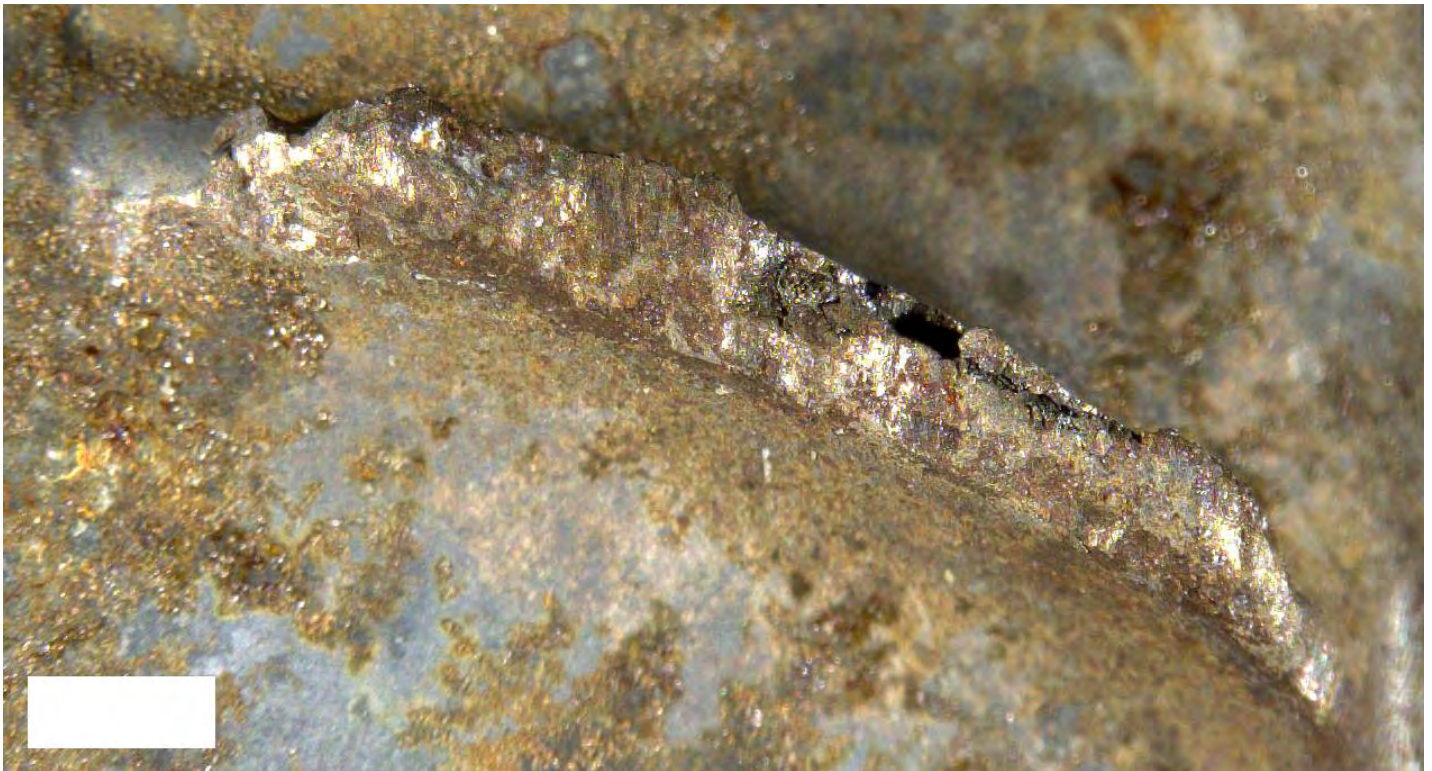
**Figure 56. Detailed views of two stage 5 blade fracture surfaces. No fatigue fracture features were present on either of the fracture surfaces.**

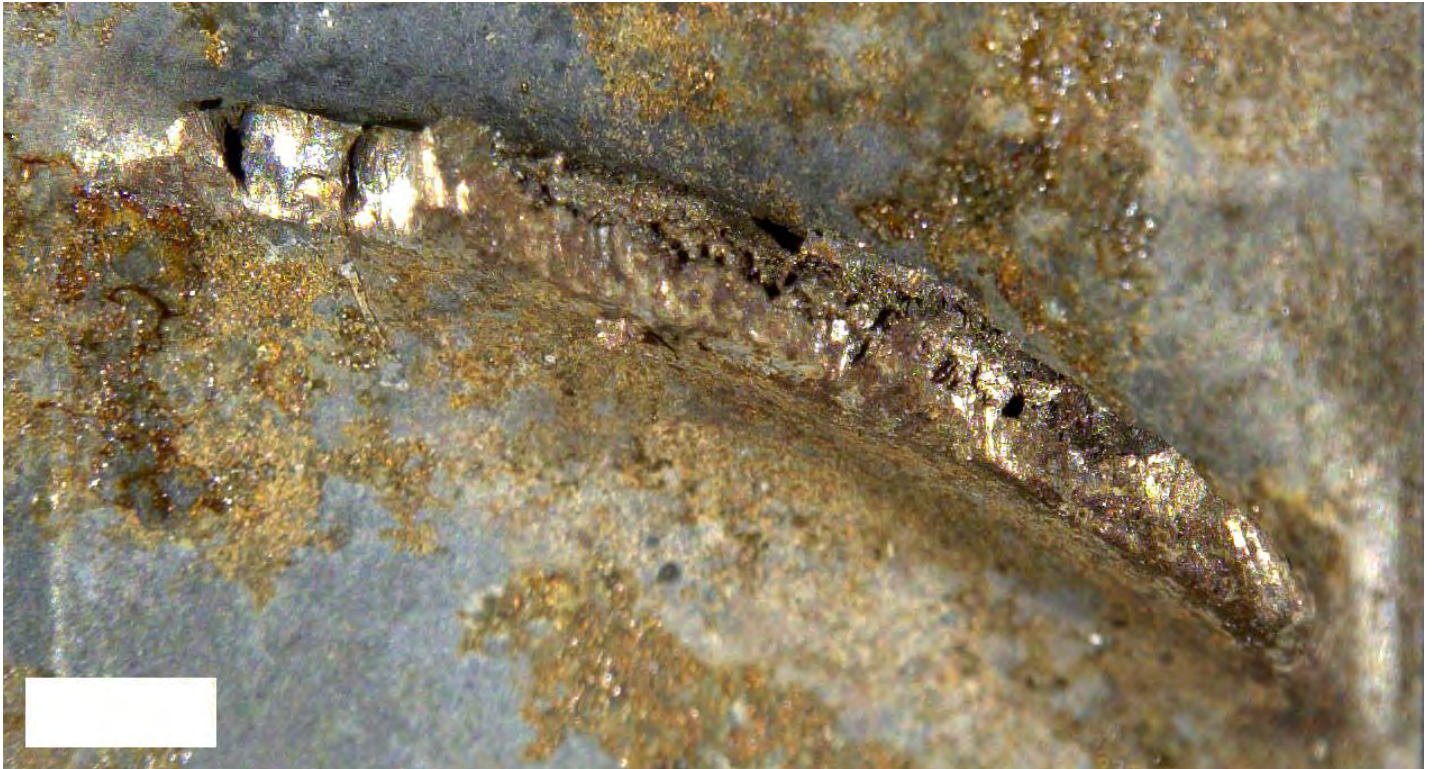
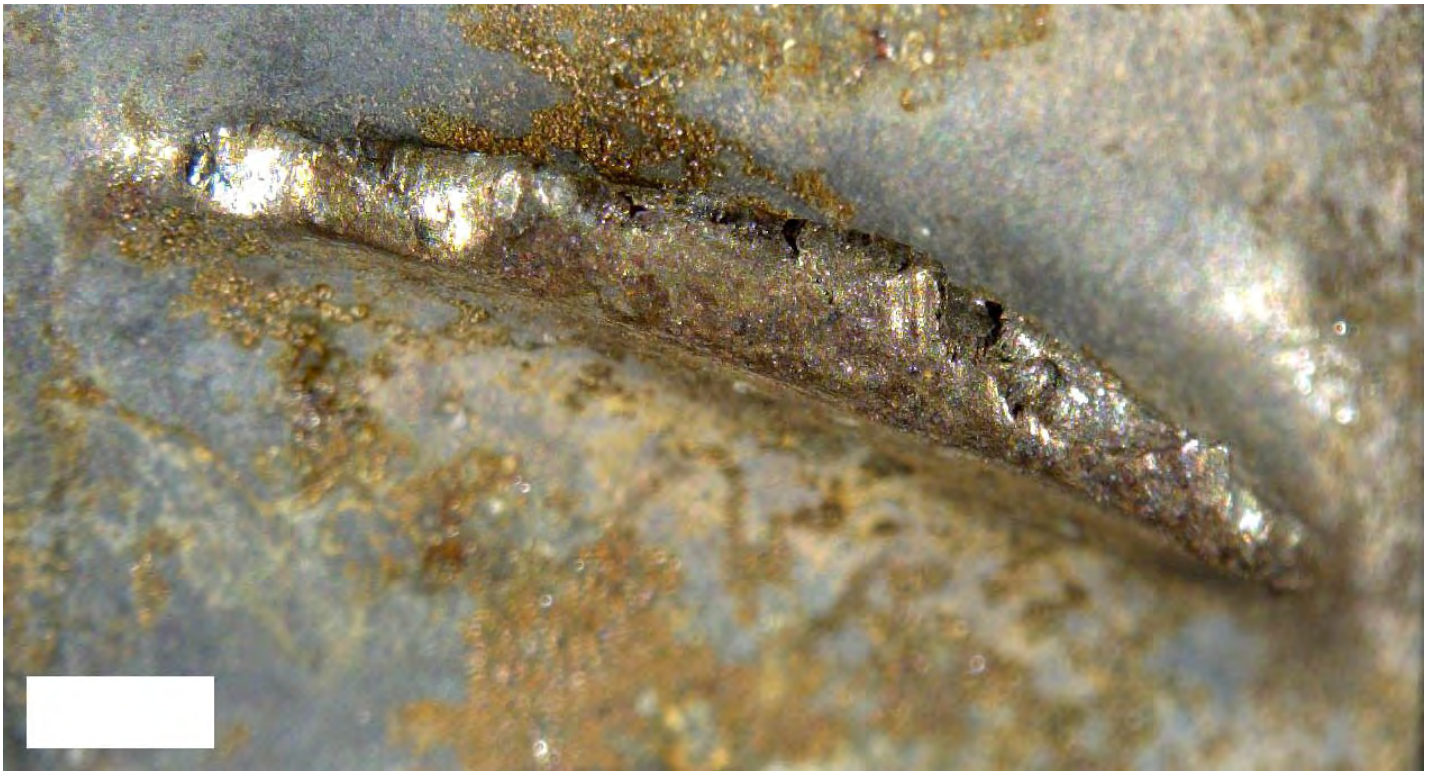
**Figure 57. Detailed views of two stage 5 blade fracture surfaces. No fatigue fracture features were present on either of the fracture surfaces.**

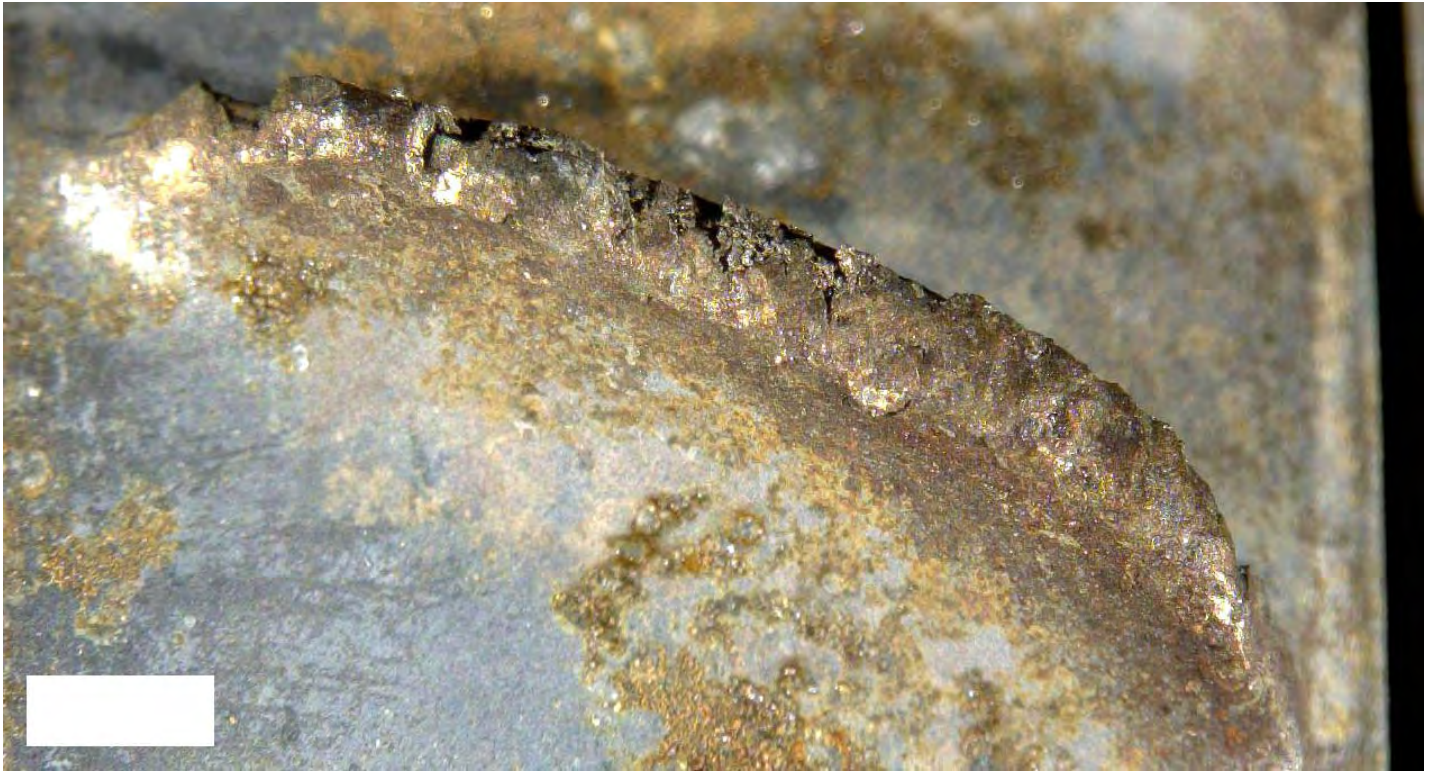
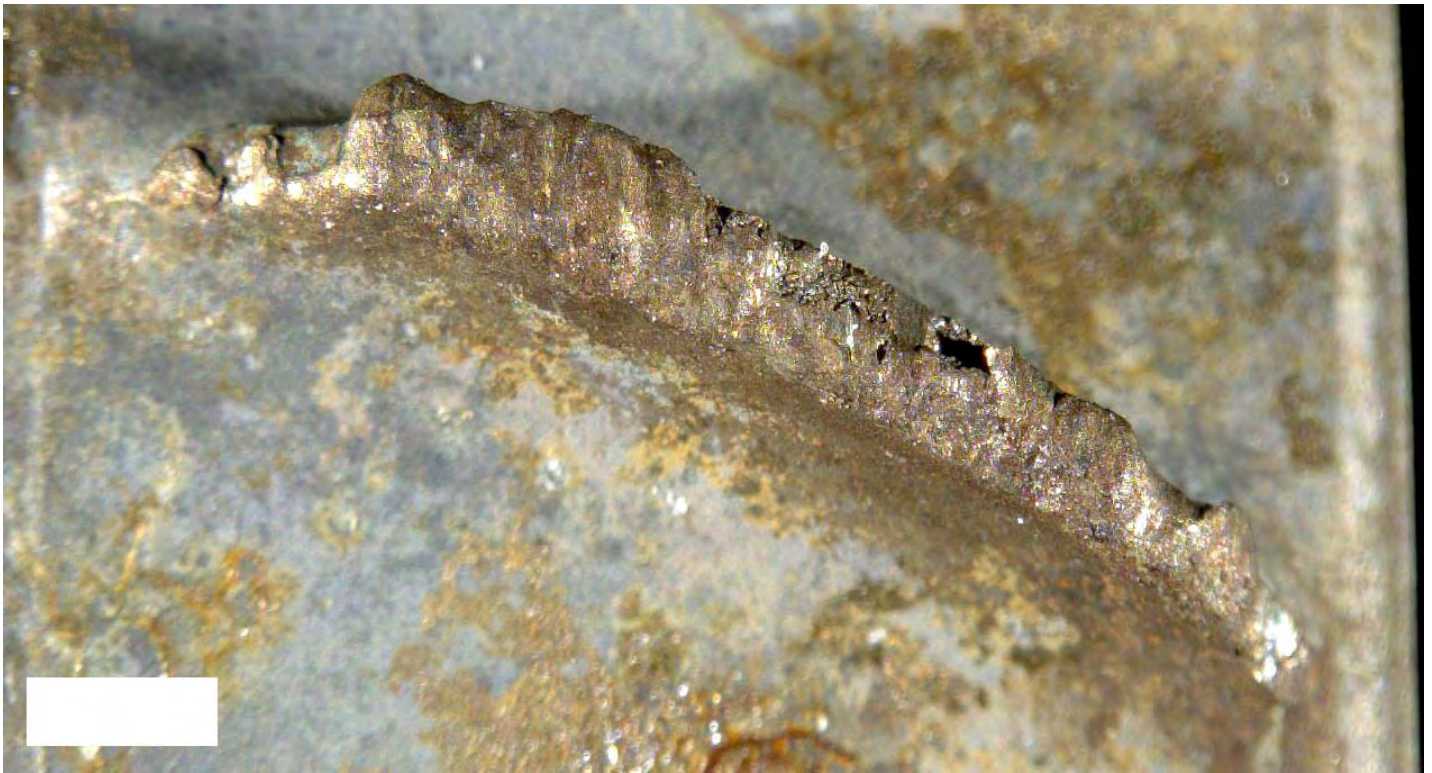
**Figure 58. Detailed views of two stage 5 blade fracture surfaces. No fatigue fracture features were present on either of the fracture surfaces.**

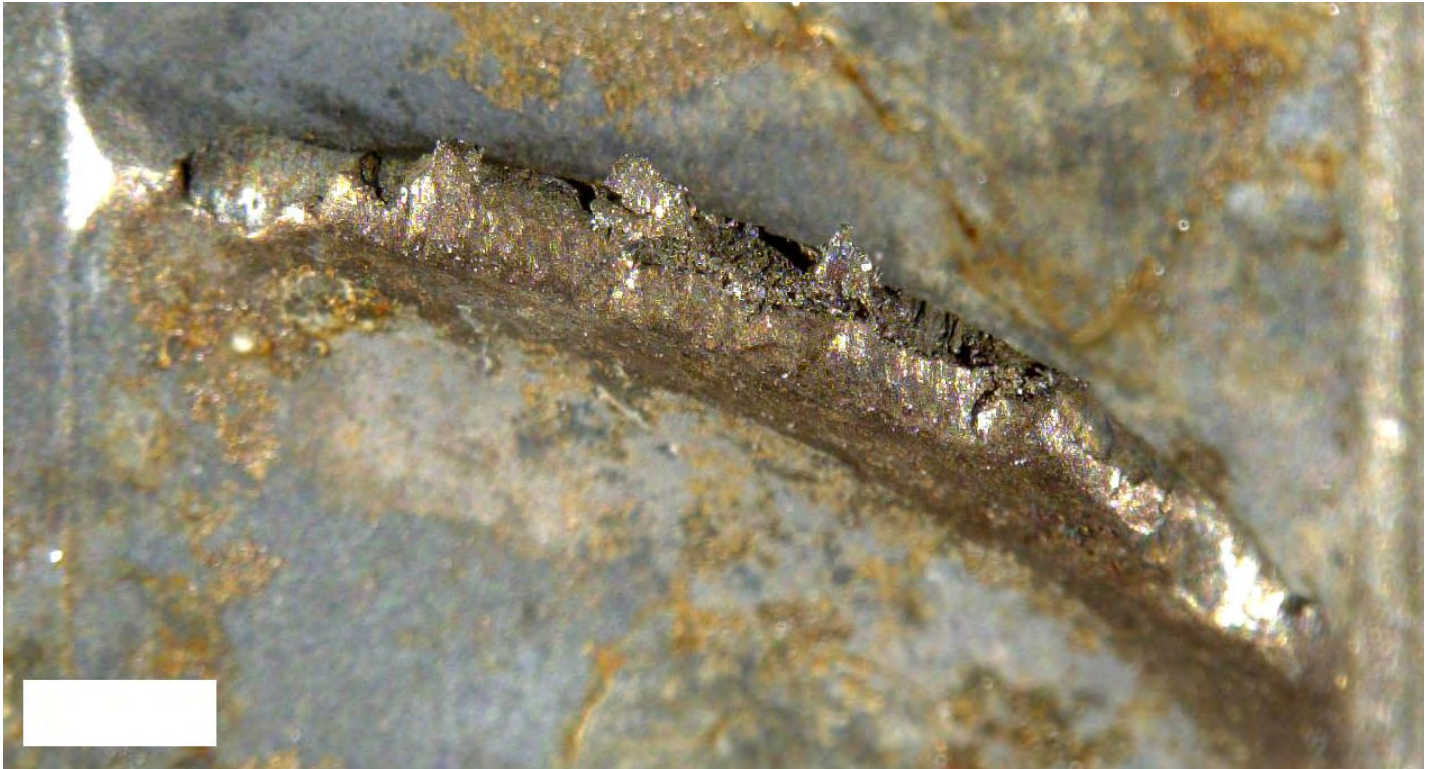
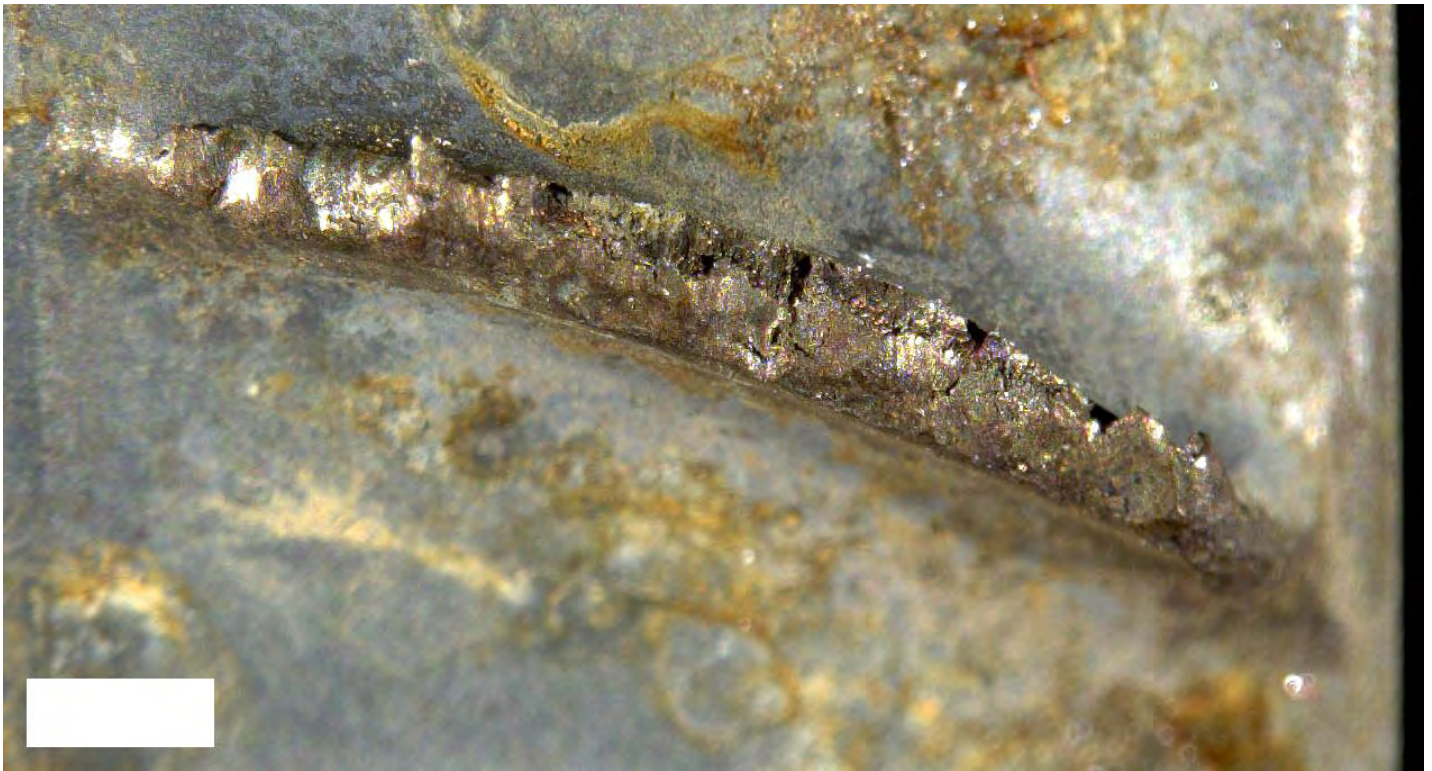
**Figure 59. Detailed views of two stage 5 blade fracture surfaces. No fatigue fracture features were present on either of the fracture surfaces.**

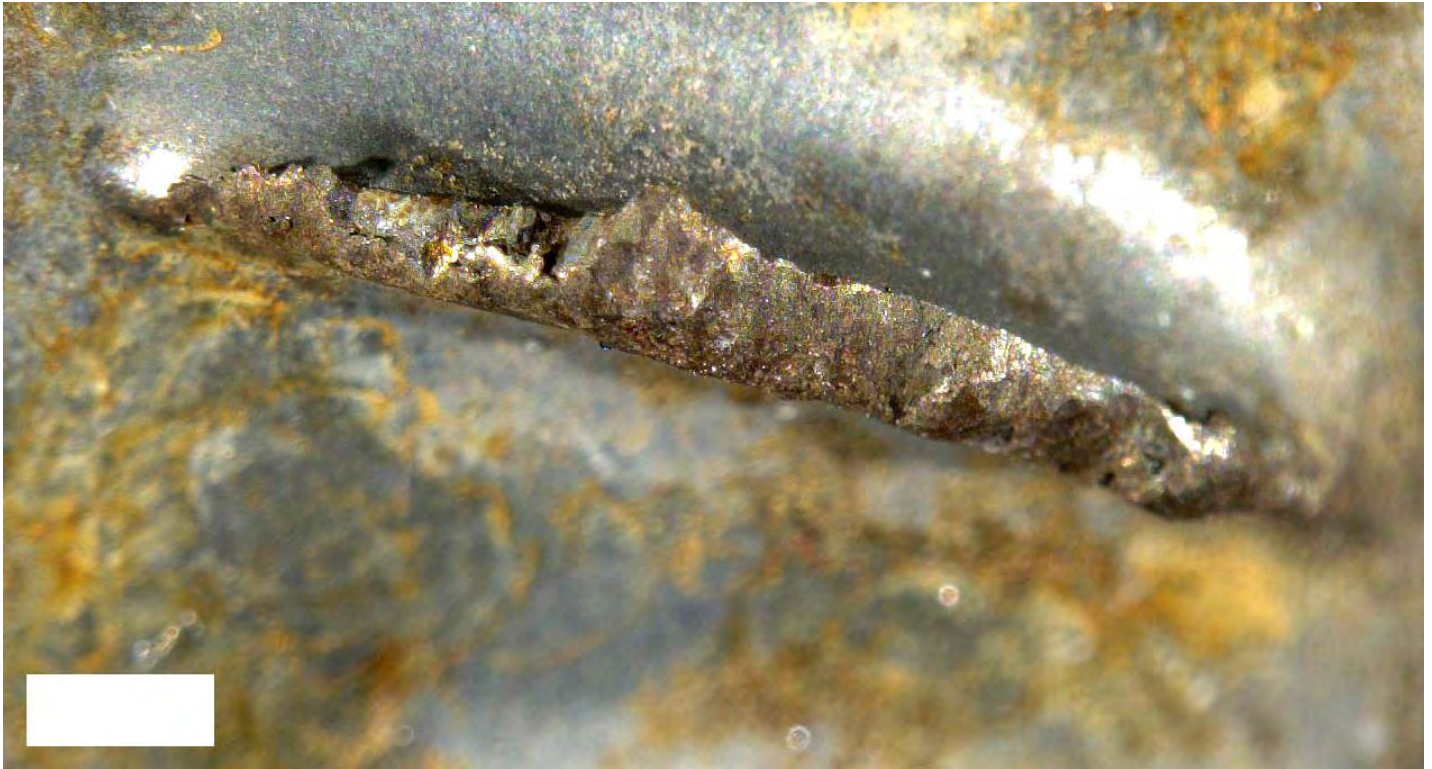
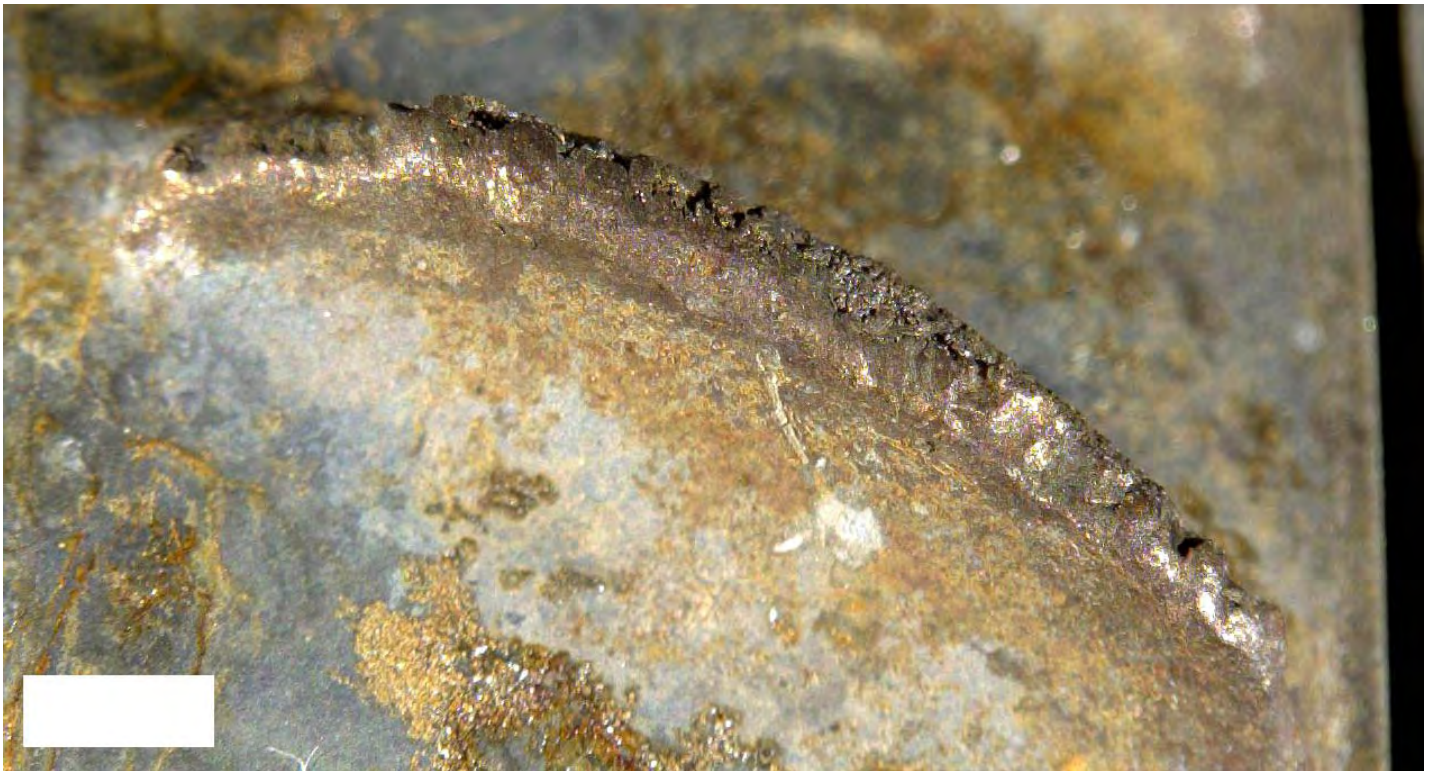
**Figure 60. Detailed views of two stage 5 blade fracture surfaces. No fatigue fracture features were present on either of the fracture surfaces.**

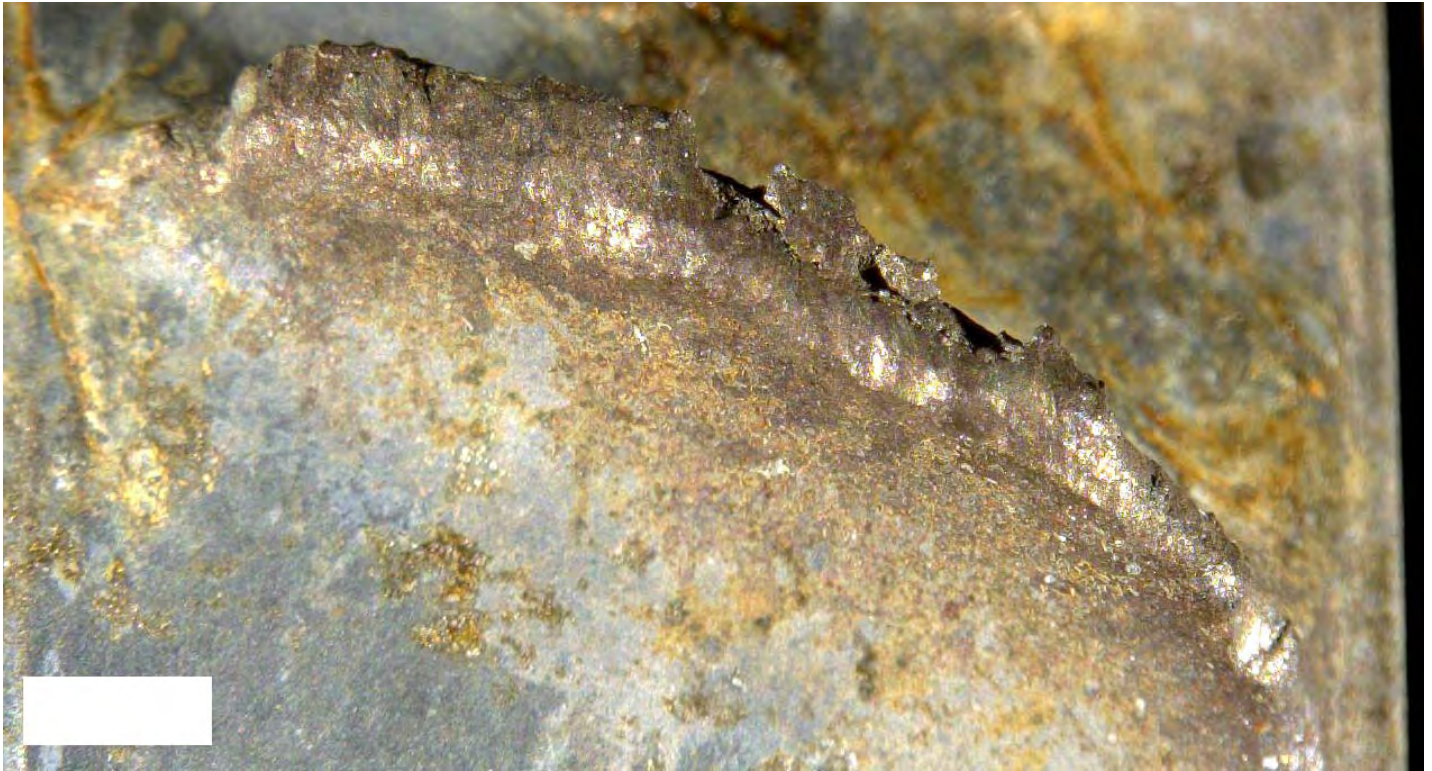
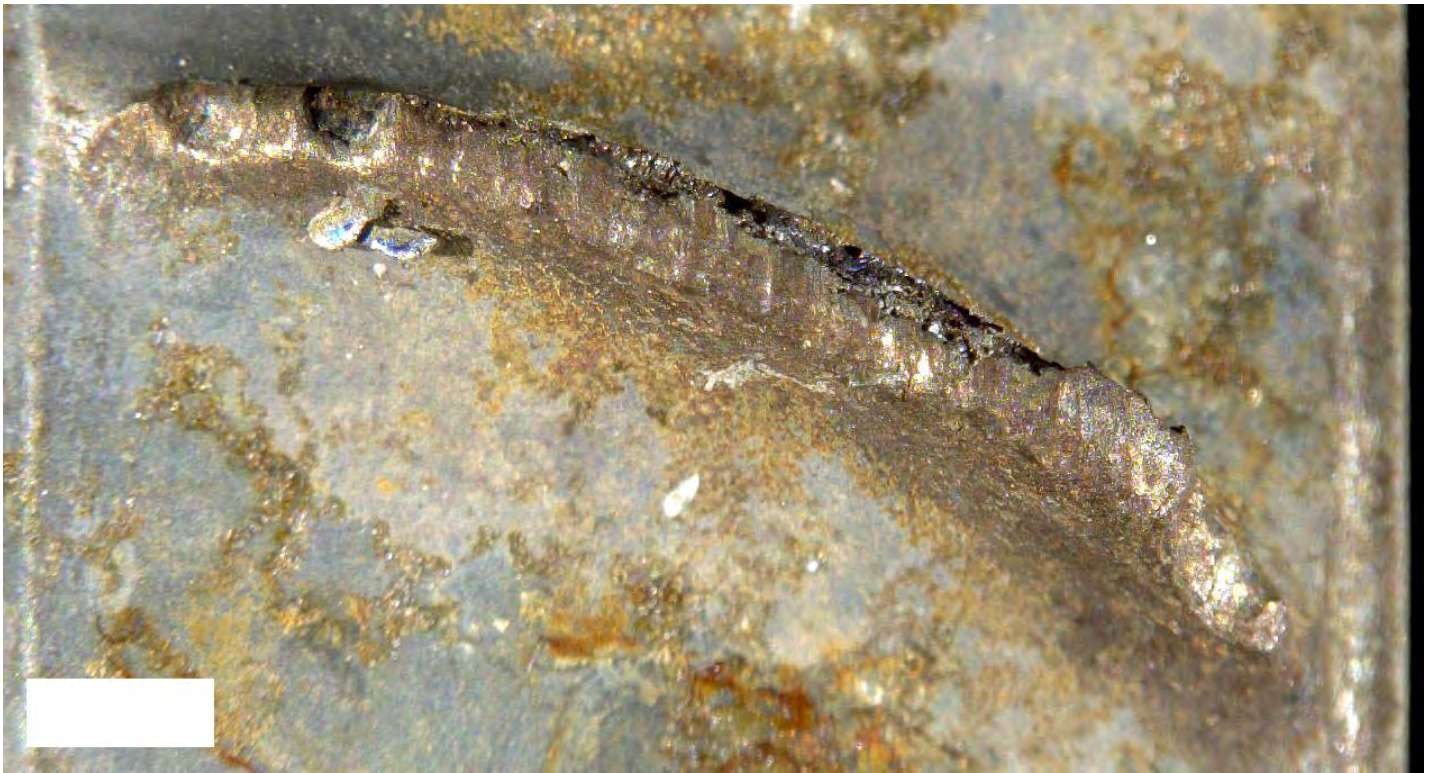
**Figure 61. Detailed views of two stage 5 blade fracture surfaces. No fatigue fracture features were present on either of the fracture surfaces.**

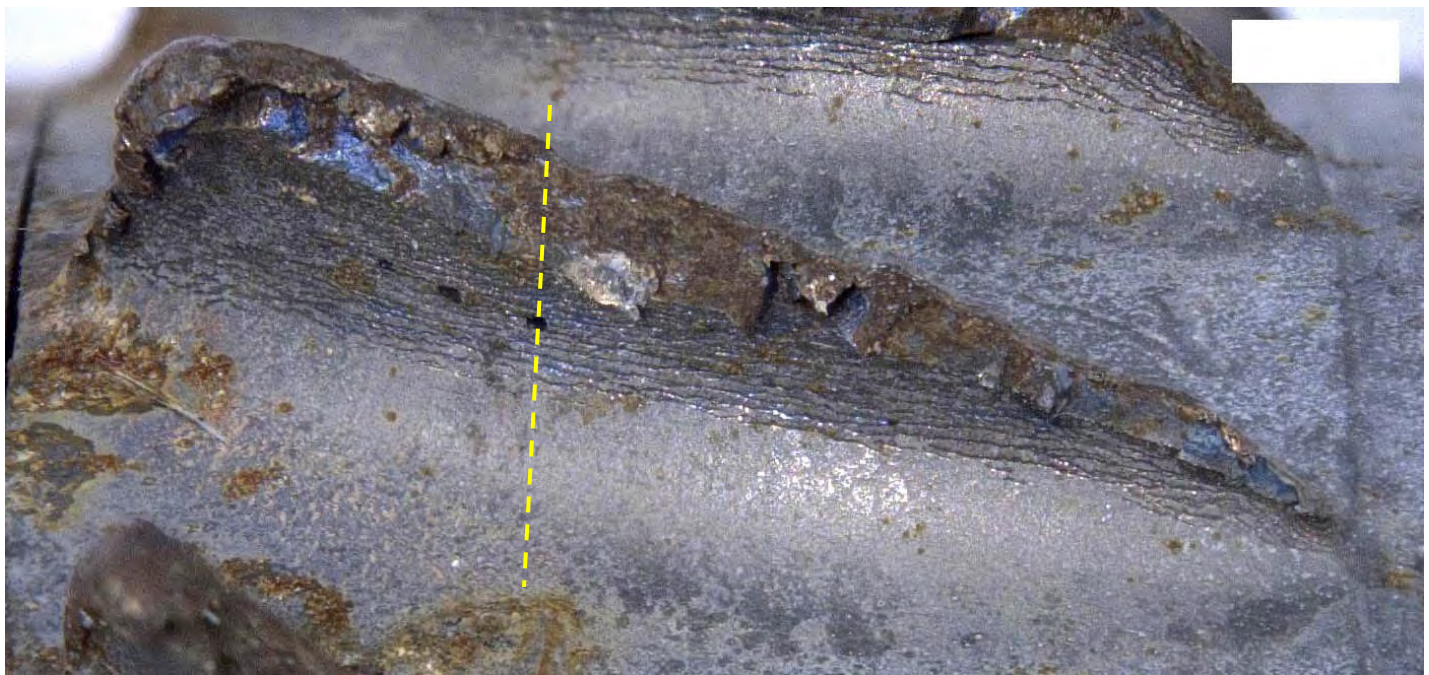
Two representative compressor blades were selected for transverse cross sections through the suction side crown root (see Figures 65 and 74). The cross sections were mounted in slow set epoxy, polished per standard laboratory procedures, and examined in the unetched condition.

The cross section through blade 2 is shown in Figures 91 through 93, and the cross section through blade 11 is shown in Figures 94 through 96. Both cross sections exhibited multiple cracks on both the pressure side and suction side surfaces.

**Figure 65. Detailed views of the fracture surface (top) and suction side surface (bottom) of stage 6 compressor blade 2 (see Figures 62 and 63). The red arrows indicate the local direction of fatigue progression. The yellow line indicates the plane of metallographic cross section in Figure 91.**

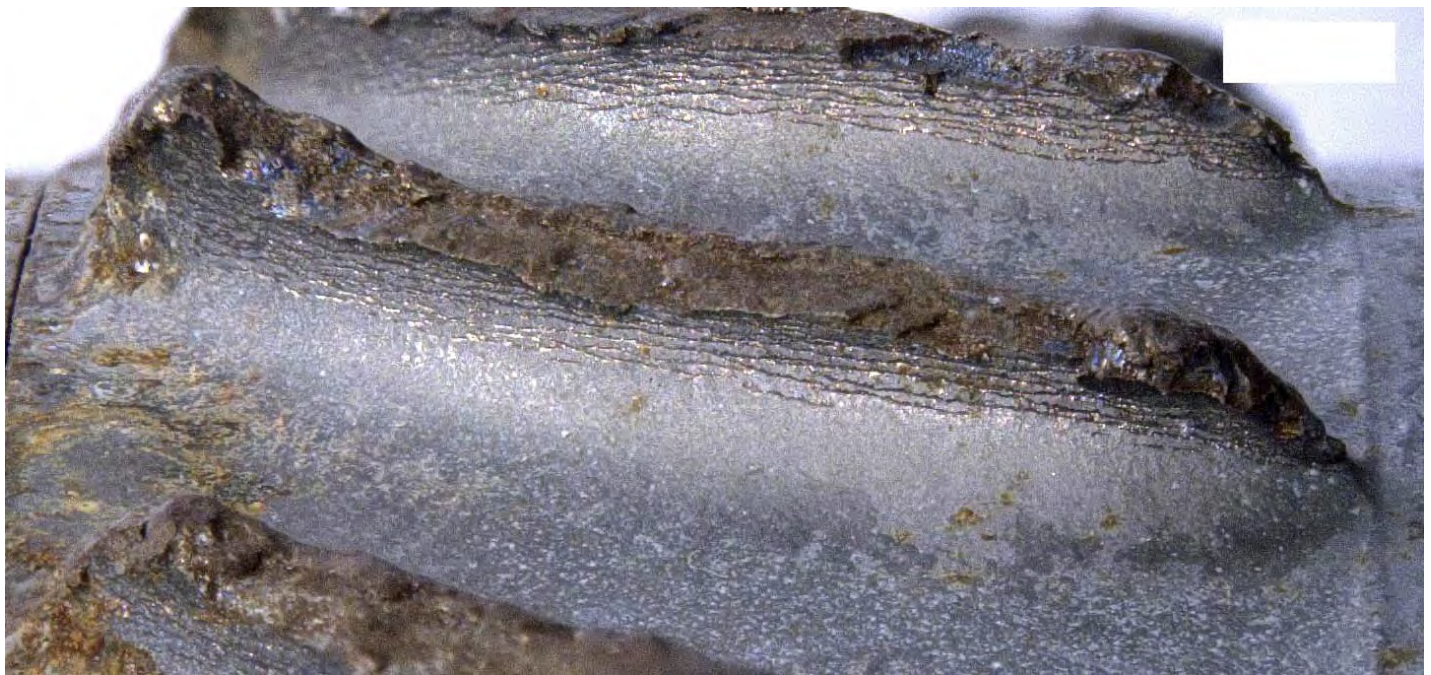
**Figure 67.** Detailed views of the fracture surface (top) and suction side surface (bottom) of stage 6 compressor blade 4 (see Figures 62 and 63). The red arrow indicates the local direction of fatigue progression. The yellow arrows indicate ratchet marks consistent with fatigue initiation on the suction side surface.

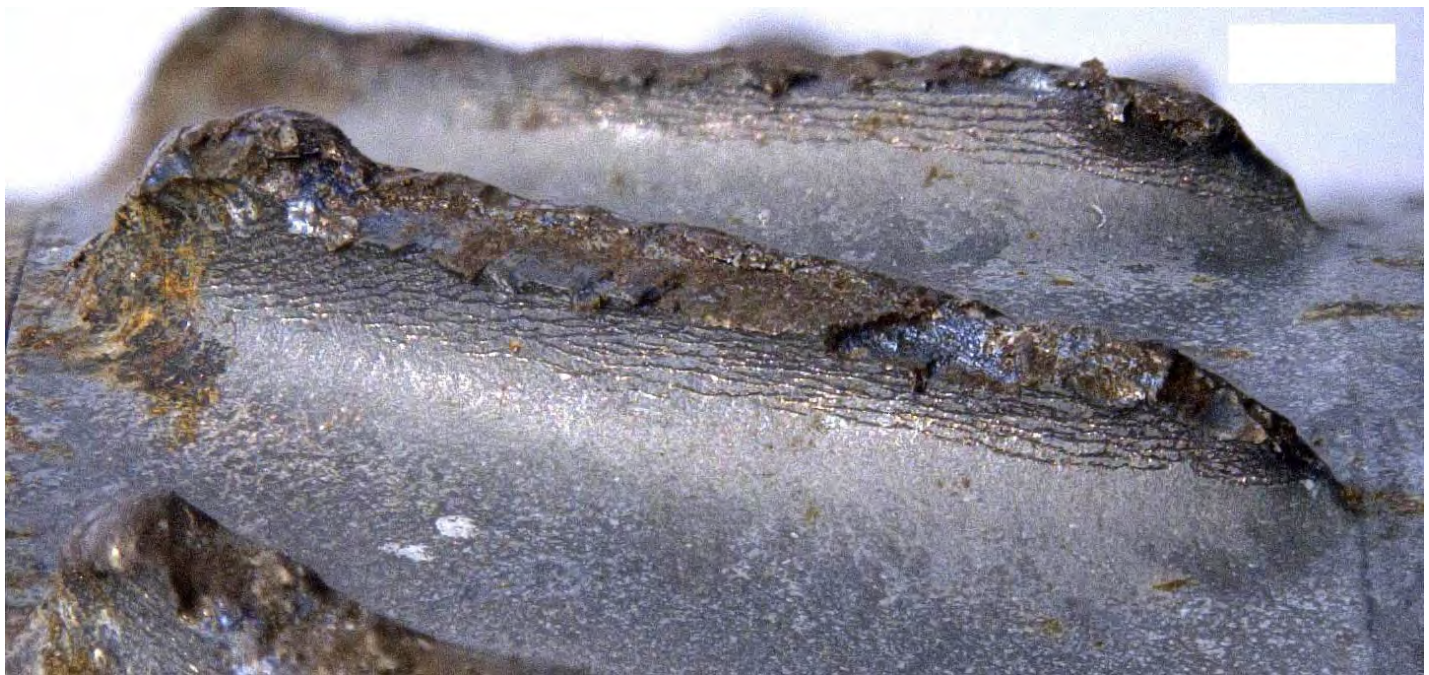
**Figure 68.** Detailed views of the fracture surface (top) and suction side surface (bottom) of stage 6 compressor blade 5 (see Figures 62 and 63). The red arrows indicate the direction of fatigue progression.

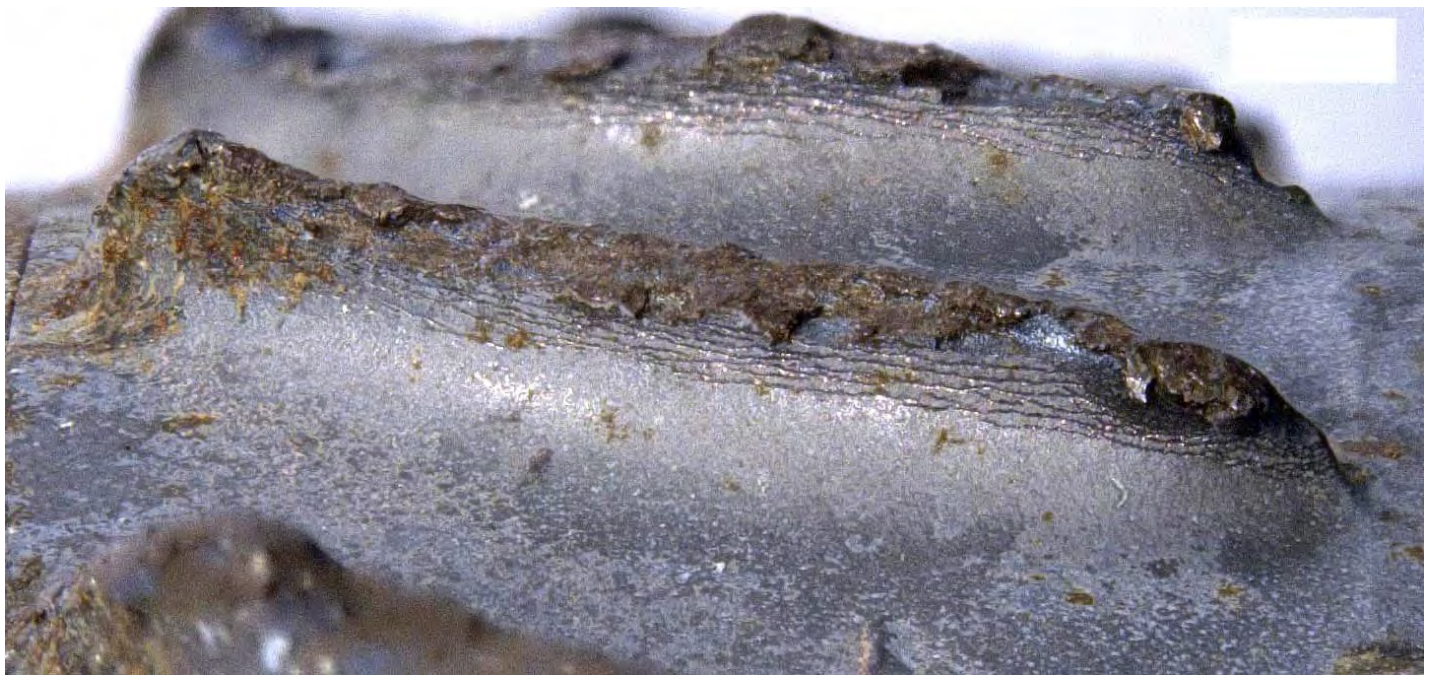
**Figure 69.** Detailed views of the fracture surface (top) and suction side surface (bottom) of stage 6 compressor blade 6 (see Figures 62 and 63). The red arrow indicates the local direction of fatigue progression. The yellow arrows indicate ratchet marks consistent with fatigue initiation on the suction side surface.
