## **AIRWORTHINESS GROUP FACTUAL REPORT**

**NTSB No. ERA21FA130**

**Rolls-Royce Materials Evaluation Report No. 21FAE-025-PR  
(111 pages)**

| <b>TITLE</b><br><br><b>METALLURGICAL INVESTIGATION OF COMPRESSOR COMPONENTS REMOVED FROM AN M250-C20B, ENGINE S/N CAE833459, OPERATED BY CARIBBEAN BUZZ HELICOPTER</b> | | <b>PREPARED</b><br>Signatures on File | | |

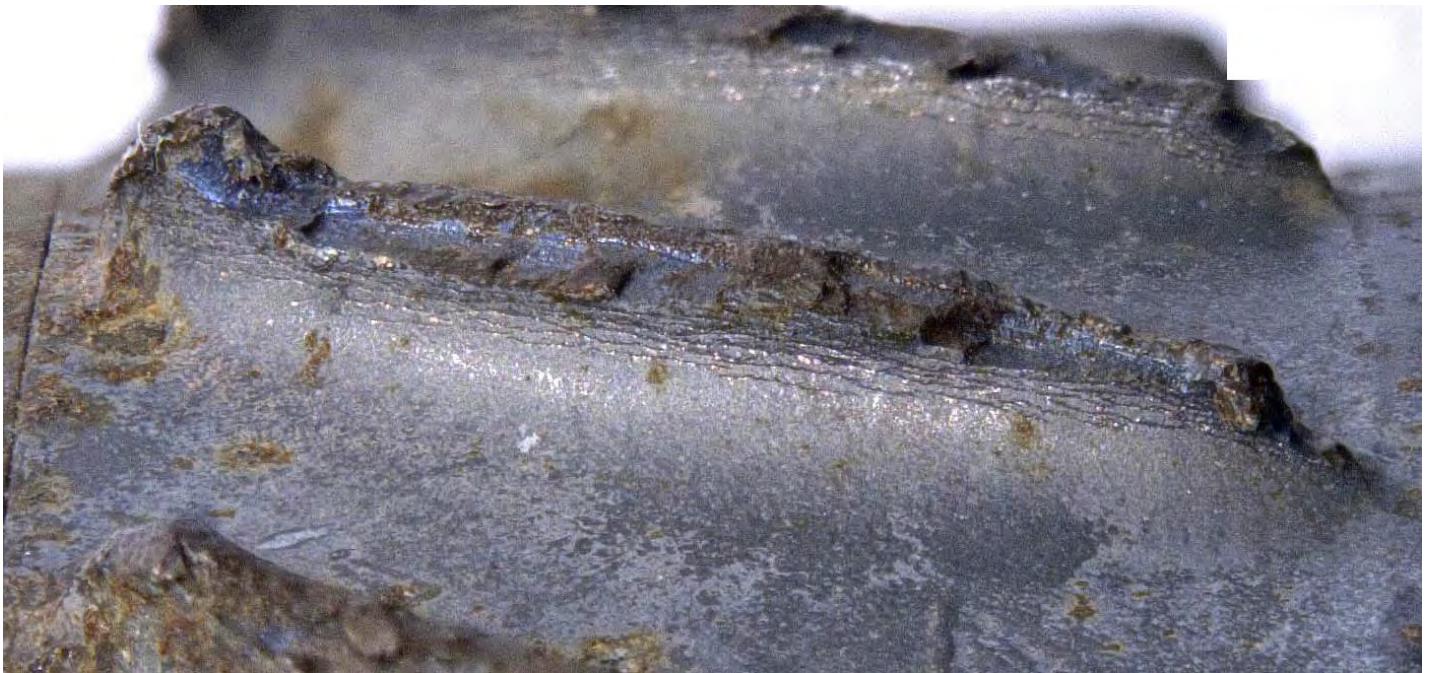
**Figure 70.** Detailed views of the fracture surface (top) and suction side surface (bottom) of stage 6 compressor blade 7 (see Figures 62 and 63). The red arrows indicate the local direction of fatigue progression. The yellow arrows indicate ratchet marks consistent with fatigue initiation on the suction side surface.

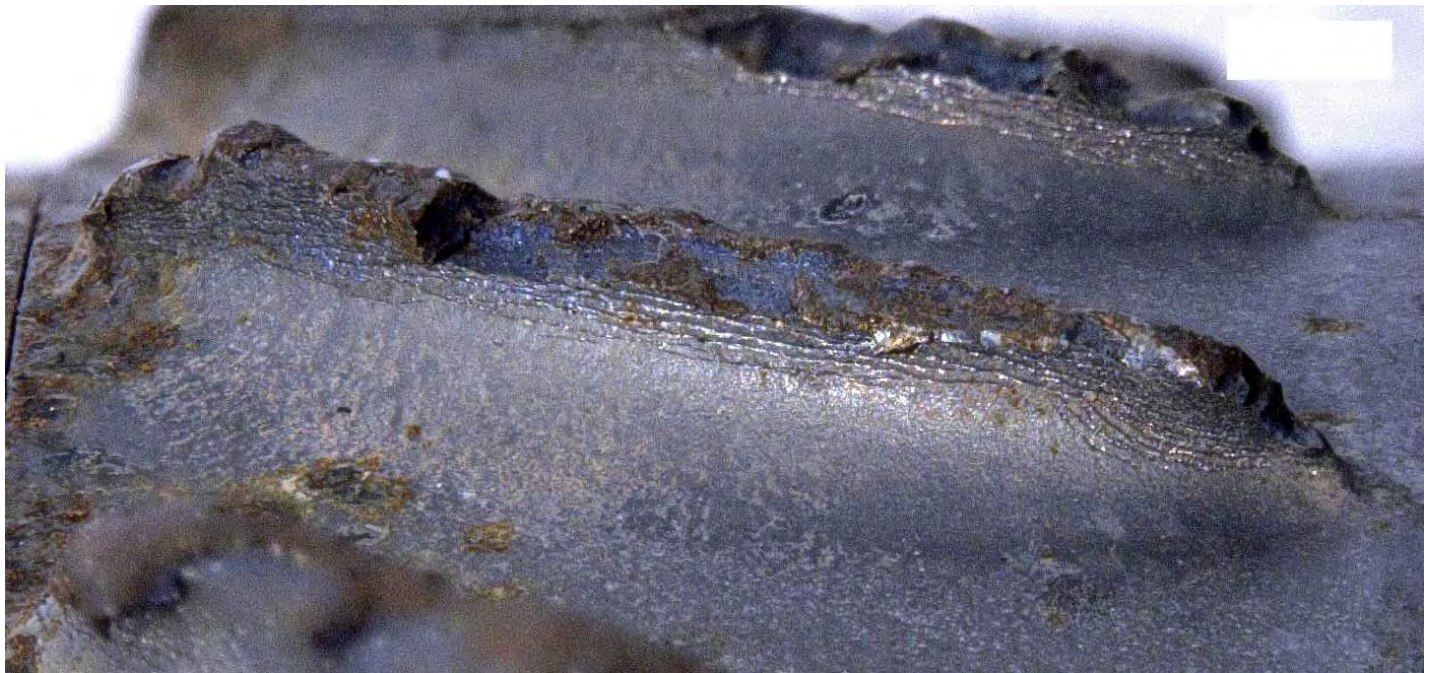
**Figure 72.** Detailed views of the fracture surface (top) and suction side surface (bottom) of stage 6 compressor blade 9 (see Figures 62 and 63). The red arrows indicate the direction of fatigue progression. The yellow arrows indicate ratchet marks consistent with fatigue initiation on the suction side surface.

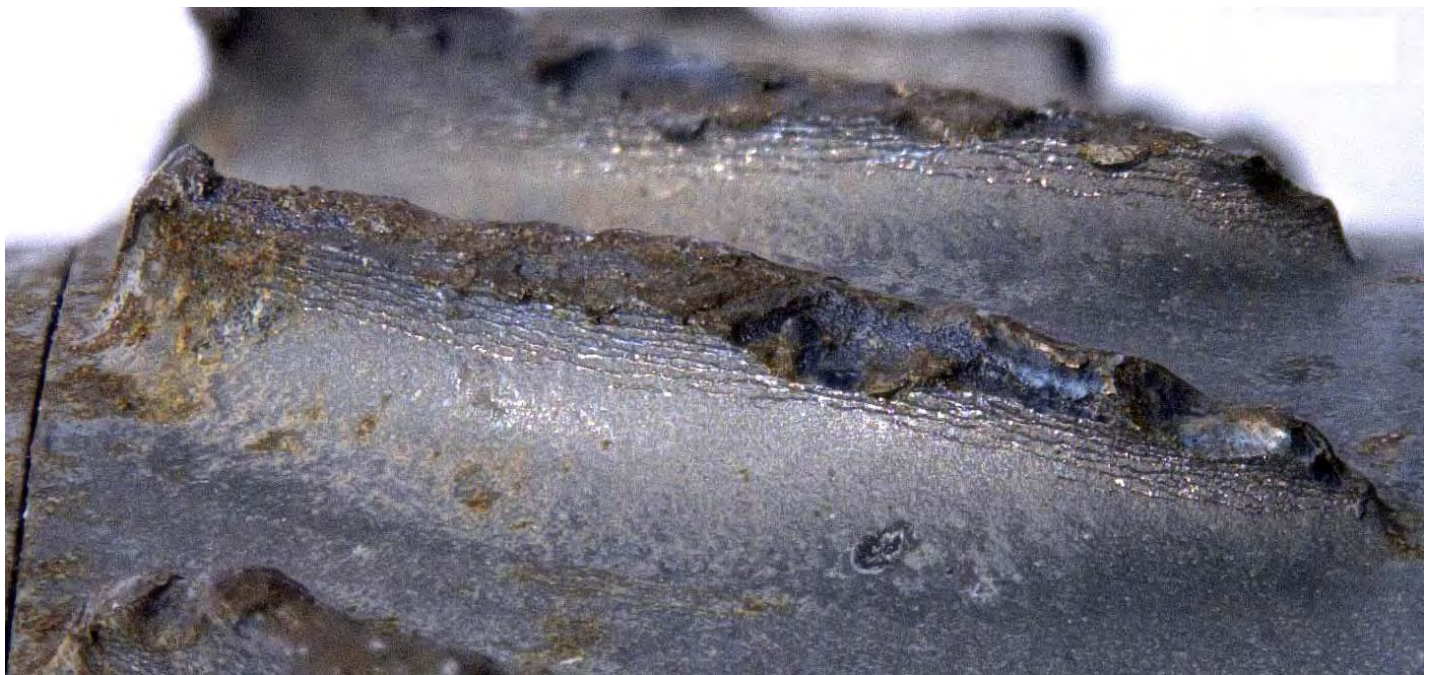
**Figure 73. Detailed views of the fracture surface (top) and suction side surface (bottom) of stage 6 compressor blade 10 (see Figures 62 and 63). The red arrows indicate the direction of fatigue progression. The yellow arrow indicates a ratchet mark consistent with fatigue initiation on the suction side surface.**

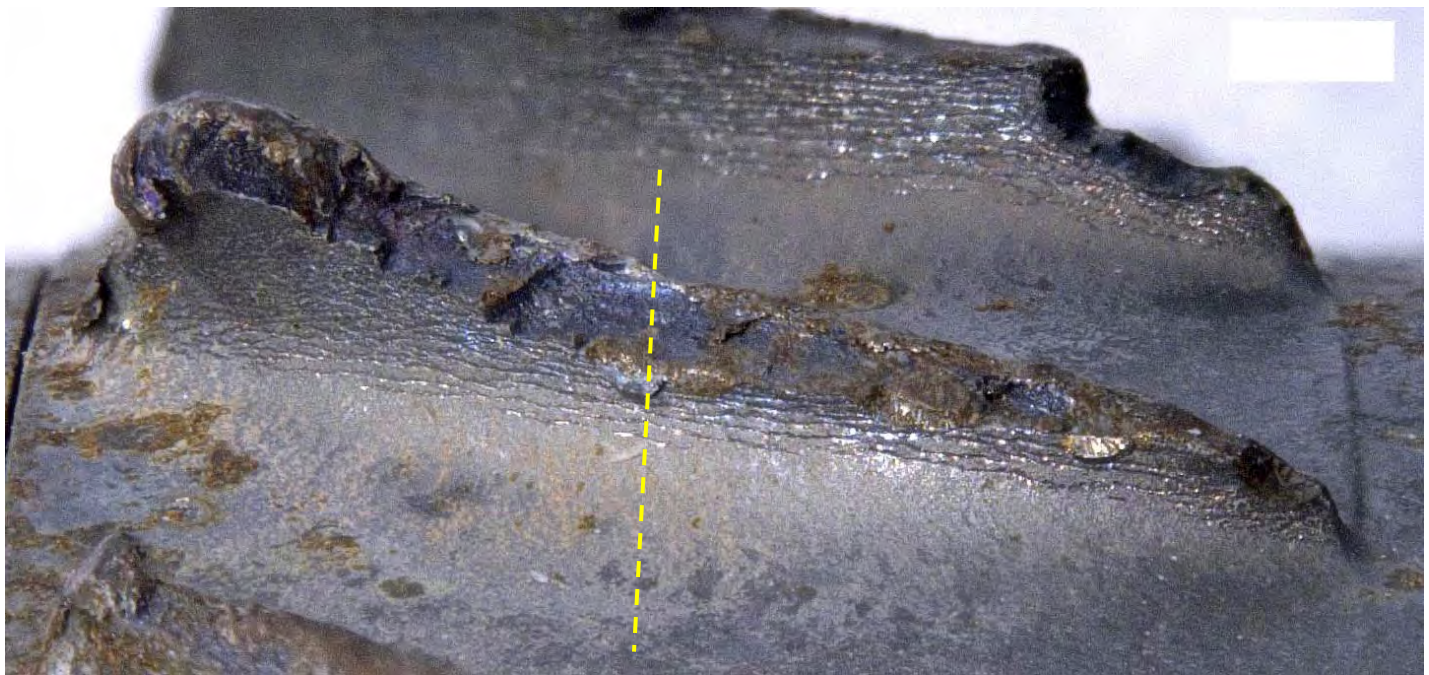
Two representative compressor blades were selected for transverse cross sections through the suction side crown root (see Figures 65 and 74). The cross sections were mounted in slow set epoxy, polished per standard laboratory procedures, and examined in the unetched condition.

The cross section through blade 2 is shown in Figures 91 through 93, and the cross section through blade 11 is shown in Figures 94 through 96. Both cross sections exhibited multiple cracks on both the pressure side and suction side surfaces.

**Figure 74.** Detailed views of the fracture surface (top) and suction side surface (bottom) of stage 6 compressor blade 11 (see Figures 62 and 63). The red arrows indicate the local direction of fatigue progression. The yellow arrows indicate ratchet marks consistent with fatigue initiation on the suction side surface. The yellow line indicates the plane of metallographic cross section in Figure 94.

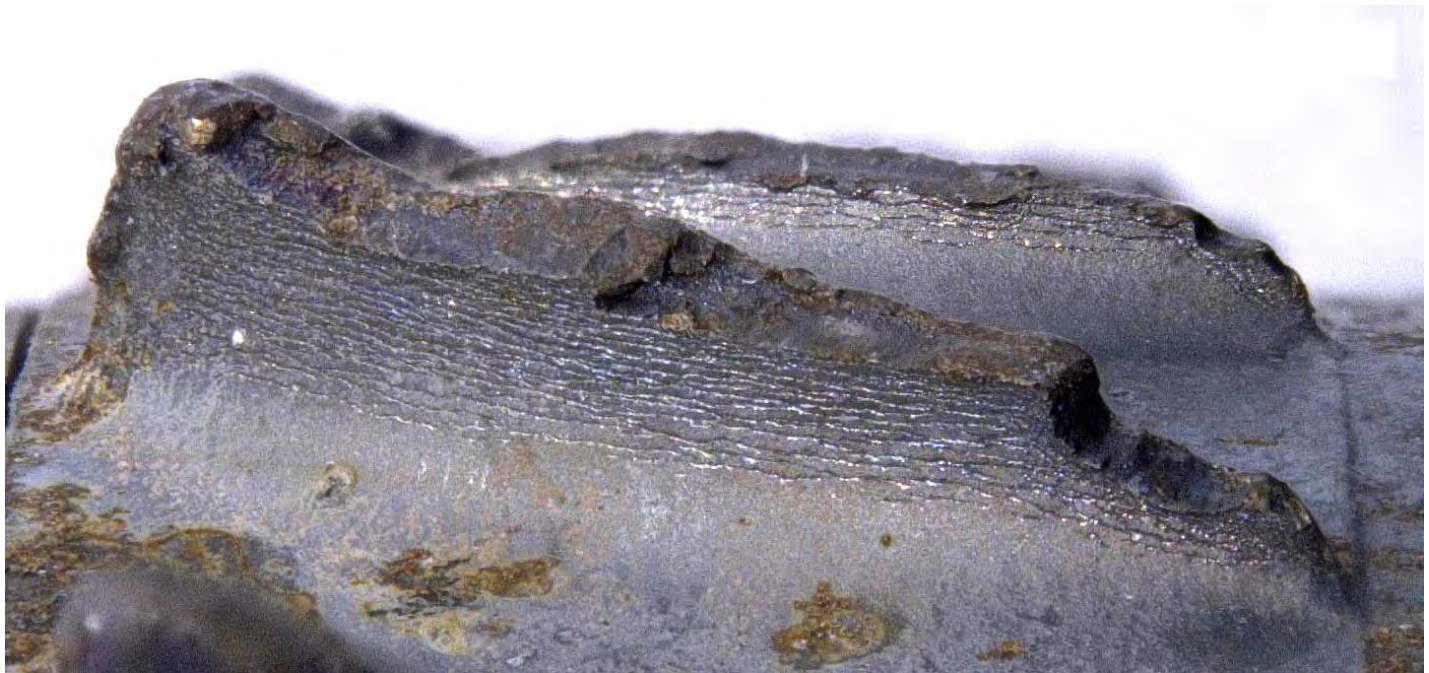
**Figure 75.** Detailed views of the fracture surface (top) and suction side surface (bottom) of stage 6 compressor blade 12 (see Figures 62 and 63). The red arrows indicate the local direction of fatigue progression. The yellow arrows indicate ratchet marks consistent with fatigue initiation on the suction side surface.

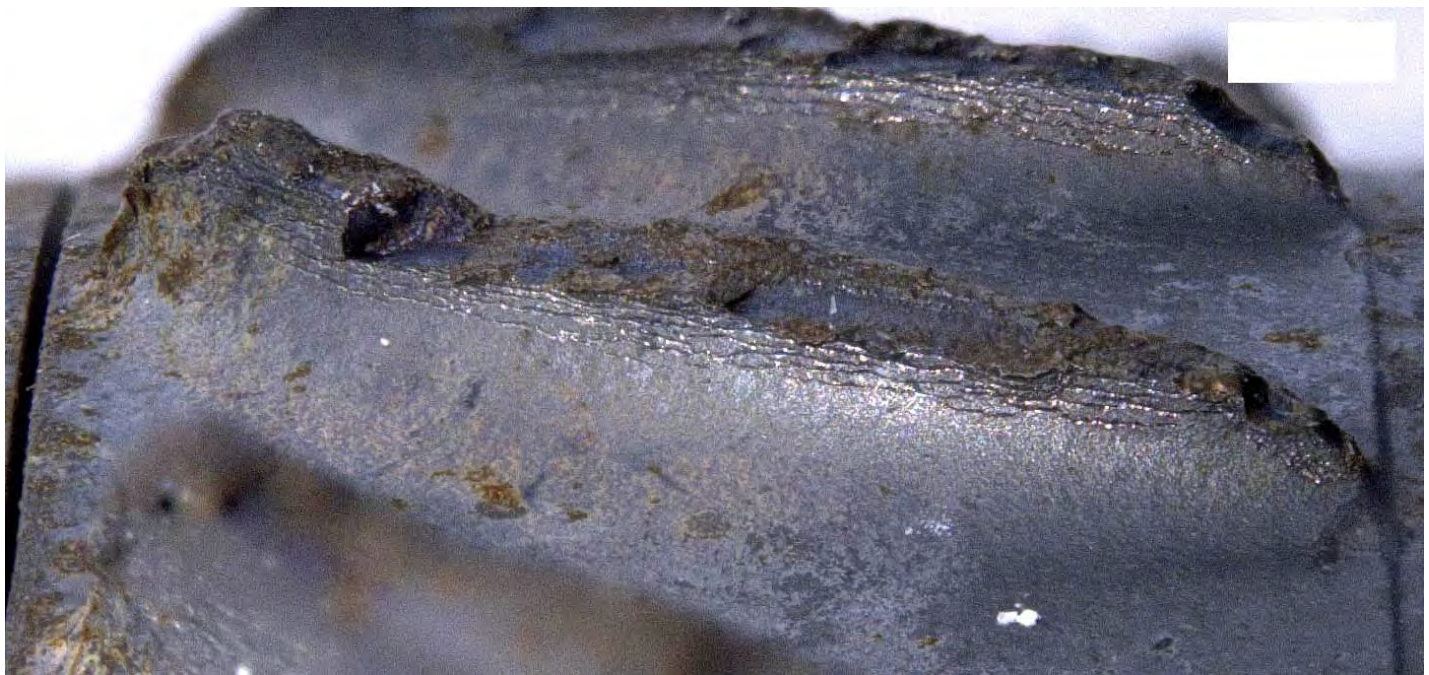
**Figure 76. Detailed views of the fracture surface (top) and suction side surface (bottom) of stage 6 compressor blade 13 (see Figures 62 and 63). The red arrows indicate the local direction of fatigue progression. The yellow arrows indicate ratchet marks consistent with fatigue initiation on the suction side surface.**

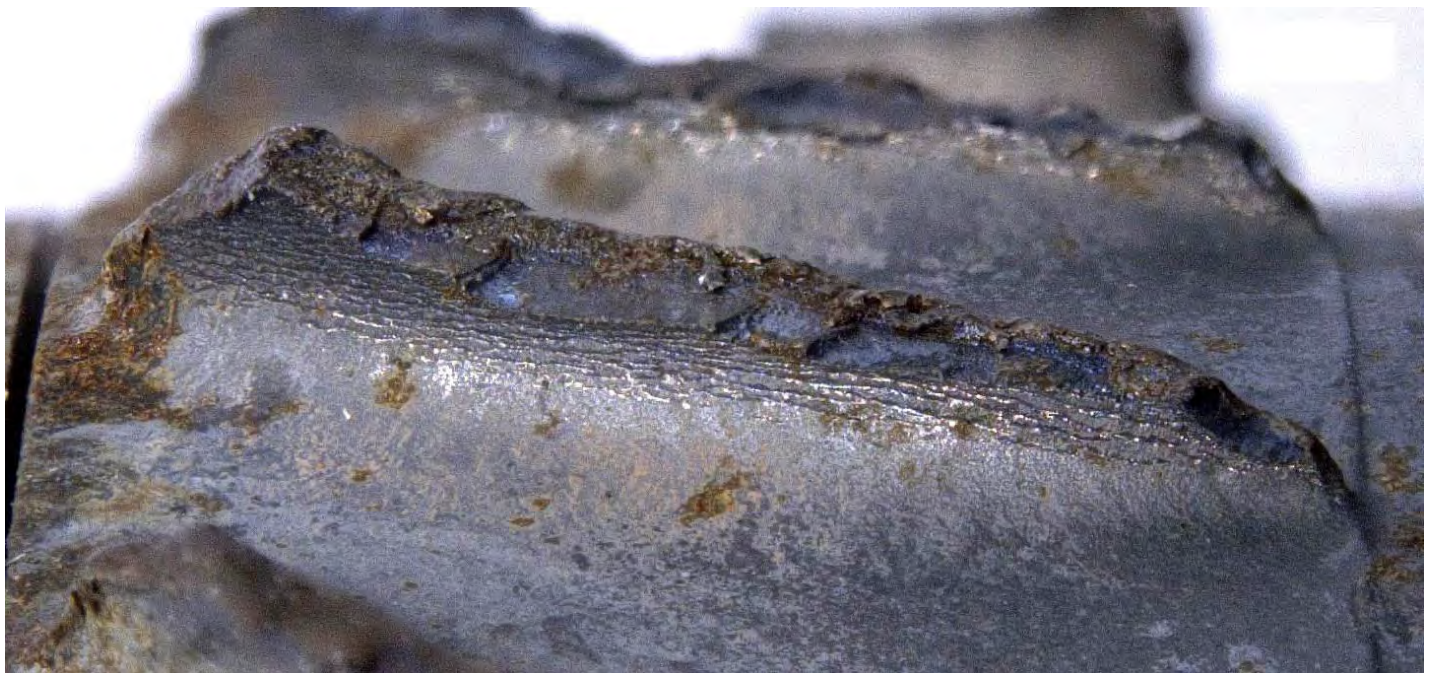
Figures 64 through 88 show the fracture surfaces and suction side surfaces of the stage 3 blades. Every fracture surface, except for one, exhibited fatigue progression from multiple origins near the suction side crown root. Every airfoil suction side surface also exhibited parallel coating cracking. All the airfoils exhibited this cracking on the entirety of the suction side surface. The airfoil that did not exhibit fatigue fracture features did have a crack on the suction side surface when observed in the SEM (see Figure 89), and laboratory fracture of the crack revealed fatigue progression from multiple origins near the suction side crown root on this airfoil as well (see Figure 90). Detailed SEM examination of all the fracture surfaces revealed that the fine fatigue fracture features were obliterated by smearing damage.

**Figure 77.** Detailed views of the fracture surface (top) and suction side surface (bottom) of stage 6 compressor blade 14 (see Figures 62 and 63). The red arrows indicate the local direction of fatigue progression. The yellow arrows indicate ratchet marks consistent with fatigue initiation on the suction side surface.

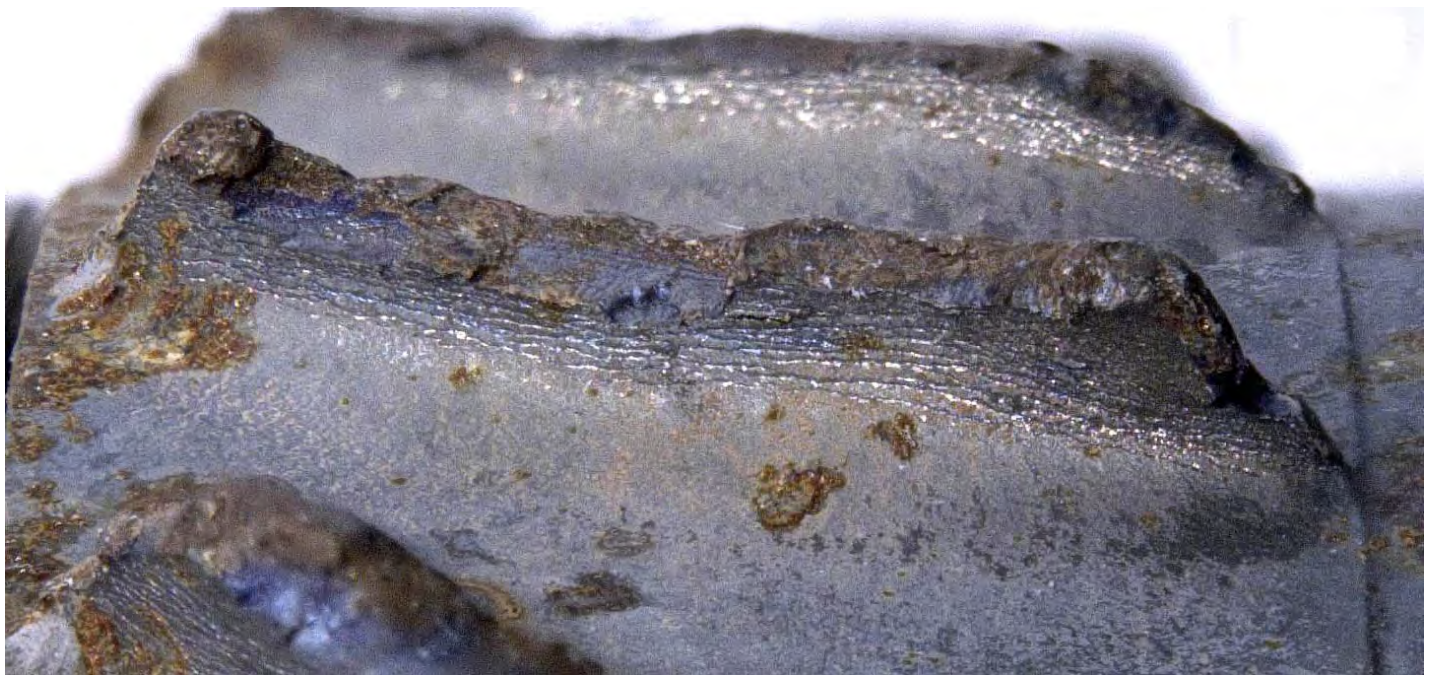
**Figure 79.** Detailed views of the fracture surface (top) and suction side surface (bottom) of stage 6 compressor blade 16 (see Figures 62 and 63). The red arrows indicate the local direction of fatigue progression. The yellow arrows indicate ratchet marks consistent with fatigue initiation on the suction side surface.

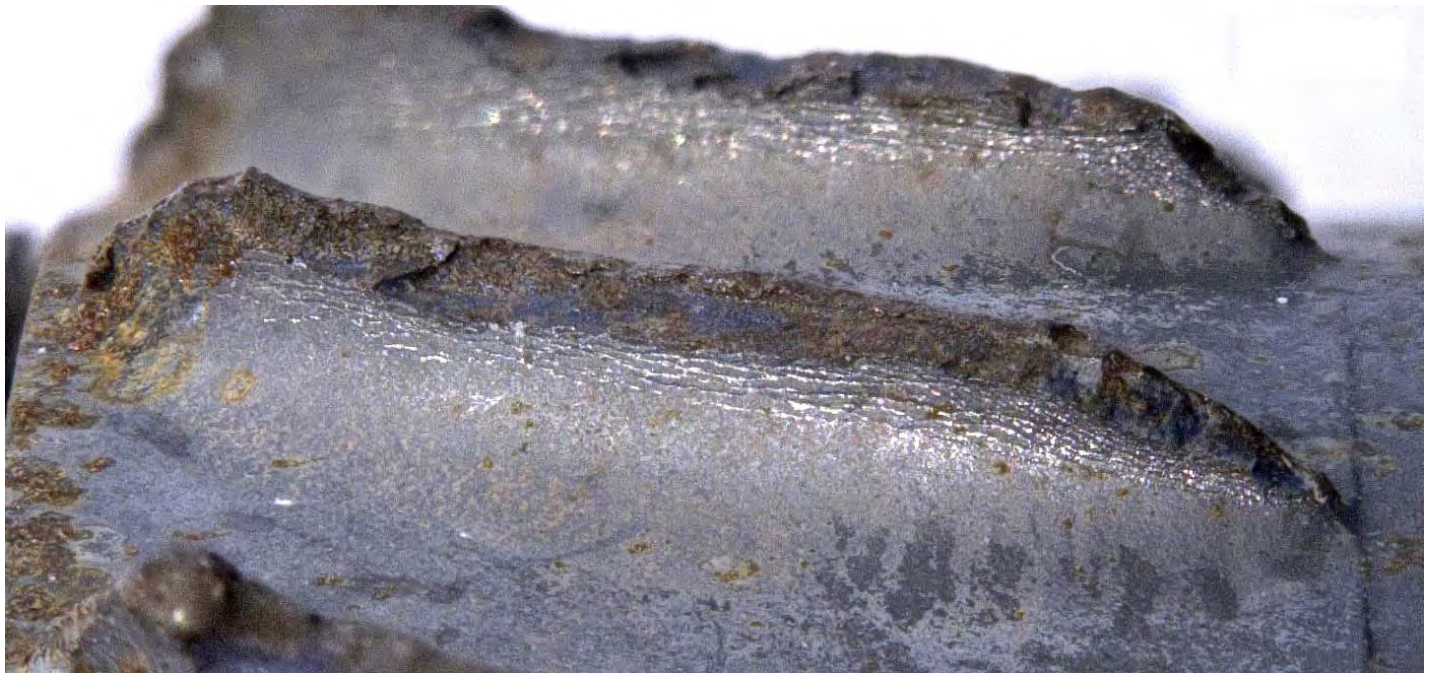
**Figure 80.** Detailed views of the fracture surface (top) and suction side surface (bottom) of stage 6 compressor blade 17 (see Figures 62 and 63). The red arrows indicate the local direction of fatigue progression. The yellow arrows indicate ratchet marks consistent with fatigue initiation on the suction side surface.

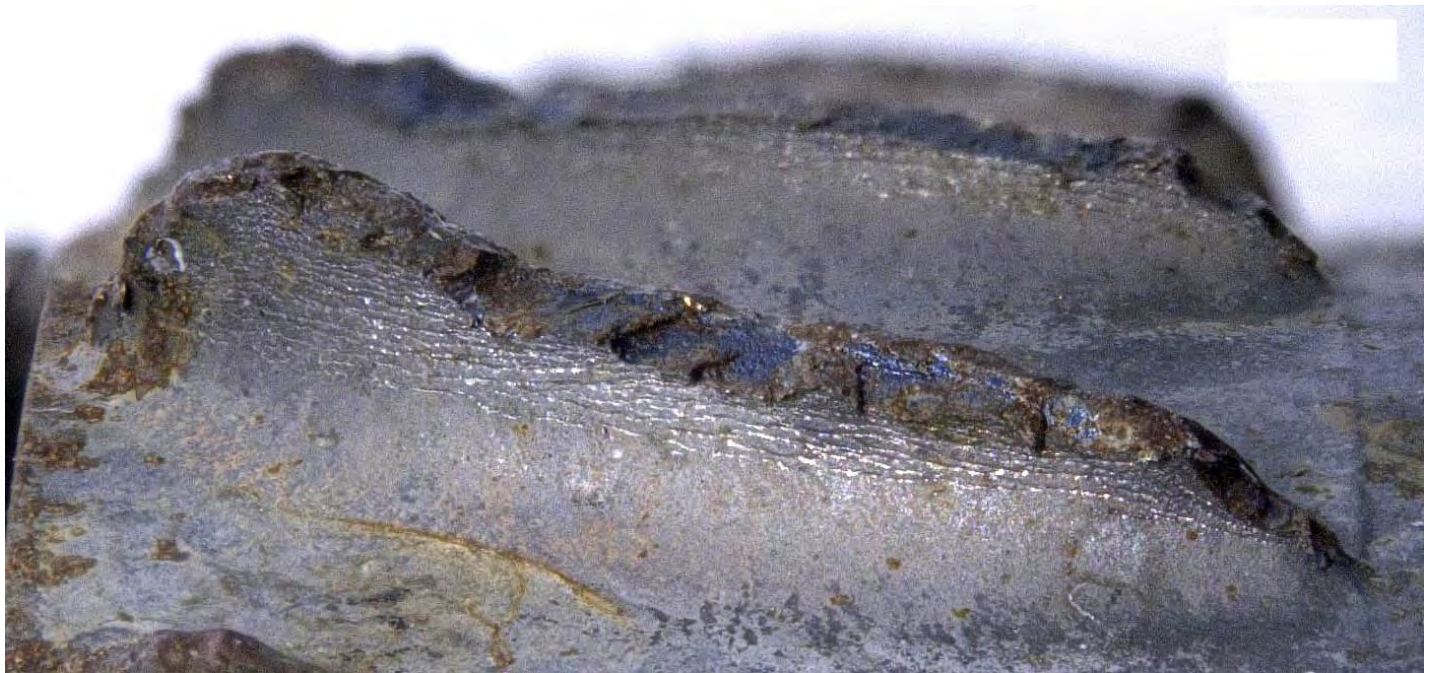
**Figure 81.** Detailed views of the fracture surface (top) and suction side surface (bottom) of stage 6 compressor blade 18 (see Figures 62 and 63). The red arrows indicate the local direction of fatigue progression. The yellow arrows indicate ratchet marks consistent with fatigue initiation on the suction side surface.

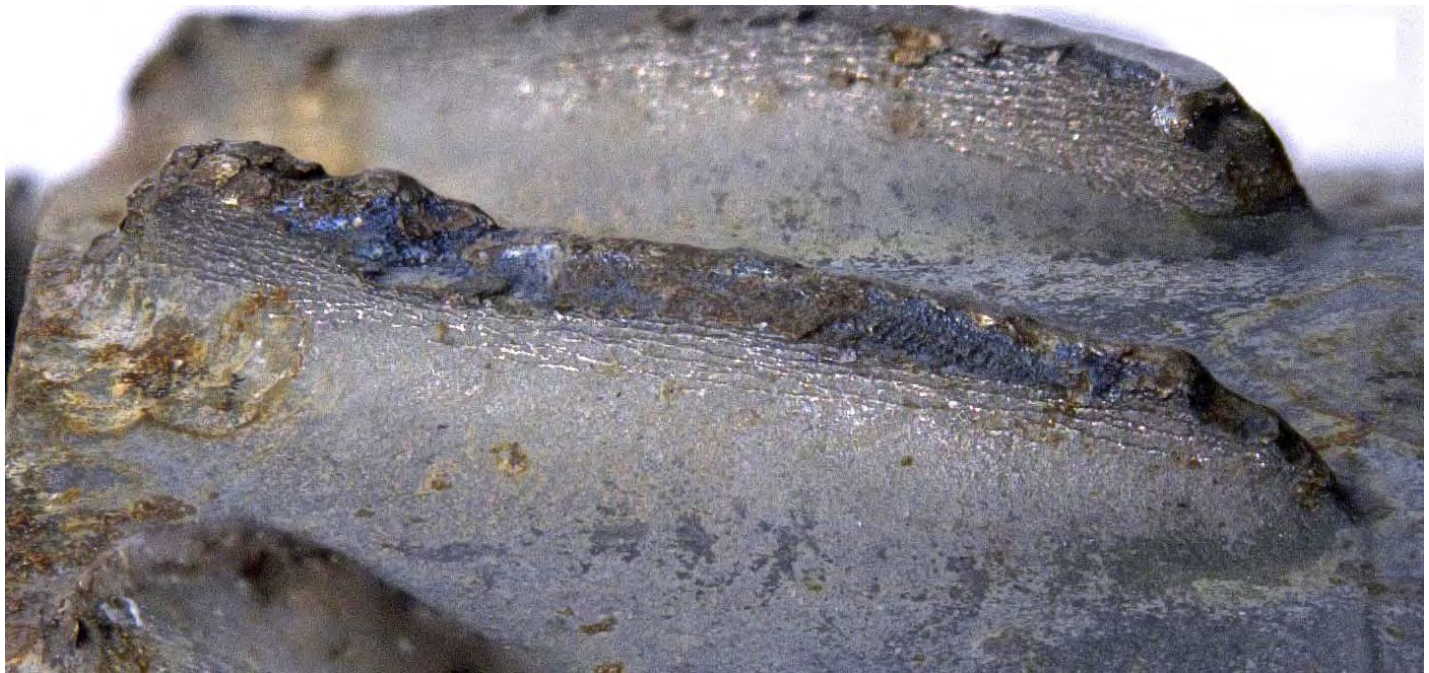
**Figure 82.** Detailed views of the fracture surface (top) and suction side surface (bottom) of stage 6 compressor blade 19 (see Figures 62 and 63). The red arrows indicate the local direction of fatigue progression. The yellow arrows indicate ratchet marks consistent with fatigue initiation on the suction side surface.

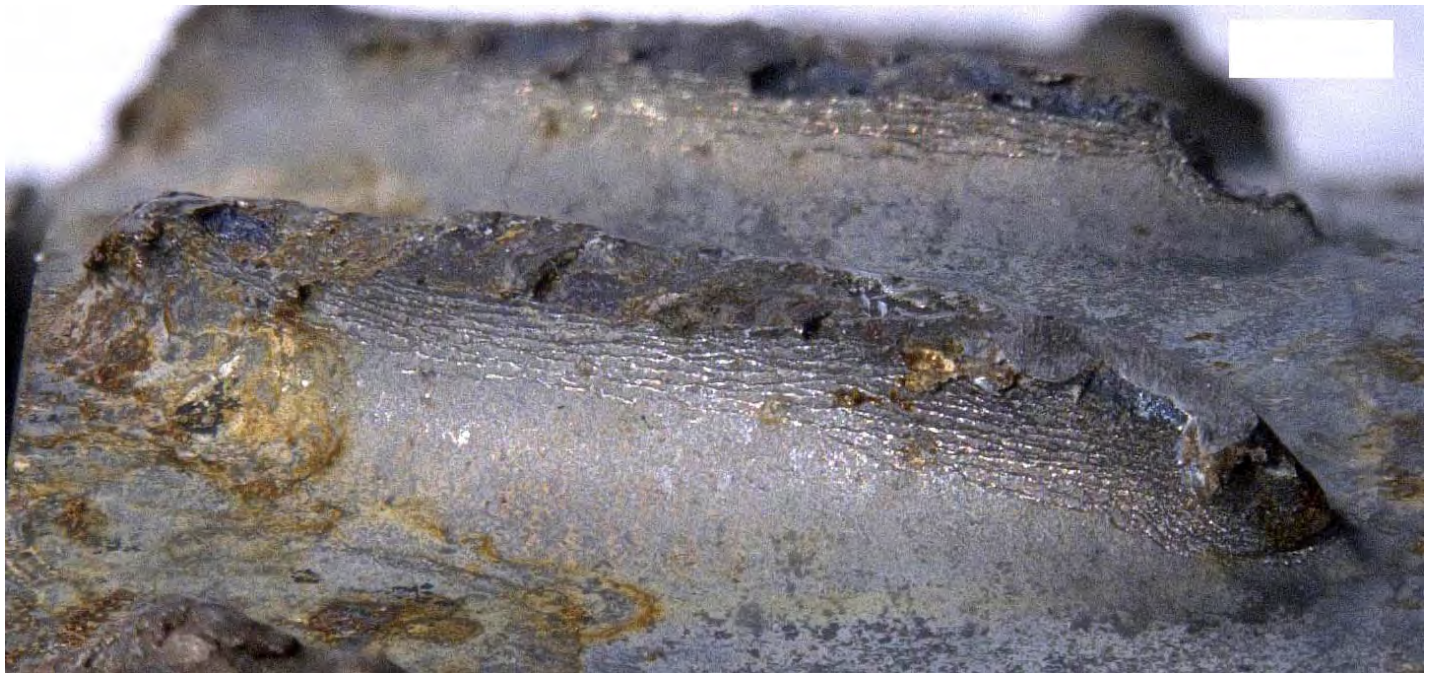
**Figure 83.** Detailed views of the fracture surface (top) and suction side surface (bottom) of stage 6 compressor blade 20 (see Figures 62 and 63). The red arrows indicate the local direction of fatigue progression. The yellow arrows indicate ratchet marks consistent with fatigue initiation on the suction side surface.

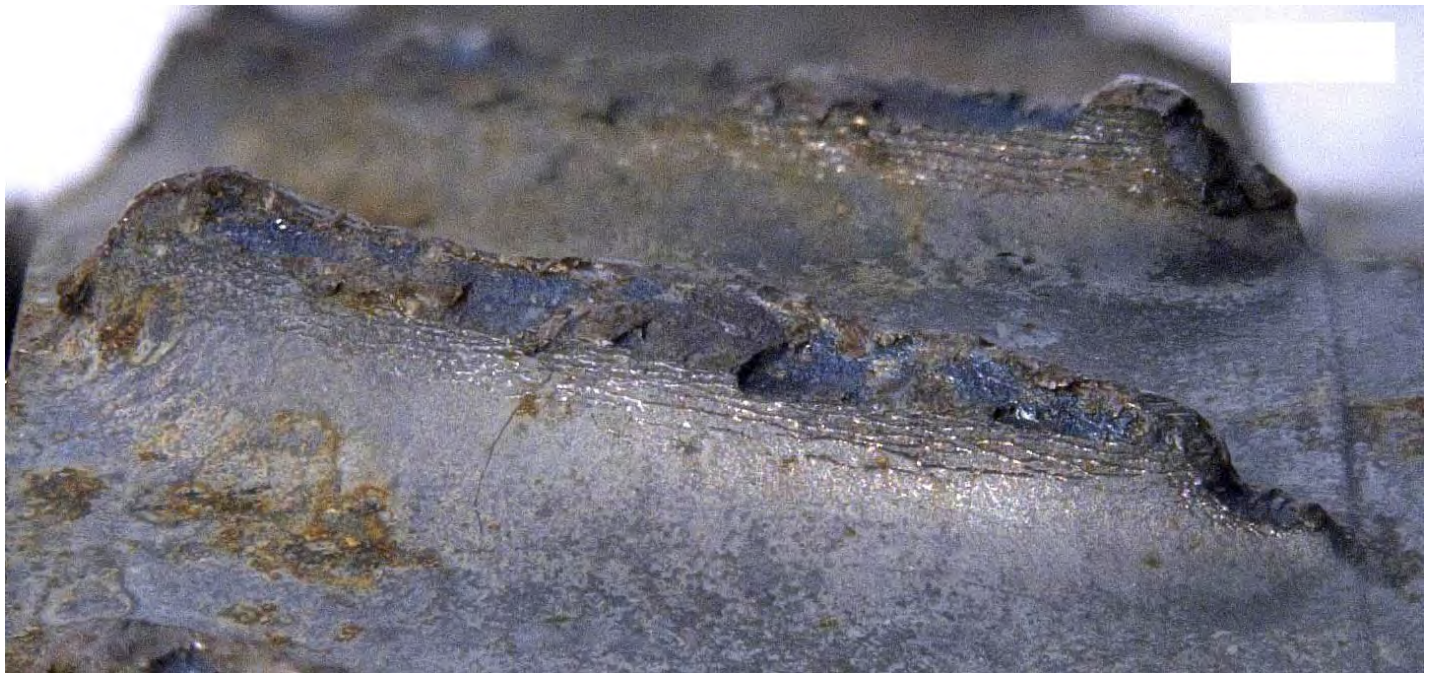
**Figure 84.** Detailed views of the fracture surface (top) and suction side surface (bottom) of stage 6 compressor blade 21 (see Figures 62 and 63). The red arrows indicate the local direction of fatigue progression. The yellow arrow indicates a ratchet mark consistent with fatigue initiation on the suction side surface.

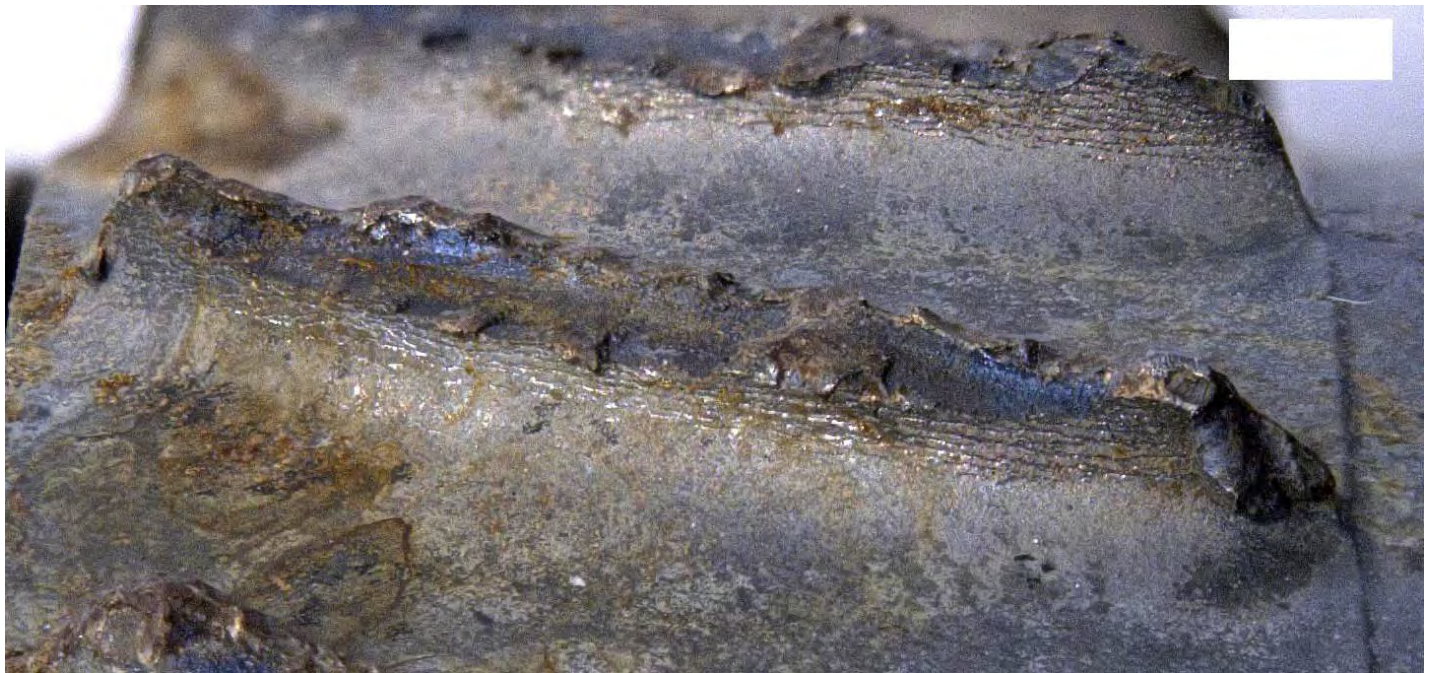
**Figure 85.** Detailed views of the fracture surface (top) and suction side surface (bottom) of stage 6 compressor blade 22 (see Figures 62 and 63). The red arrows indicate the local direction of fatigue progression. The yellow arrows indicate ratchet marks consistent with fatigue initiation on the suction side surface.

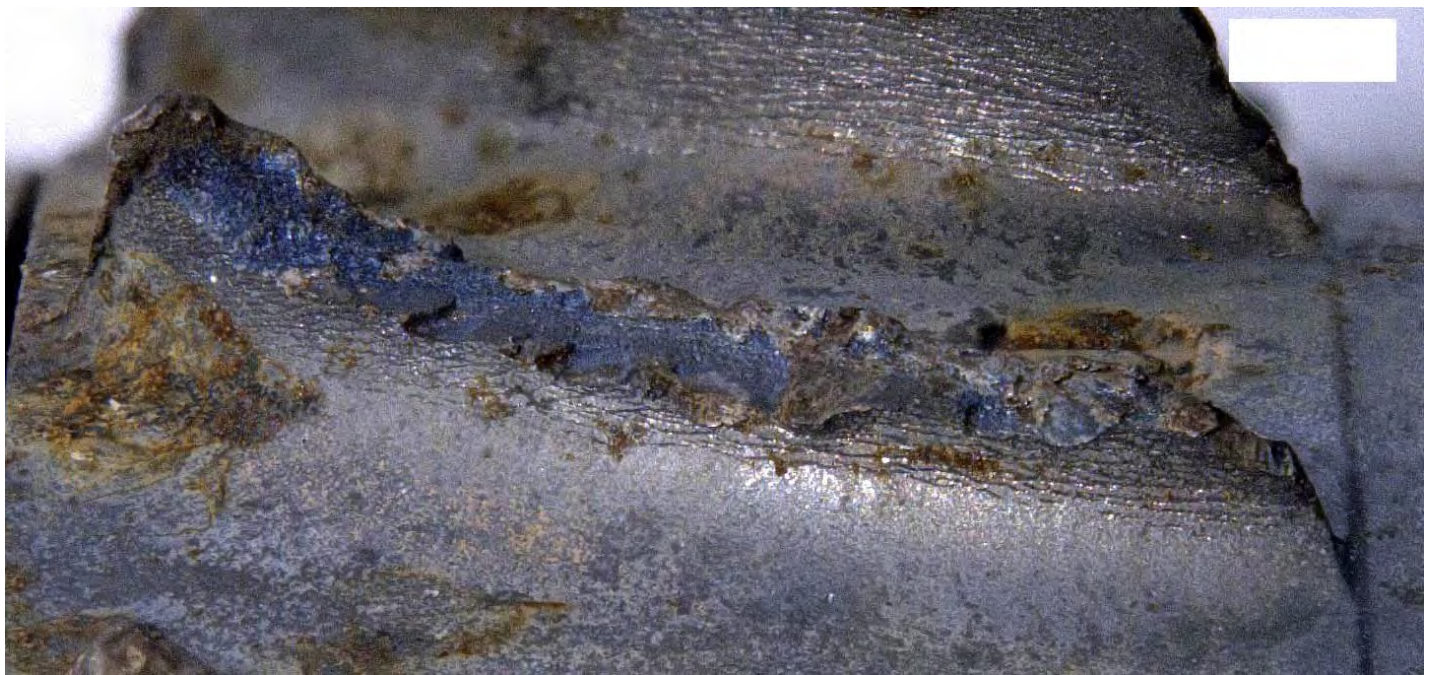
**Figure 86.** Detailed views of the fracture surface (top) and suction side surface (bottom) of stage 6 compressor blade 23 (see Figures 62 and 63). The red arrows indicate the local direction of fatigue progression. The yellow arrows indicate ratchet marks consistent with fatigue initiation on the suction side surface.

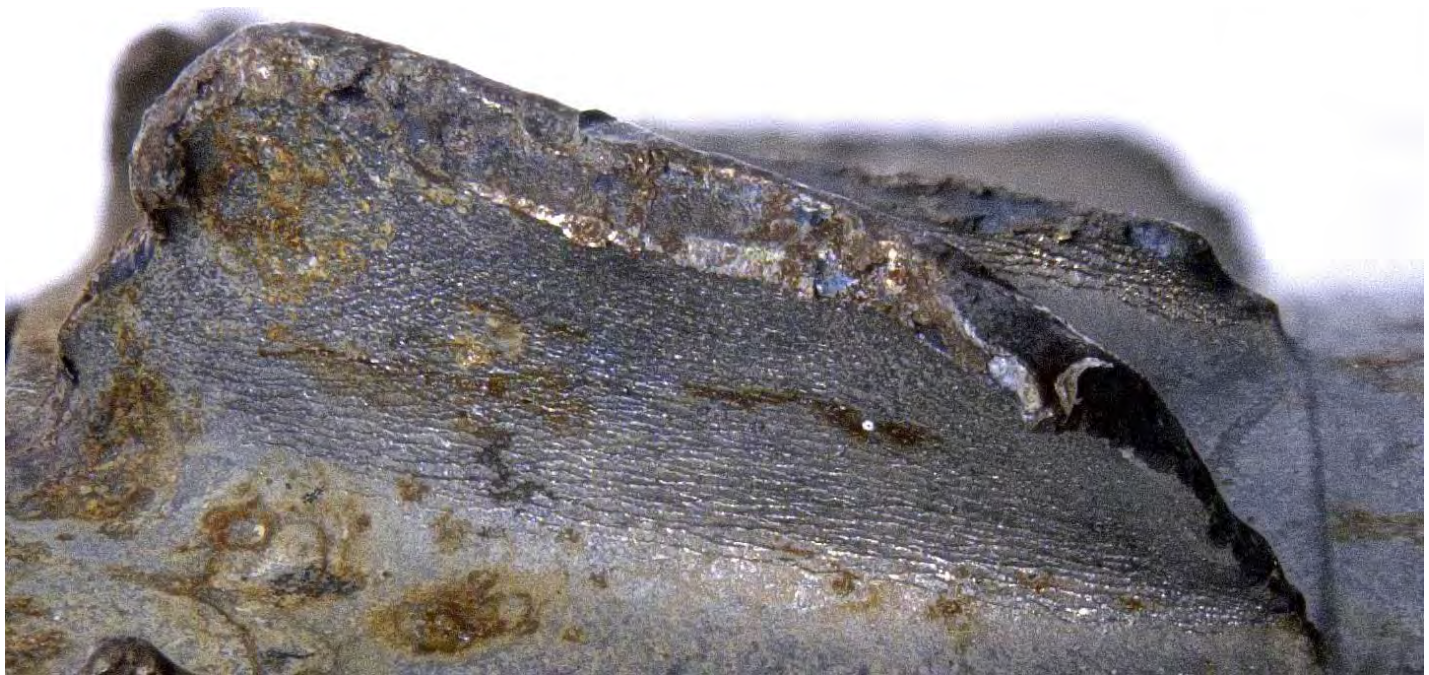
**Figure 87. Detailed views of the fracture surface (top) and suction side surface (bottom) of stage 6 compressor blade 24 (see Figures 62 and 63). There were no fatigue progression features on this fracture surface. This blade is shown in more detail in Figures 89 and 90.**

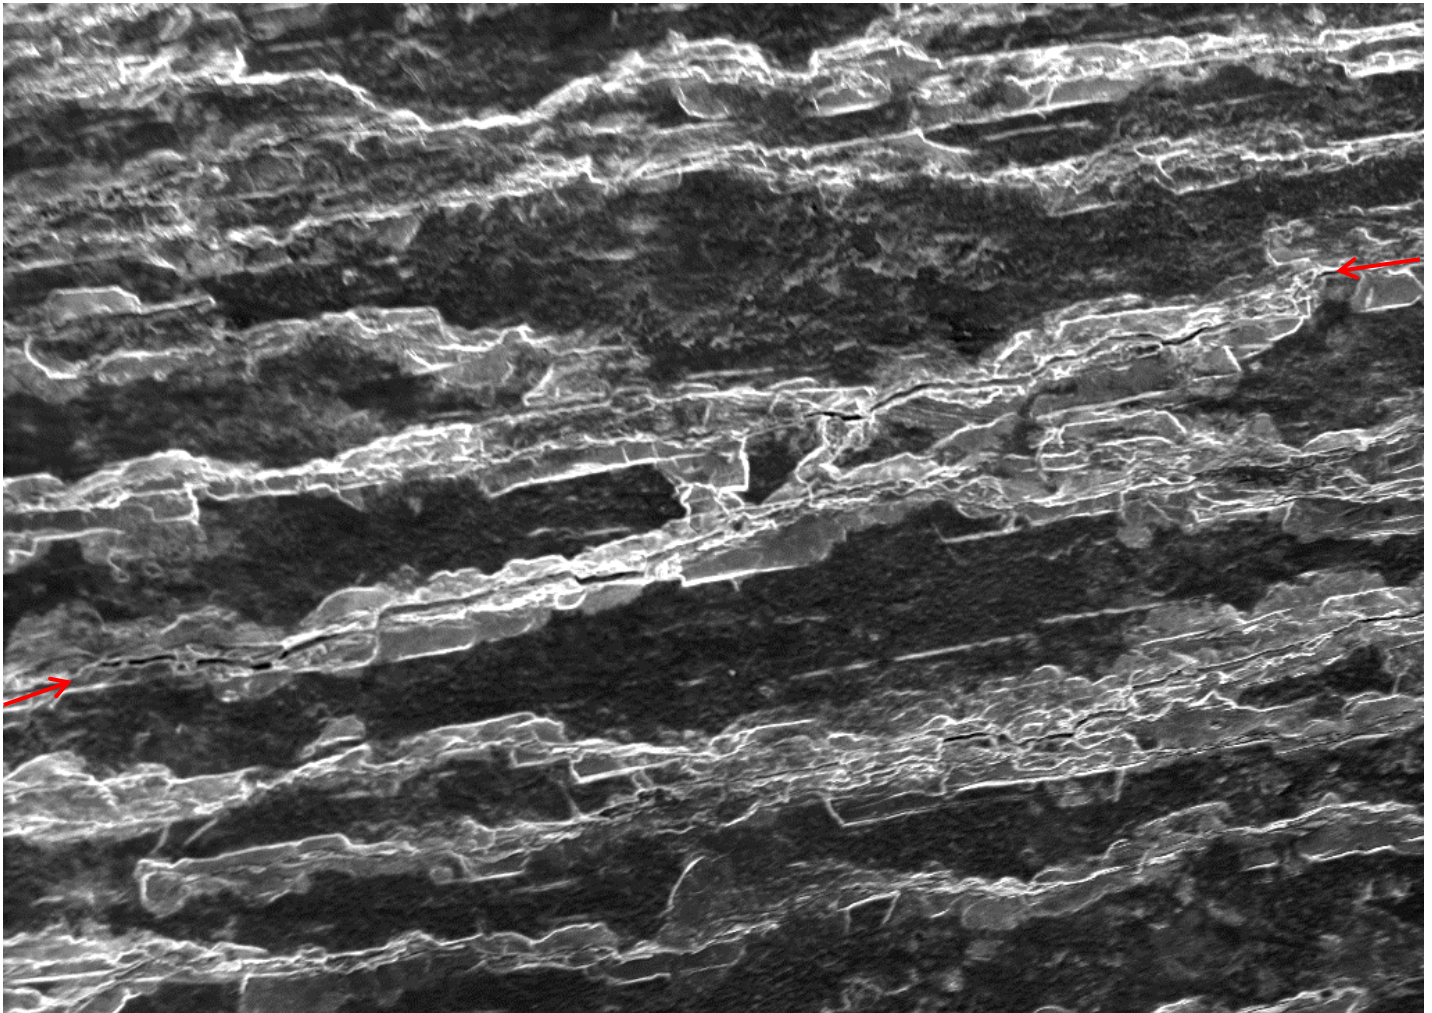
**Figure 89. Secondary SEM image of the suction side crown root of blade 24 (see Figure 87). The red arrows indicate a crack in the surface.**

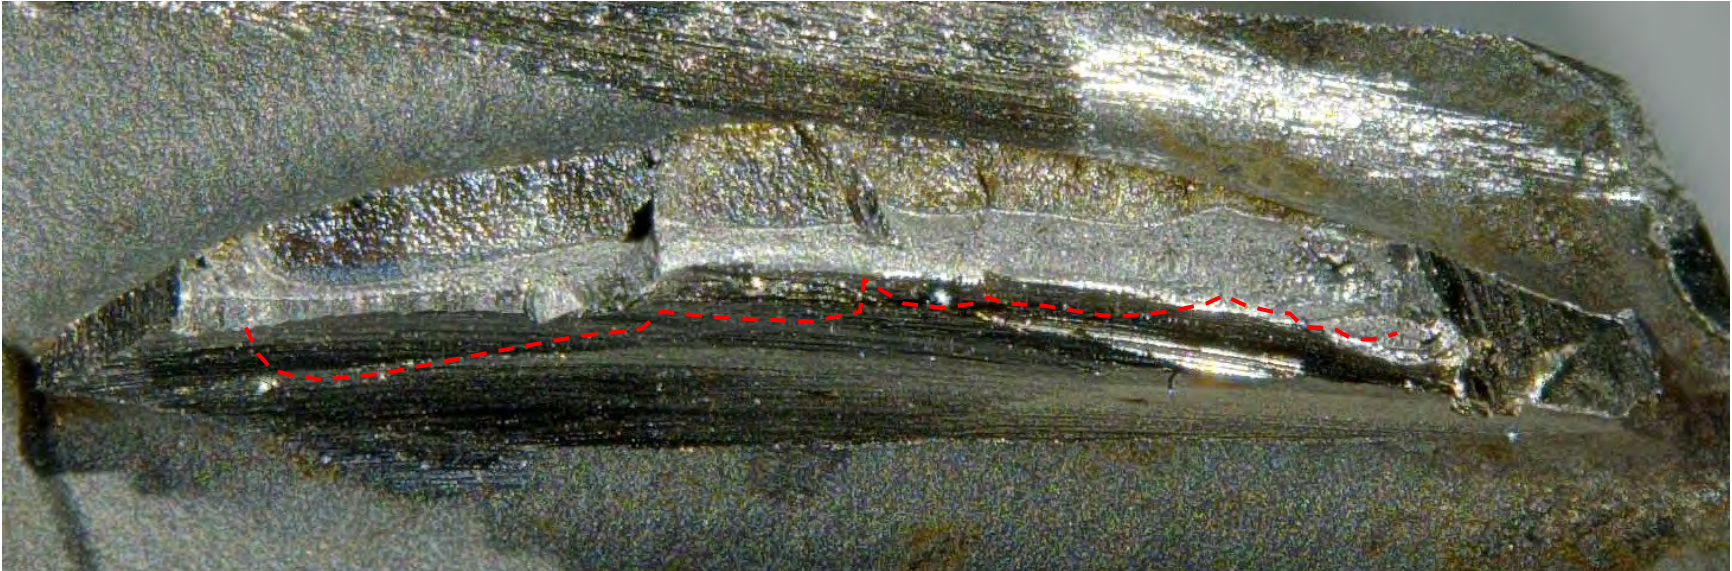
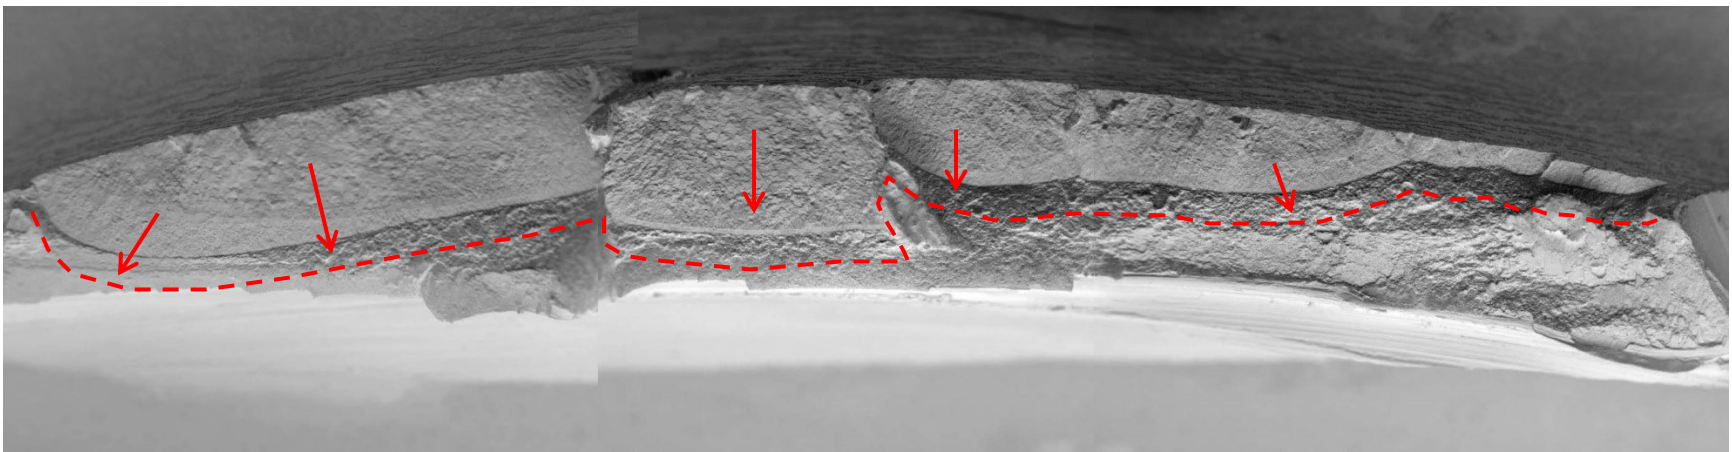
**Figure 90. Optical (top) and backscattered electron SEM (bottom) images of the fatigue fracture surface from blade 24 after laboratory fracture. The red dashed lines show the transition from fatigue to laboratory overload. The red arrows indicate the local direction of fatigue progression.**

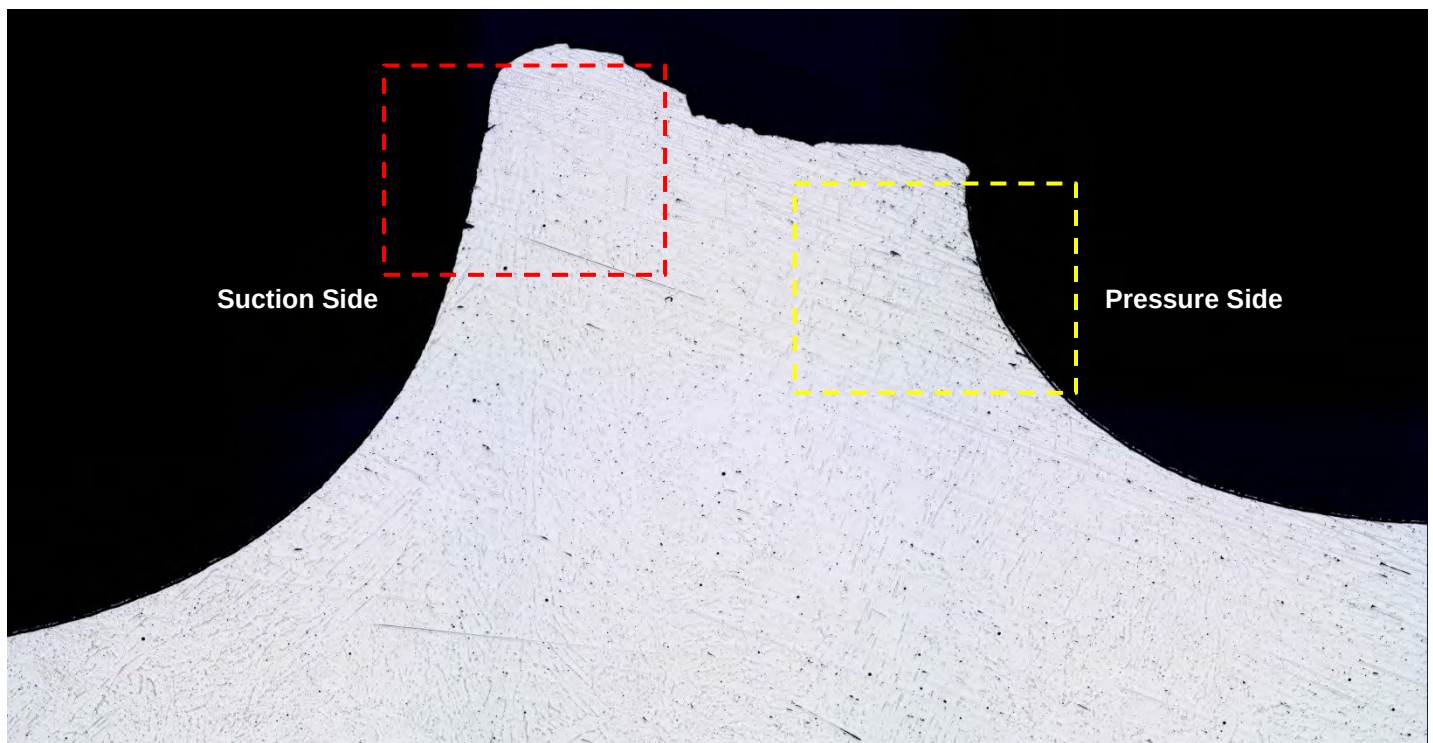
**Figure 91.** Overall view of the section through the first representative stage 6 blade, blade 2 (see Figure 65). The areas in the red and yellow dashed boxes are shown in greater detail in Figures 92 and 93, respectively. Unetched.

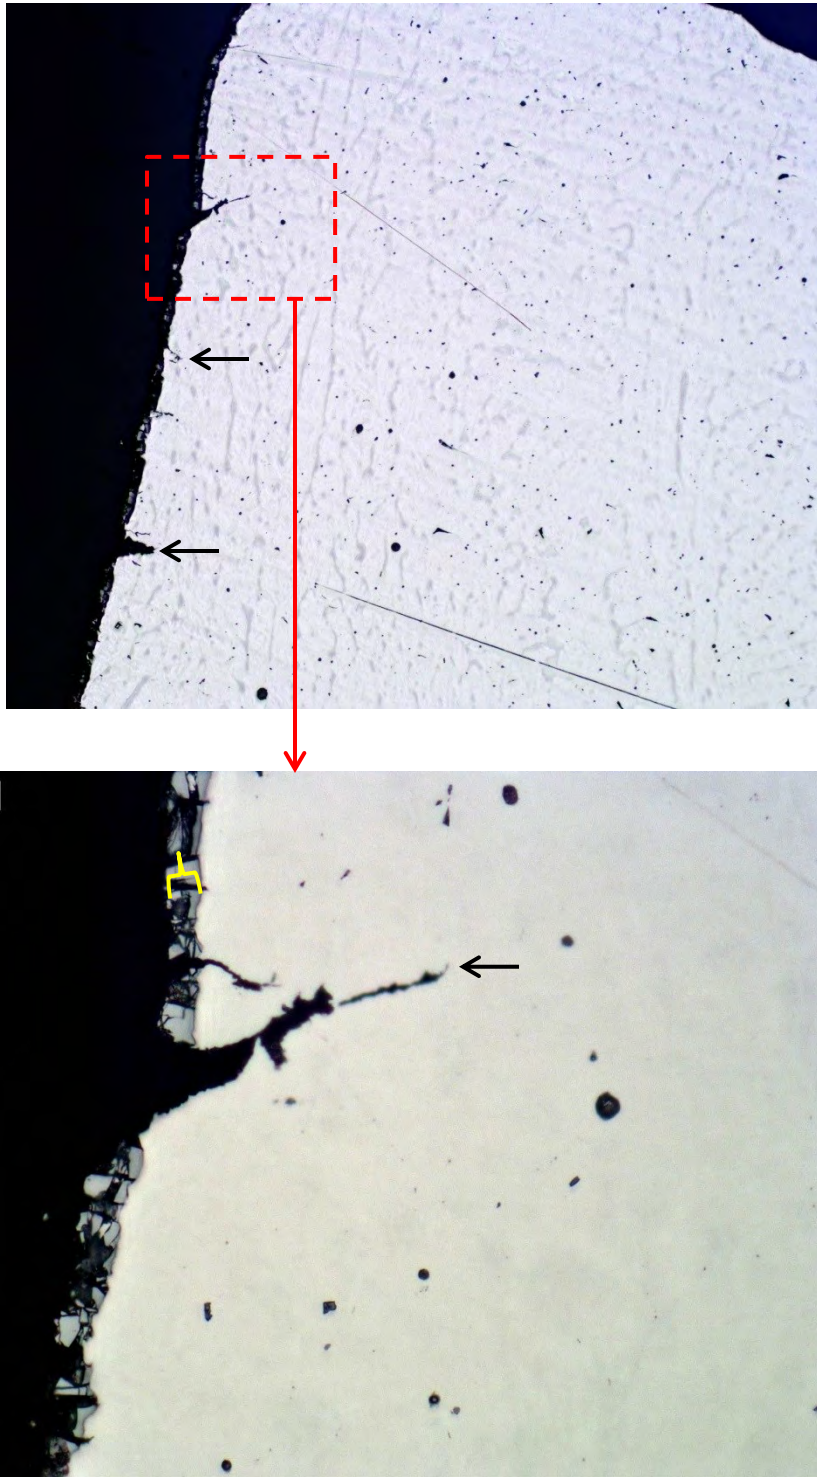
**Figure 92. Cracks (black arrows) in the suction side crown of blade 2 (see Figure 91). The aluminide coating in indicated by the yellow brace. Unetched**
