## **AIRWORTHINESS GROUP FACTUAL REPORT**

**NTSB No. ERA21FA130**

**Rolls-Royce Materials Evaluation Report No. 21FAE-025-PR  
(111 pages)**

| <b>TITLE</b><br><br><b>METALLURGICAL INVESTIGATION OF COMPRESSOR COMPONENTS REMOVED FROM AN M250-C20B, ENGINE S/N CAE833459, OPERATED BY CARIBBEAN BUZZ HELICOPTER</b> | | <b>PREPARED</b><br>Signatures on File | | |

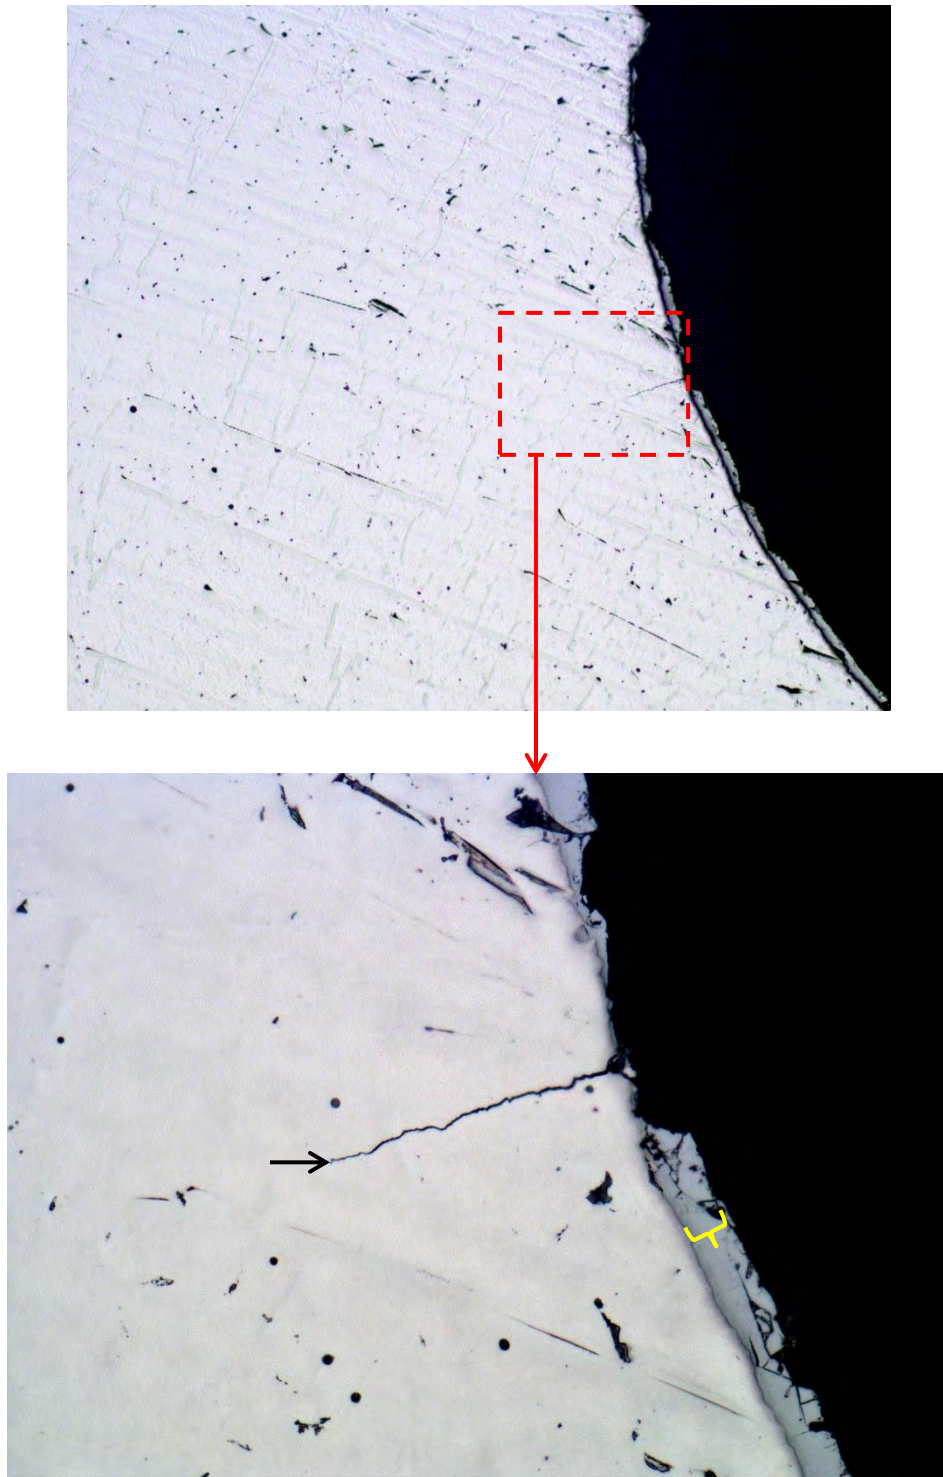
The cross section through blade 2 is shown in Figures 91 through 93, and the cross section through blade 11 is shown in Figures 94 through 96. Both cross sections exhibited multiple cracks on both the pressure side and suction side surfaces.

**Figure 93.** Crack (black arrow) in the pressure side, mid-chord of blade 2 (see Figure 94). The aluminide coating is indicated by the yellow brace. Unetched.

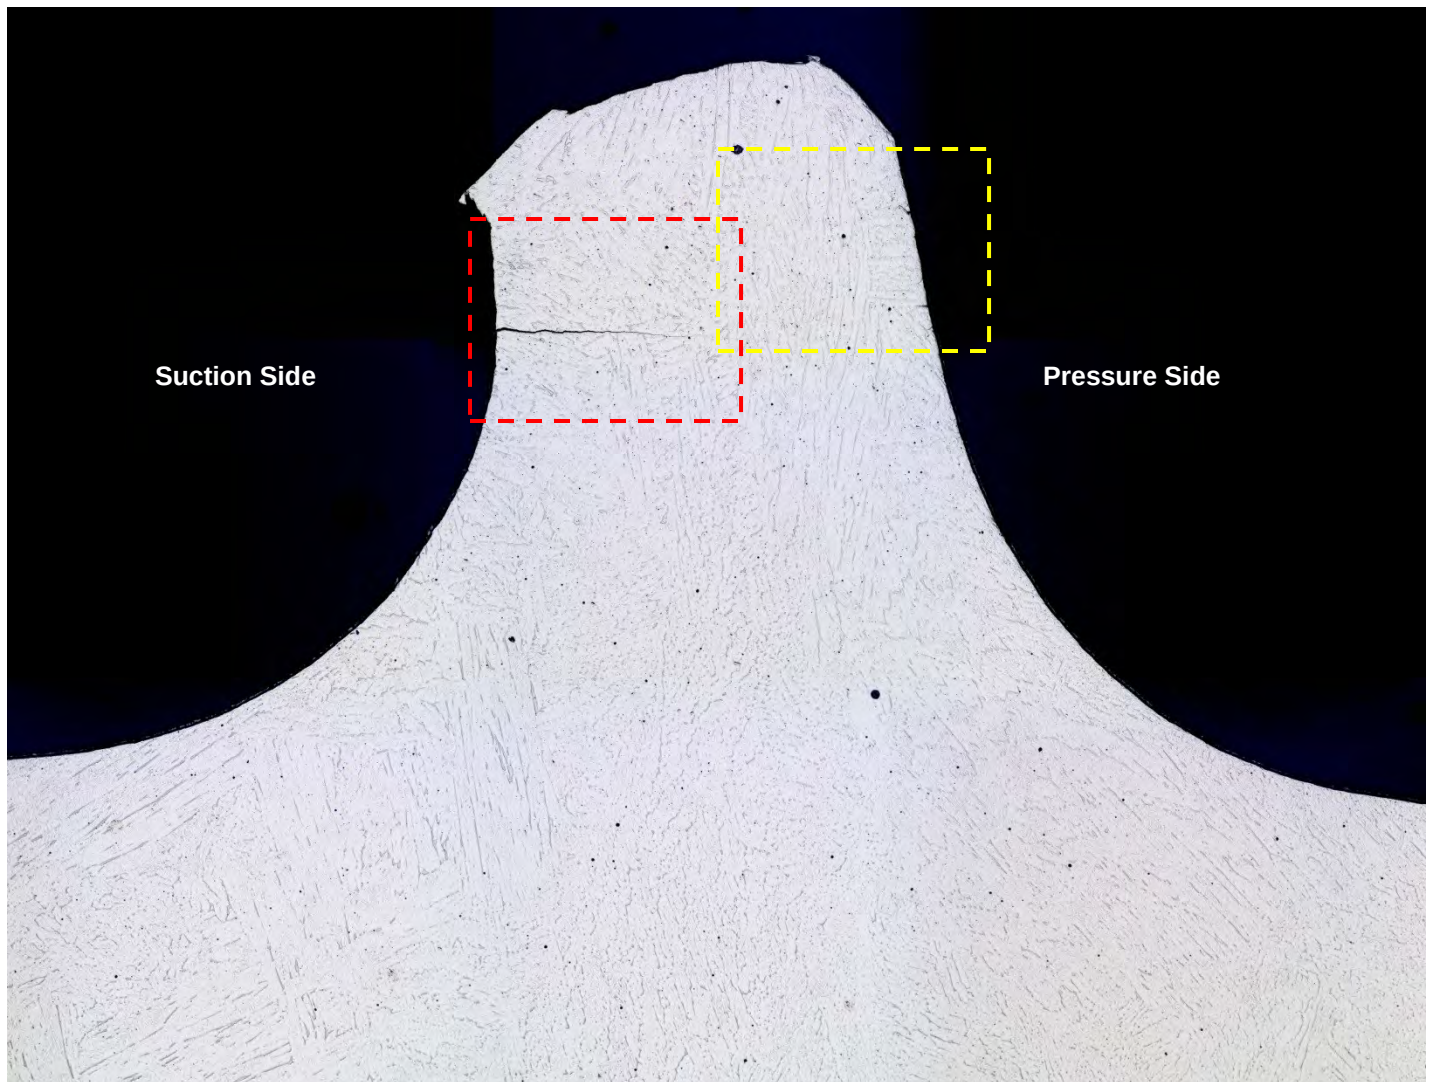
The average hardness of the stage 6 compressor wheel on the cross section in Figure 94 measured 34 HRC (averaged, converted value of 341, 336, 330, 337 HV500gf) which met the component definition requirement.

**Figure 94.** Overall view of the section through the second representative stage 6 blade, blade 11 (see Figure 74). The areas in the red and yellow dashed boxes are shown in greater detail in Figures 95 and 96, respectively. Unetched.

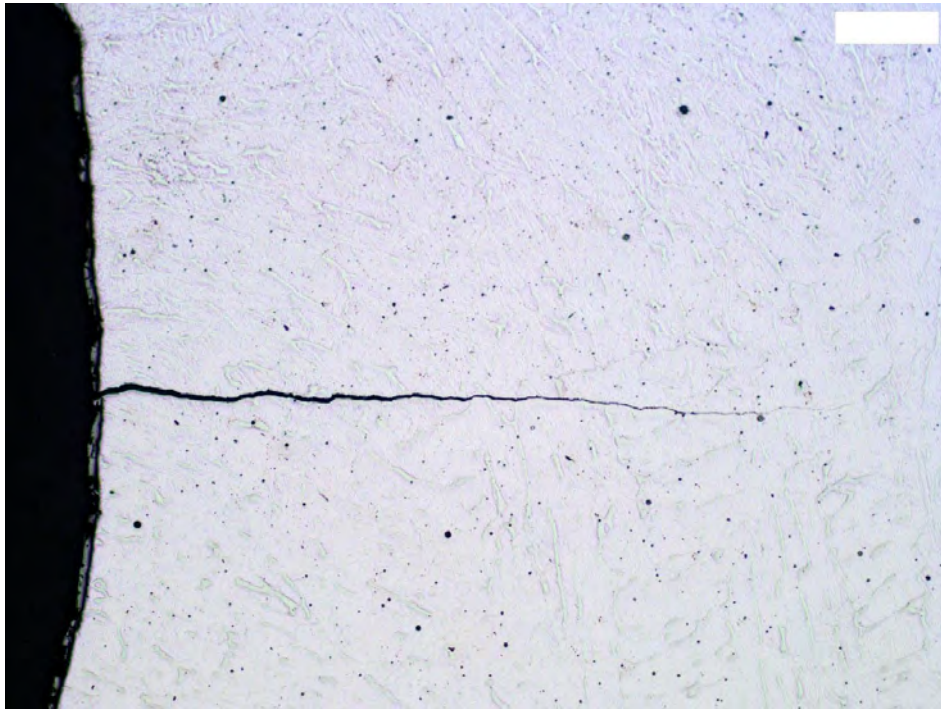
**Figure 95. Crack in the suction side crown of blade 11 (see Figure 94). Unetched**

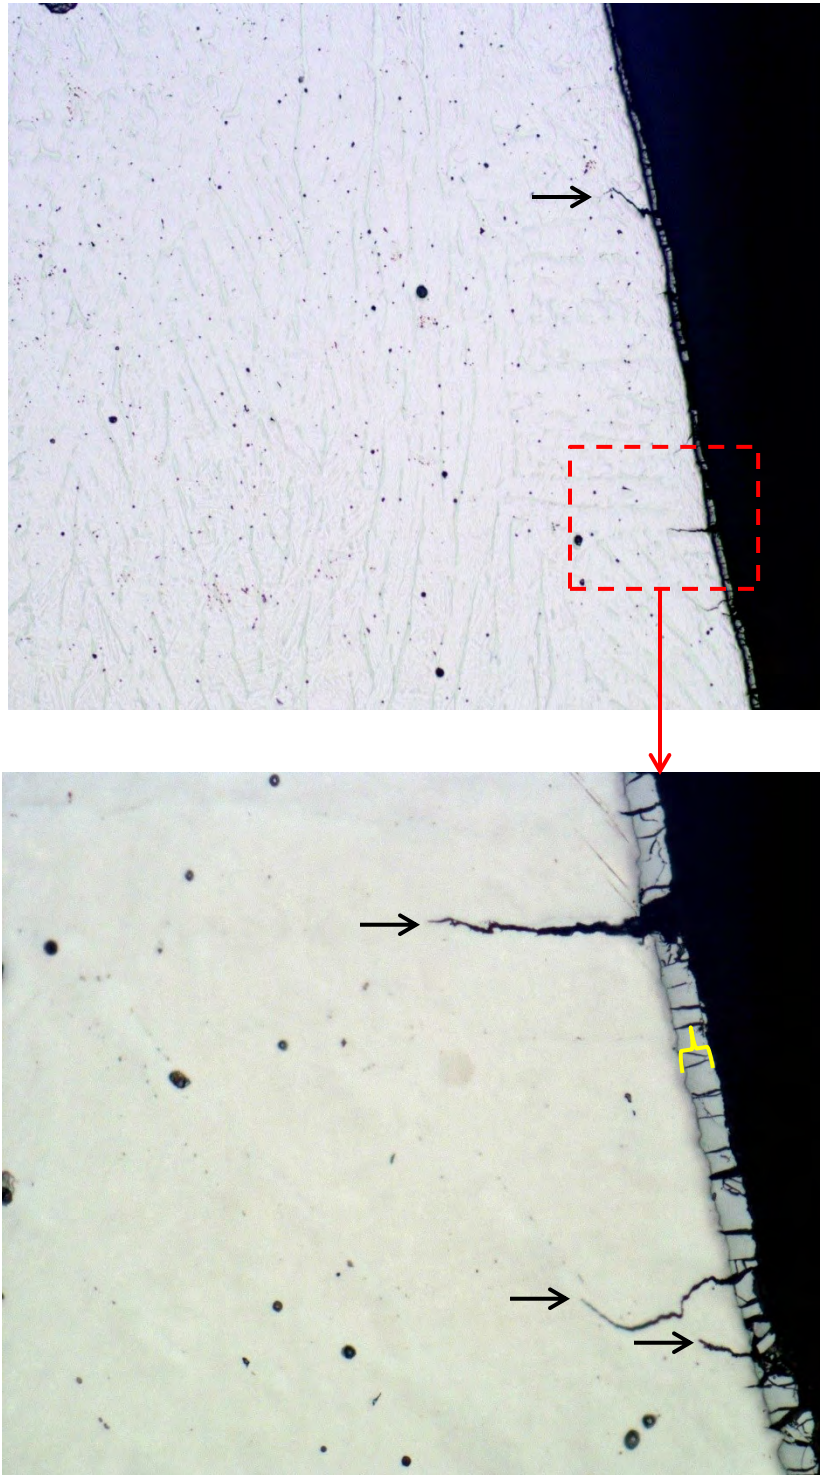
**Figure 96. Cracks (black arrows) in the pressure side, mid-chord of blade 11 (see Figure 94). The aluminide coating is indicated by the yellow brace. Unetched.**

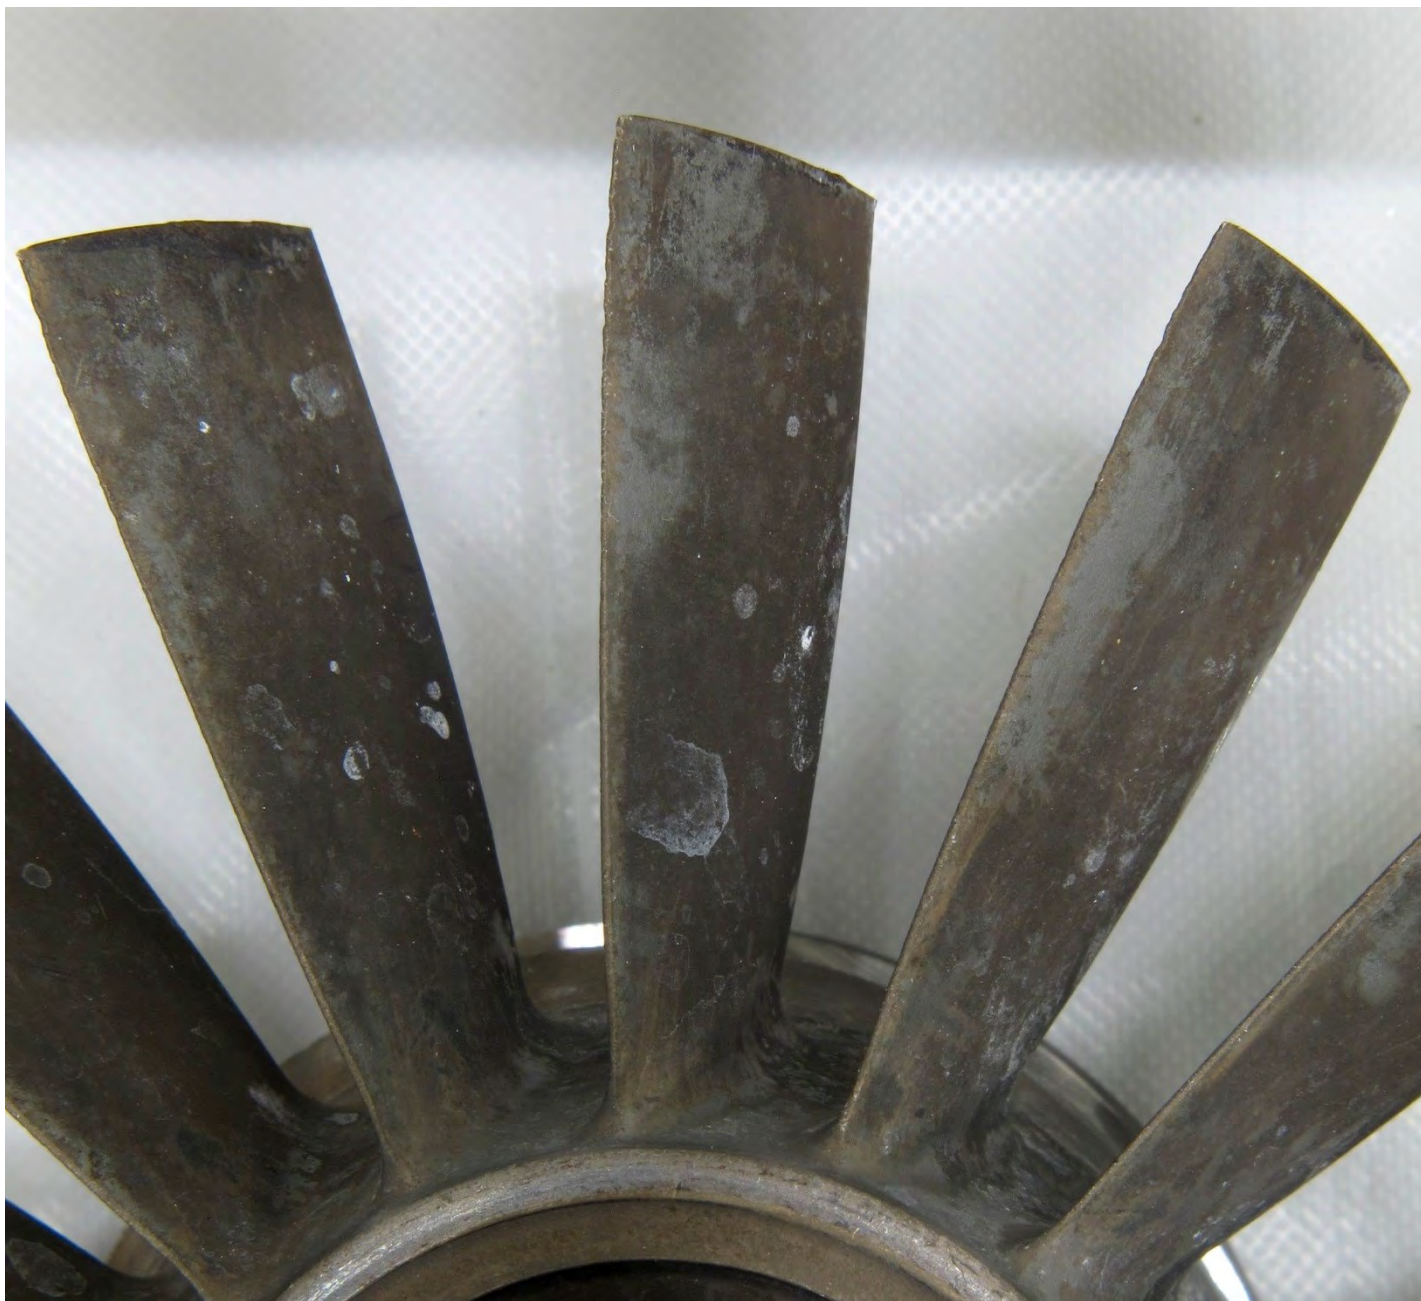
The stage 1 compressor wheel did not exhibit any damage. No impact damage was noted on the leading edge of the stage 1 blades (see Figure 97).

**Figure 97. Leading edges of representative stage 1 blades.**

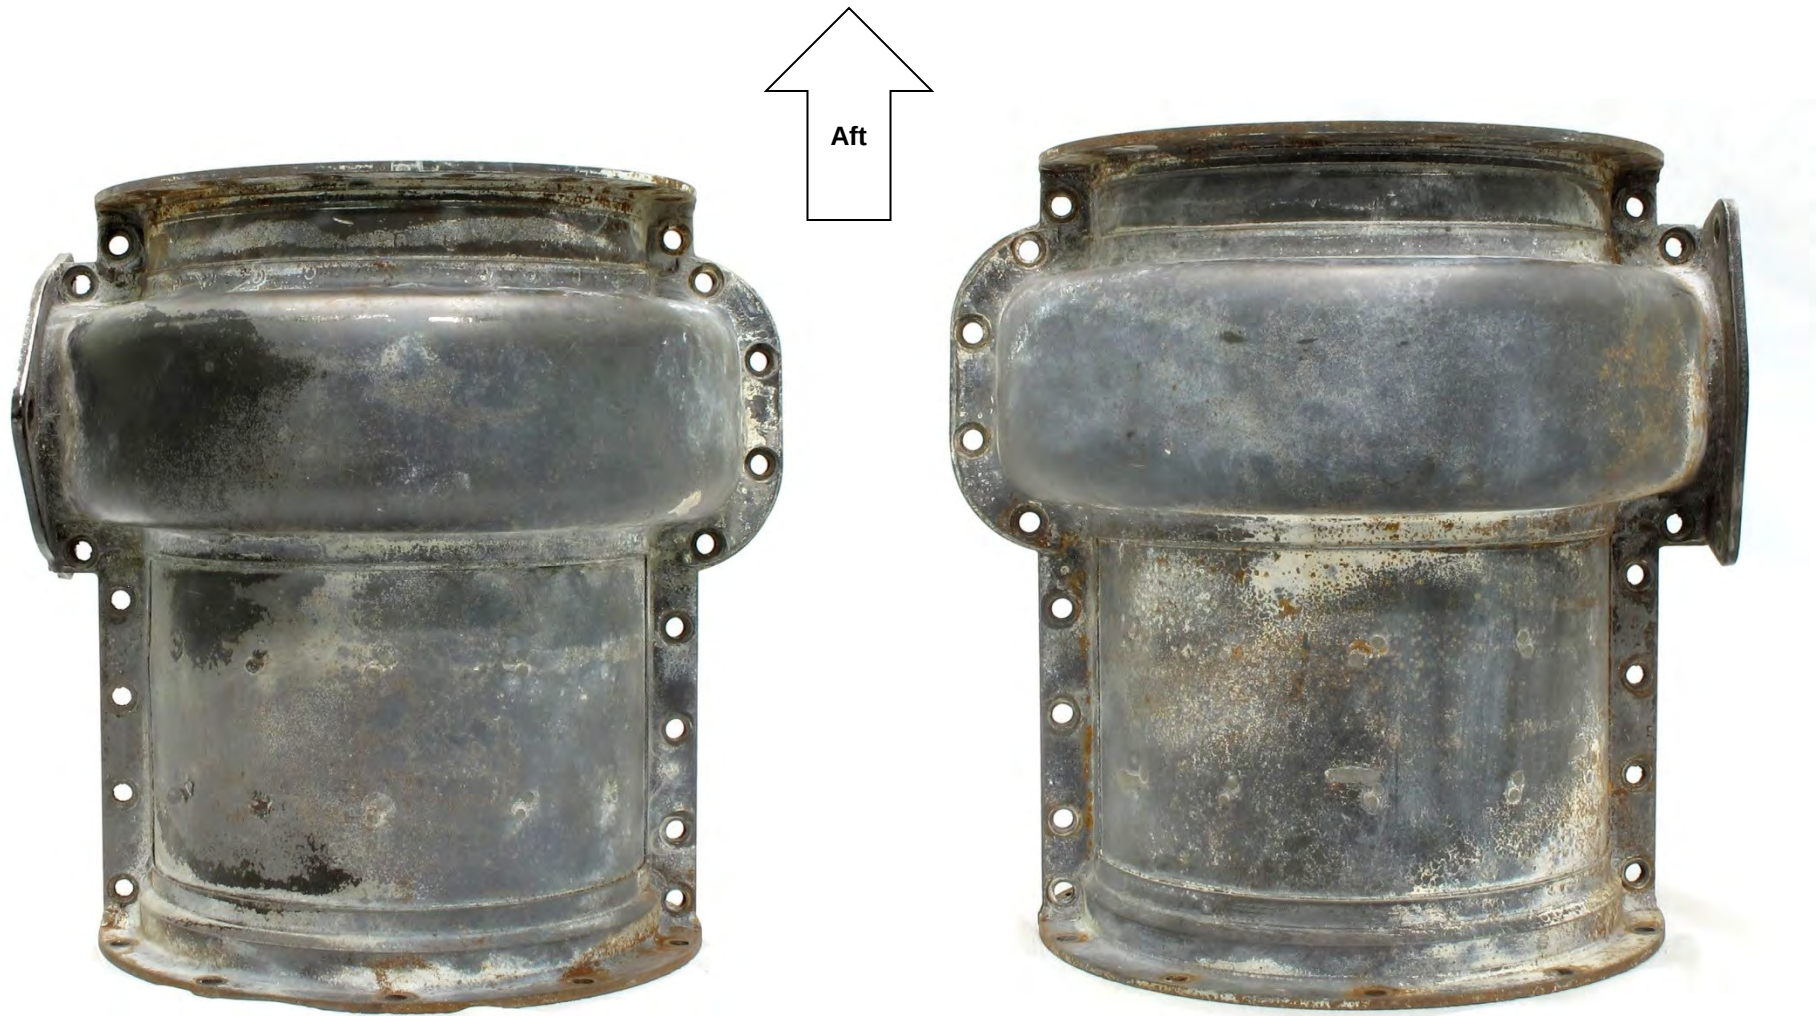
Figures 98 and 99 show the as-received condition of the compressor case halves. The outer diameter of the compressor case was missing the corrosion resistant paint and exhibited discoloration. The forward stages of the compressor vanes were intact and the aft stages of the compressor vanes were damaged. There was no impact damage on the leading edges of the stage 1 vanes (see Figure 100). Figures 101 through 103 show detailed images of each stage of vanes. The stage 1 vanes did not exhibit any deformation, and the stage 2 vanes only exhibited impact damage on the trailing edge side of a portion of the airfoils. Sixteen (16) of the stage 3 vane airfoils were liberated near the root and the rest of the airfoils were bent flat in the direction of engine rotation. All the stage 4, 5, and 6 airfoils were liberated near the root. All the remaining airfoils exhibited generalized corrosion.

Figure 98. Outer diameter of the two compressor case halves.

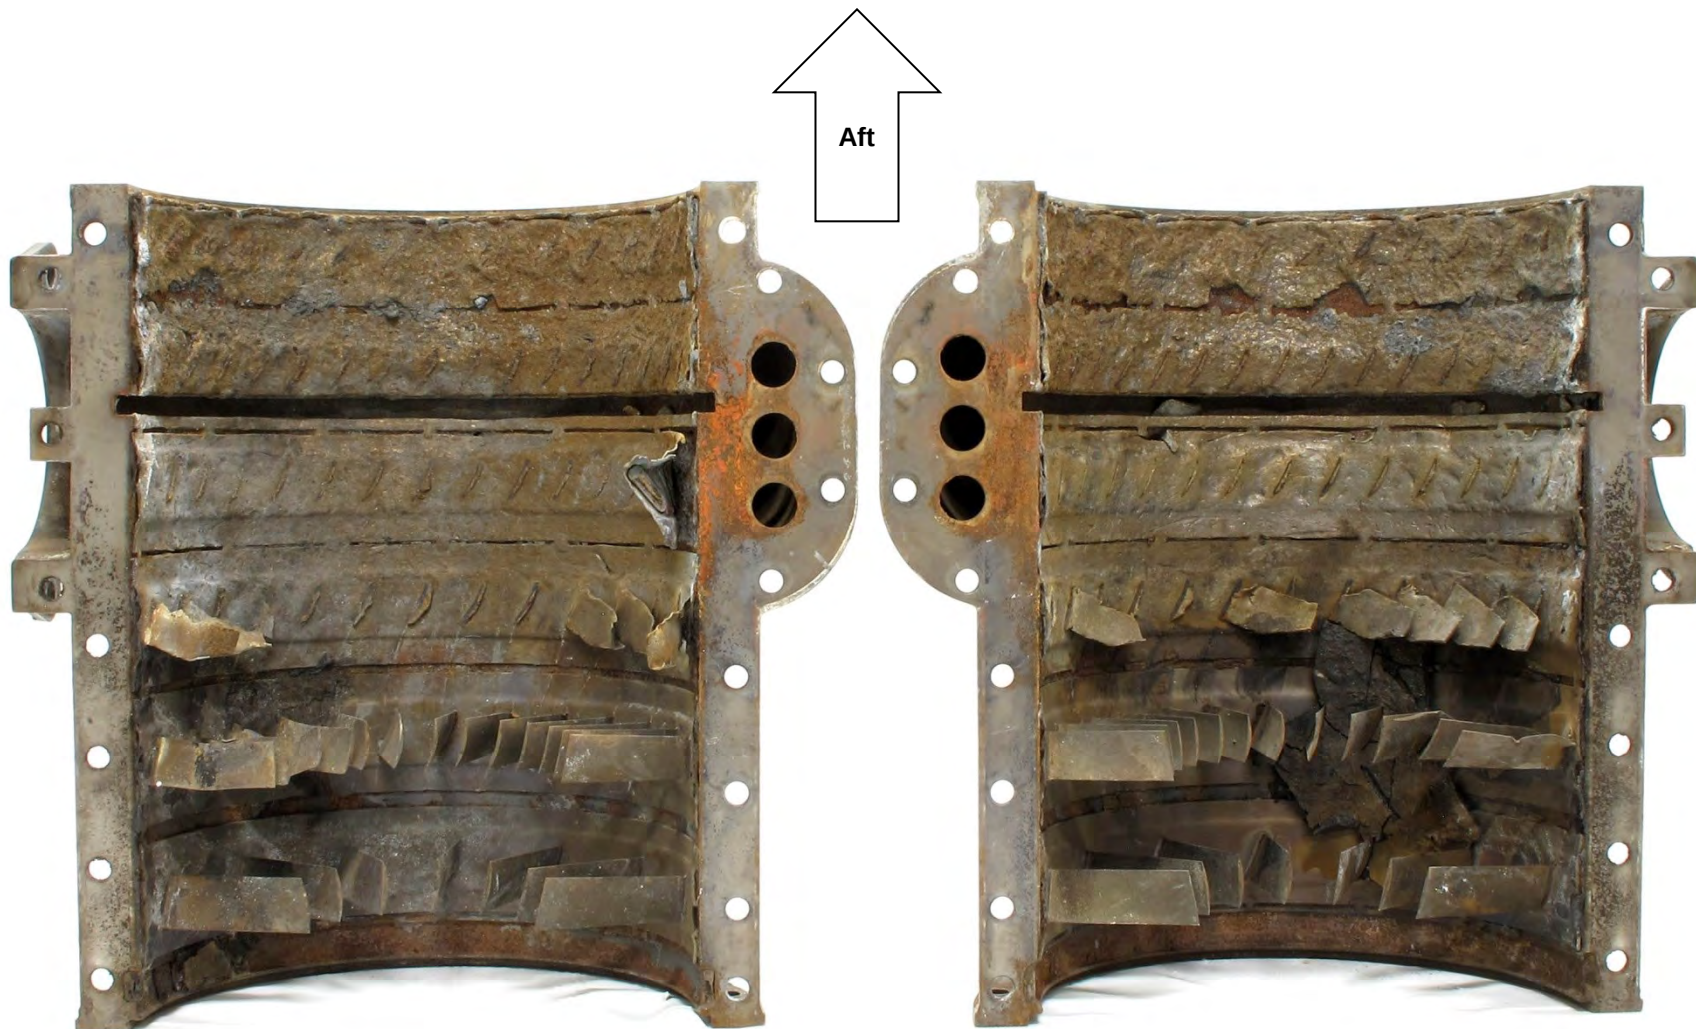
**Figure 99. Inner diameter of both compressor case halves.**

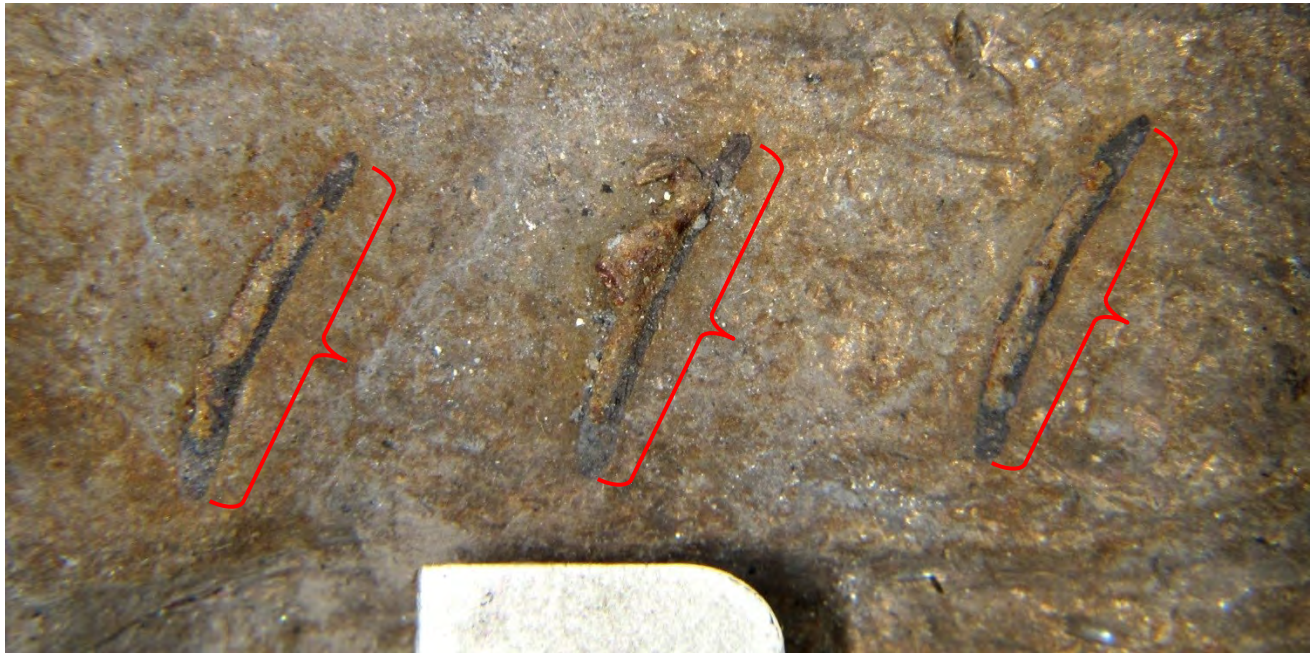
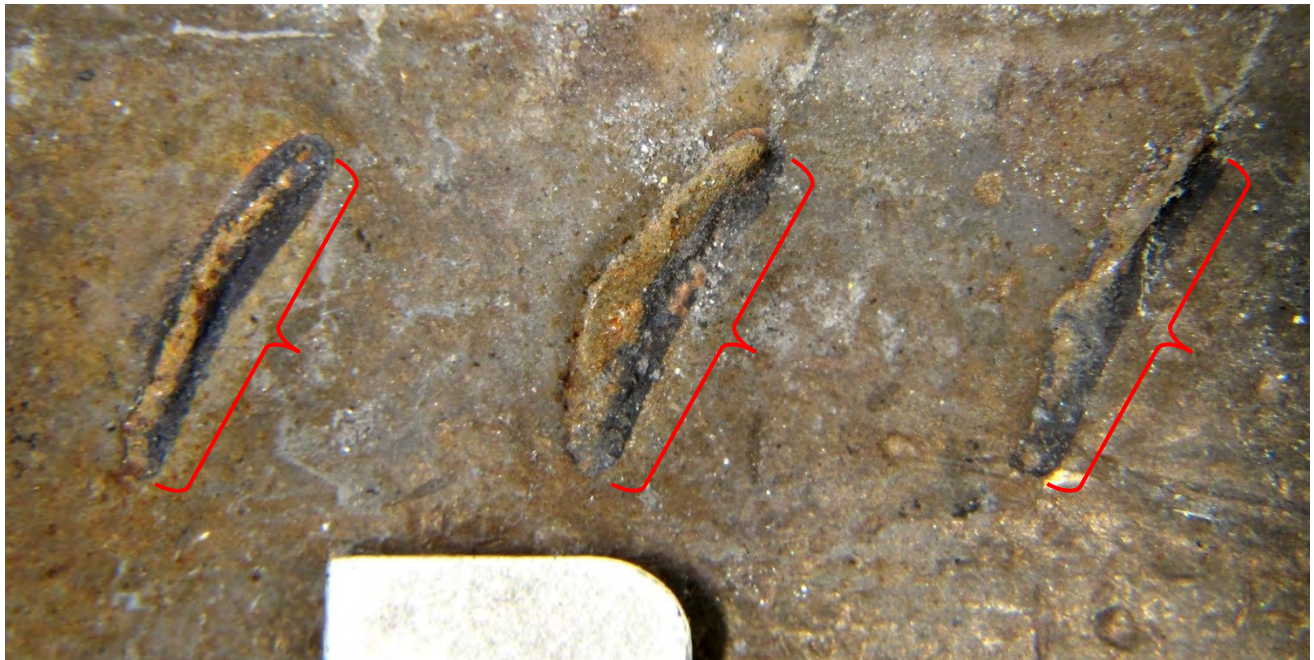
Figures 104 and 105 show detailed views of representative fracture surfaces from the stage 3 through 6 airfoils. The entirety of every fracture surface was completely obliterated by smearing damage.

**Figure 104. Detailed views of three representative stage 3 (top) and stage 4 (bottom) compressor vane fracture surfaces (red braces), which were completely smeared.**

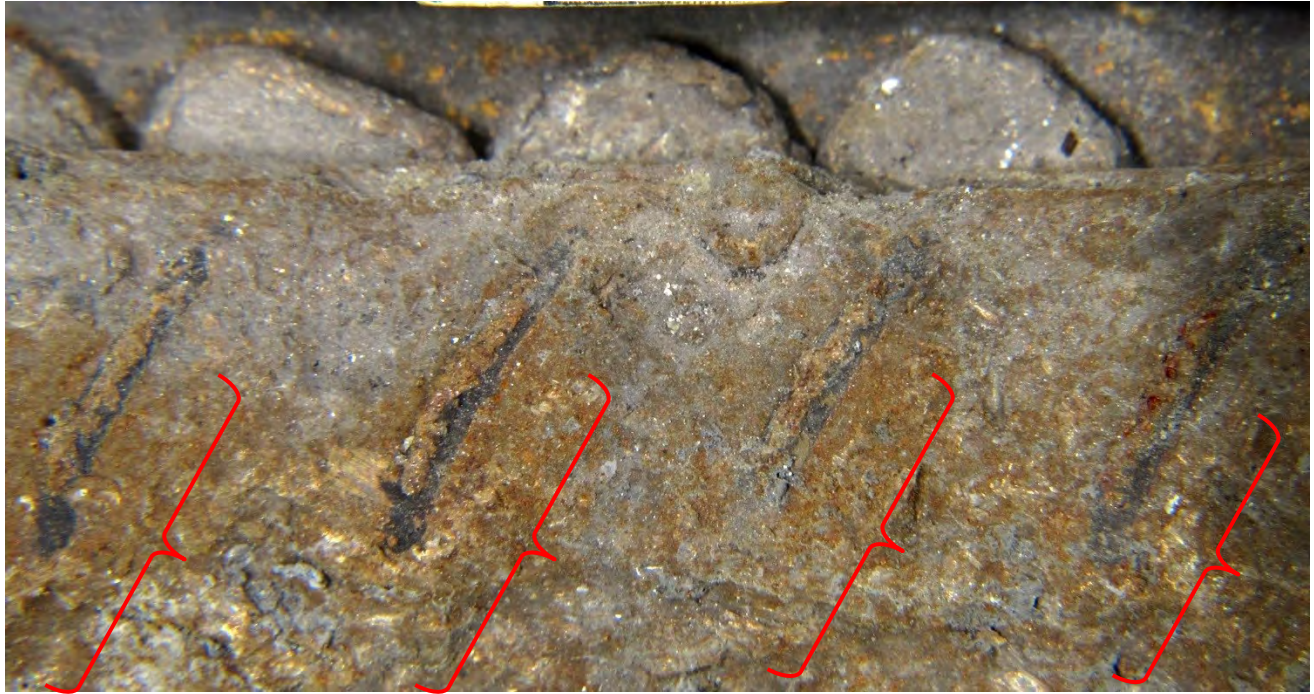
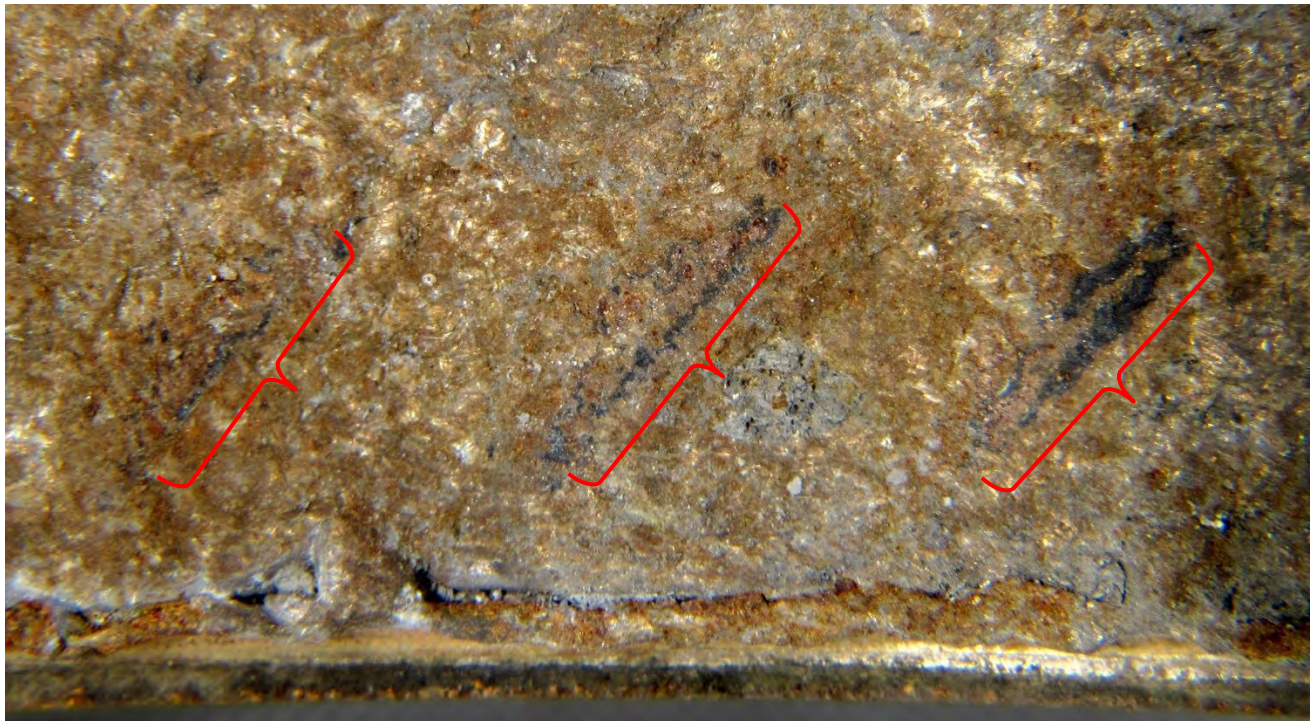
**Figure 105. Detailed views of several representative stage 5 (top) and stage 6 (bottom) compressor vane fracture surfaces (red braces), which were completely smeared.**
