# NATIONAL TRANSPORTATION SAFETY BOARD

## MATERIALS LABORATORY FACTUAL REPORT

Report No. 22-027

Place : Yulee, Florida  
Date : June 18, 2021  
Vehicle : Cessna 150L, N1300Q  
NTSB No. : ERA21FA258  
Investigator : Ralph Hicks (AS-ERA)

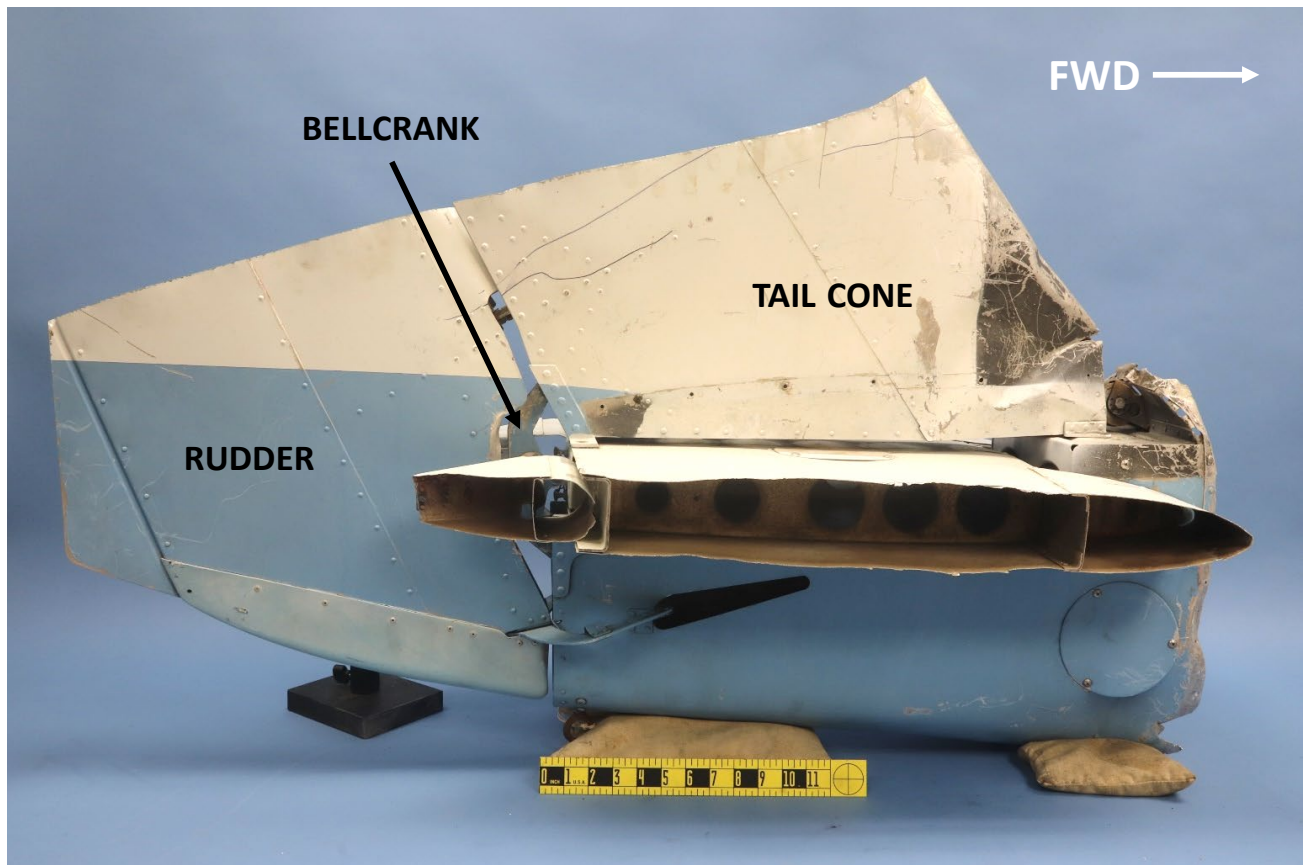
Figure 1: Overall photo showing the submitted elevator bellcrank, rudder, and a portion of tail cone as though assembled.

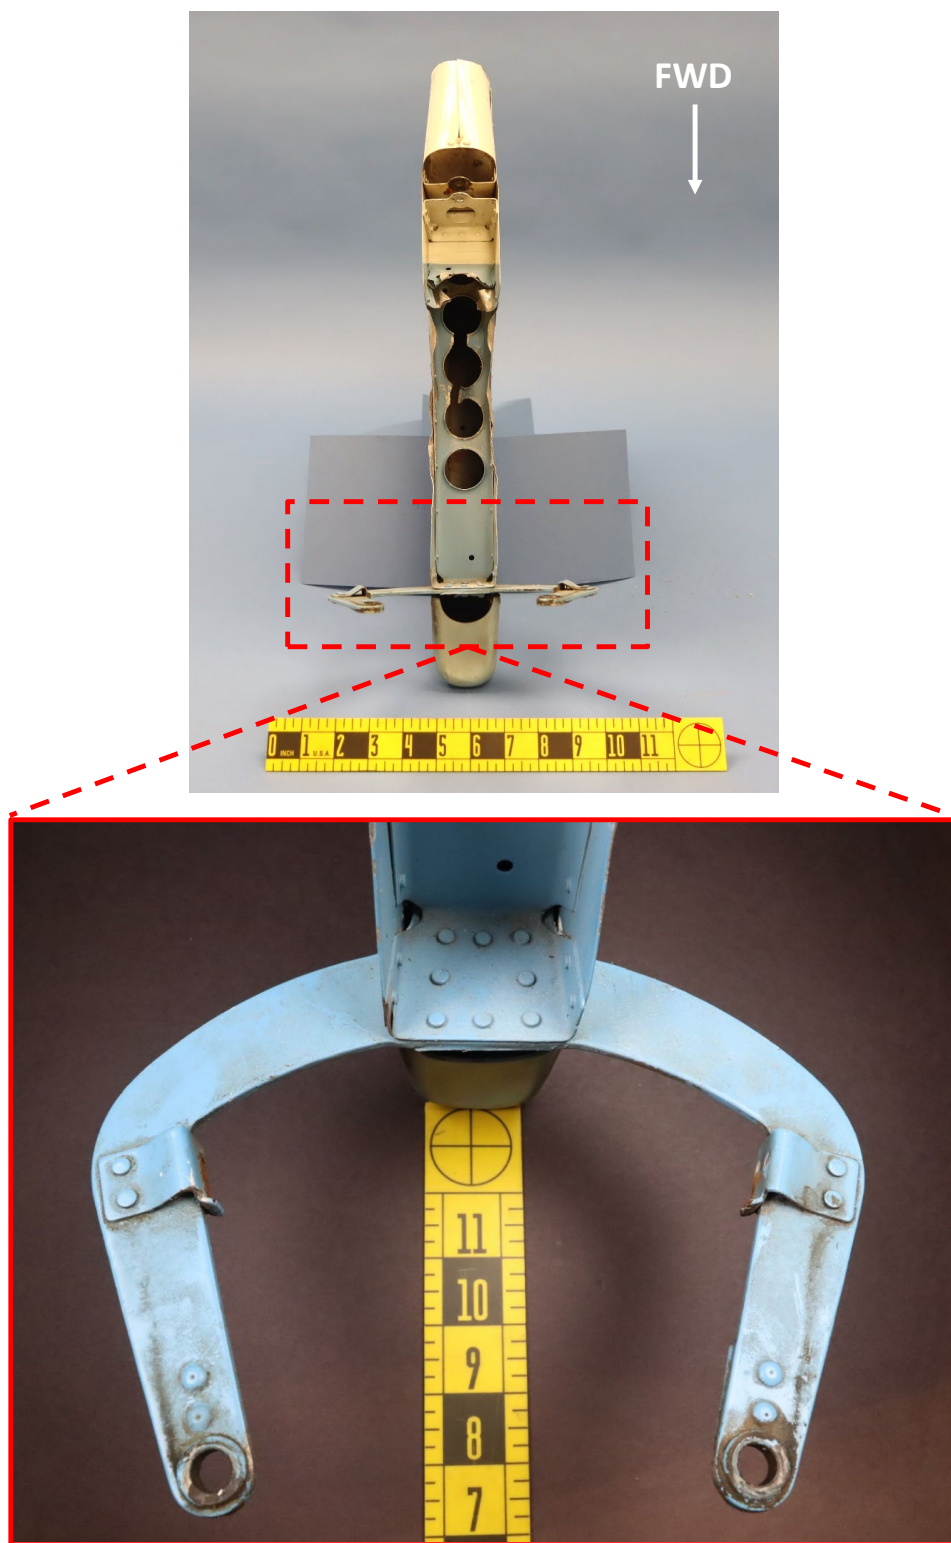
Figure 6 shows the rudder horn still assembled to the rudder. Close-up photos of the bumpers on the rudder horn are shown in Figure 7. Both bumpers had damage from contact with the mating rudder stop bolts assembled in the tail cone. The rudder stop bolts are shown still assembled to the tail cone in Figures 8–10. The heads of the bolts had rub damage consistent with contact with the rudder horn bumpers. Neither bolt had a nut

Figure 6: (Top) Overall photo of the rudder and assembled rudder horn.  
(Bottom) The rudder horn as viewed from the top.
