**Wreckage Examination  
NTSB Accident Number  
ERA21FA333**

| Location: | Wadesboro, NC (AFP) |
| Date: | August 20, 2021 |
| Aircraft: | Piper PA-24-250 |

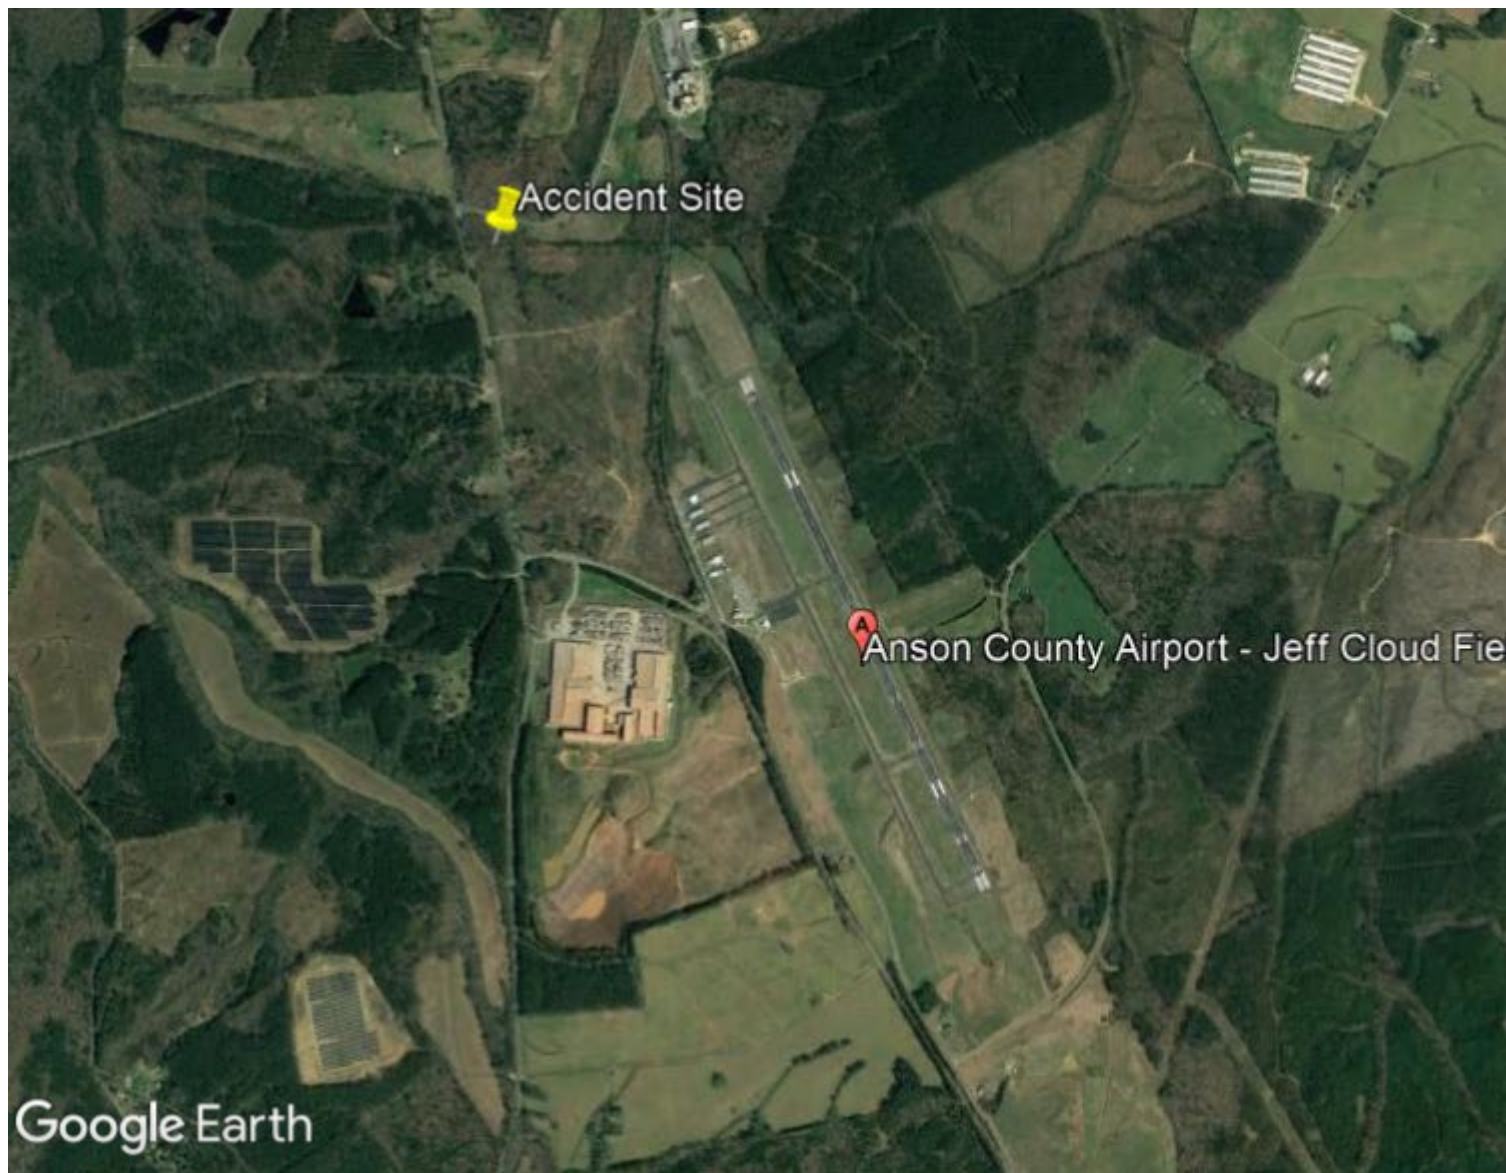
The pilot purchased 51 gallons of fuel AFP and departed for LaBelle Municipal Airport (X14), LaBelle, Florida. Witnesses reported that the airplane departed runway 34 and reached an altitude about 400 ft above ground level before the engine began to sputter. The airplane then turned left and descended nose down into wooded terrain, where a postcrash fire ensued.
