## **NATIONAL TRANSPORTATION SAFETY BOARD**

### **Group Chairman's Factual Report**

## **POWERPLANTS**

ERA21FA346

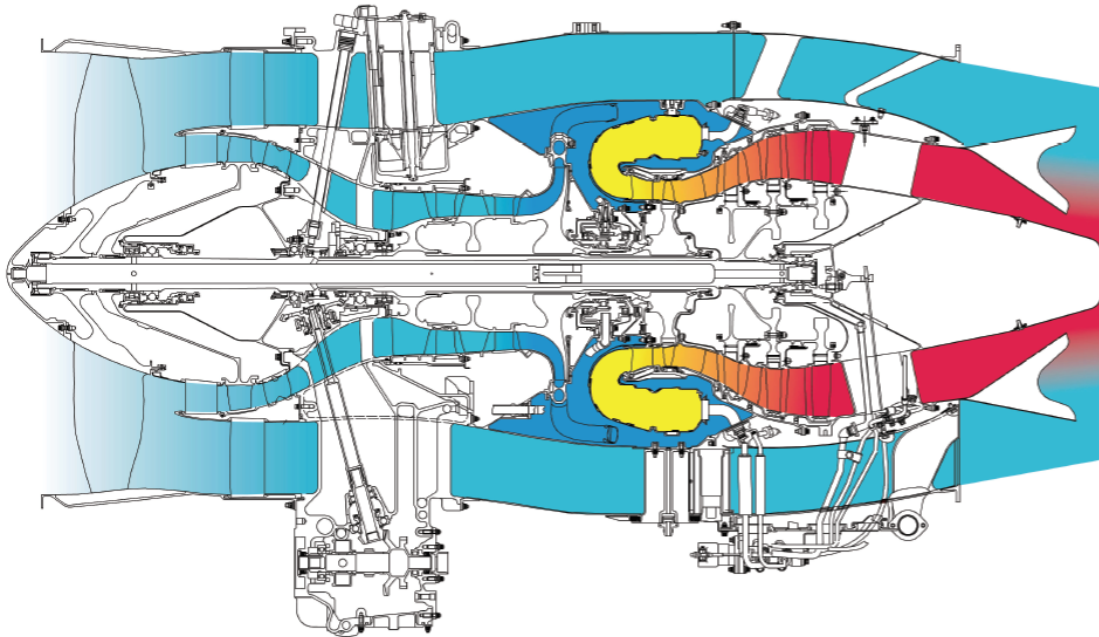
**Figure 1** - Pratt & Whitney PW545 Turbofan Engine (Figure courtesy of PWC)

The airplane was powered by two Pratt & Whitney Canada (PWC) PW545C (Figure 1) turbofan engines. The PW545C is a two-spool medium bypass ratio turbofan engine. The fan diameter is 27.3 inches, and the engine is 75.4 inches long. According to the Federal Aviation Administration (FAA) Type Certificate Data Sheet (TCDS) No. E00059EN Revision 5, the PW545C has a rated take-off thrust of 4,119 pounds at sea level and a maximum continuous thrust (MCT) of 3,372 pounds. The PW545C certification basis was 14 CFR Section 21.29; 14 CFR Part 33, Amendments 1 through 20, effective December 13, 2000, and was certified by the FAA on May 5, 2008.
