## Memorandum For Record

**Date: 7/29/2023**  
**NTSB Accident Number: ERA21FA346**

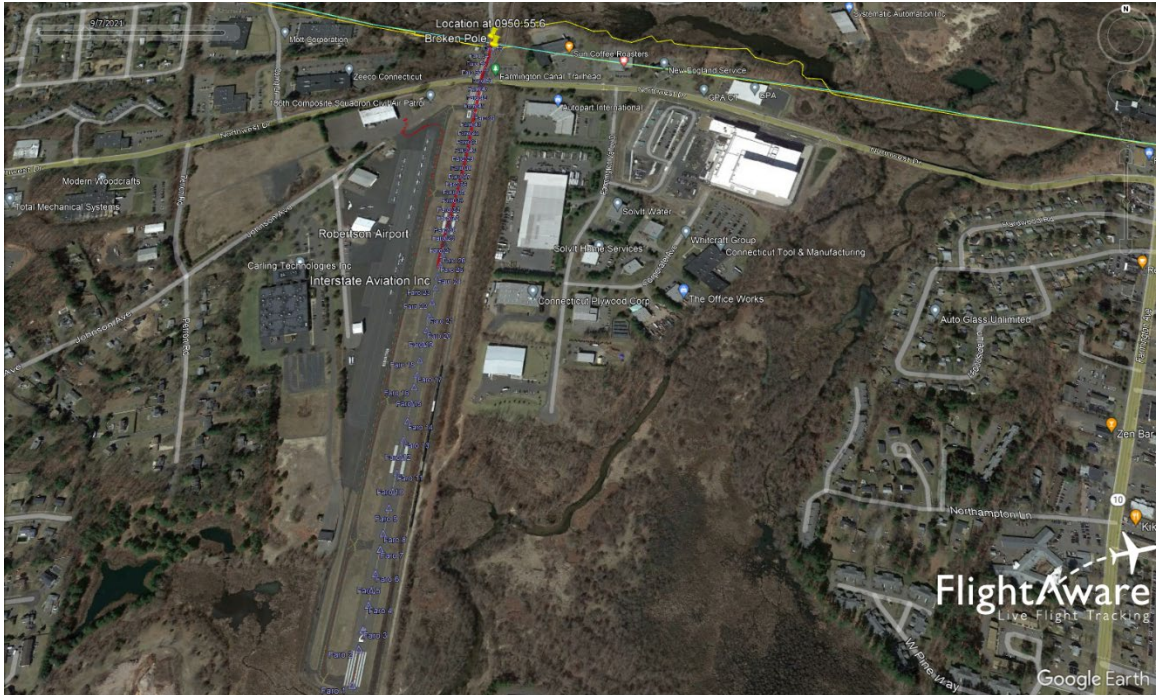
Using FARO equipment, a total of 56 scans of the runway surface, the grass north of the departure end of runway 02, and area north of the airport were performed (Figure 1)<sup>1</sup>. Of the 56 total scans, 48 scans were performed of the entire length of runway 02; 19 of which were of the approximate 1<sup>st</sup> half of the runway, and the remaining 29 were performed of the approximate 2<sup>nd</sup> half of the runway. One additional scan was made of the grass area north of the departure end of the runway. Seven scans were performed of the area immediately north of the airport to include the area of the damaged power pole.

Figure 1: Google Earth Plot of all Faro Scan locations Along Runway and Past Departure End of the Runway.
