# Runway excursion involving Cessna 550, VH-FGK

Lismore Airport, New South Wales | 25 September 2015

**ATSB Transport Safety Report**  
Aviation Occurrence Investigation  
AO-2015-114  
Final – 25 July 2016

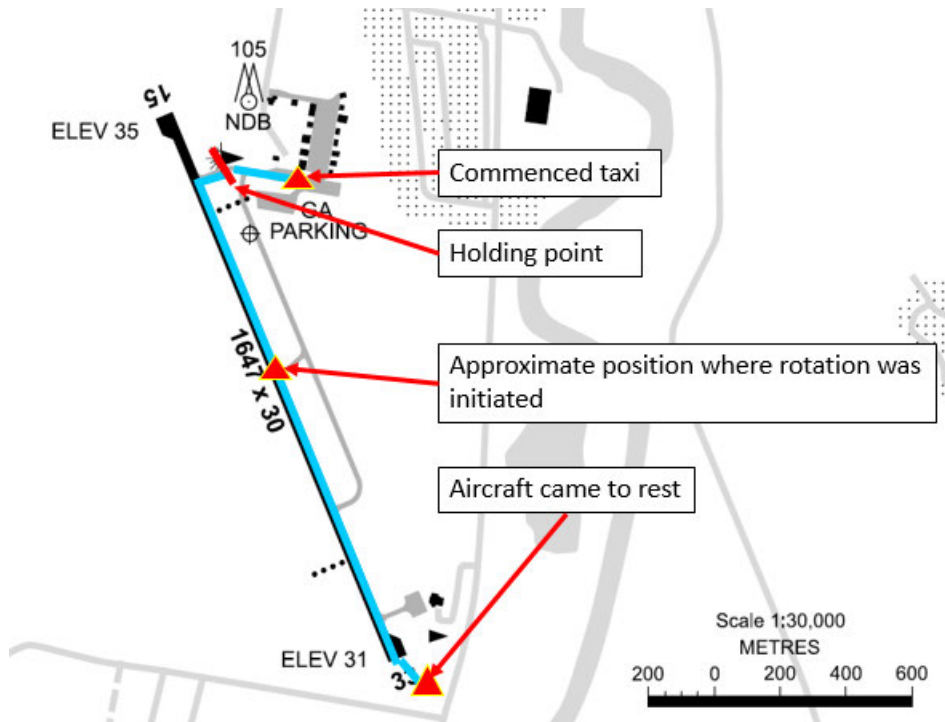
**Figure 1: Lismore Airport showing aircraft track**

The captain taxied the aircraft onto the runway, and turned left onto the runway centreline to commence the take-off run from the intersection (Figure 1). While rolling along the runway, the captain advanced the thrust levers to the approximate take-off setting. The captain then called 'set thrust', and the copilot set the thrust levers to the more precise position needed to achieve the planned engine thrust for the take-off.

Runway 15 at Lismore had an available take-off length of 1,647 m (5,403 ft). The runway sloped down by 0.1 per cent. The aircraft was taxied onto the runway at the northern taxiway intersection, about 152 m (500 ft) beyond the runway threshold (Figure 1). Although the take-off was commenced from the intersection, an additional 152 m of runway was available to the crew for the take-off.

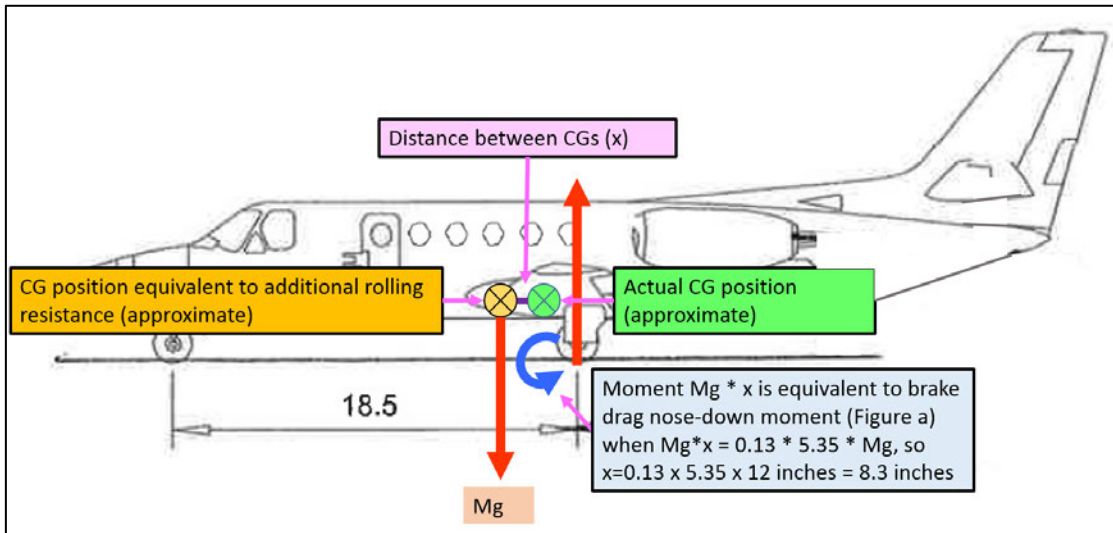
**Figure A-6: Representation of nose-down moment with additional rolling resistance equivalent to more forward centre of gravity**

The nose-down moment due to the additional rolling resistance, depicted in Figure A-4, is equivalent to the nose-down moment due to the vertical force ( $Mg$ ) through a more forward centre of gravity position (Figure A-6). So that  $0.13 Mg * 5.35 \text{ (ft)} * 12 \text{ (inches per foot)} = Mg * x$ , where  $x$  is the effective forward movement of the CG. Therefore,  $x$  is 8.35 inches, which is 10.3% MAC.

The aircraft's load sheet the flight crew prepared for the flight is depicted in Figure A-7. The computed CG was 25.1% MAC at take-off. The most forward allowable at that weight was 22% MAC. Moving the centre of gravity forwards 8.35 inches, or 10.3% MAC, would place the effective centre of gravity over 5 inches forward of the allowable range (and off the chart). In that condition it should be impossible to raise the nose of the aircraft – to rotate on take-off.
