# National Transportation Safety Board

ERA21FA354

## AIRCRAFT PERFORMANCE STUDY

November 23, 2022

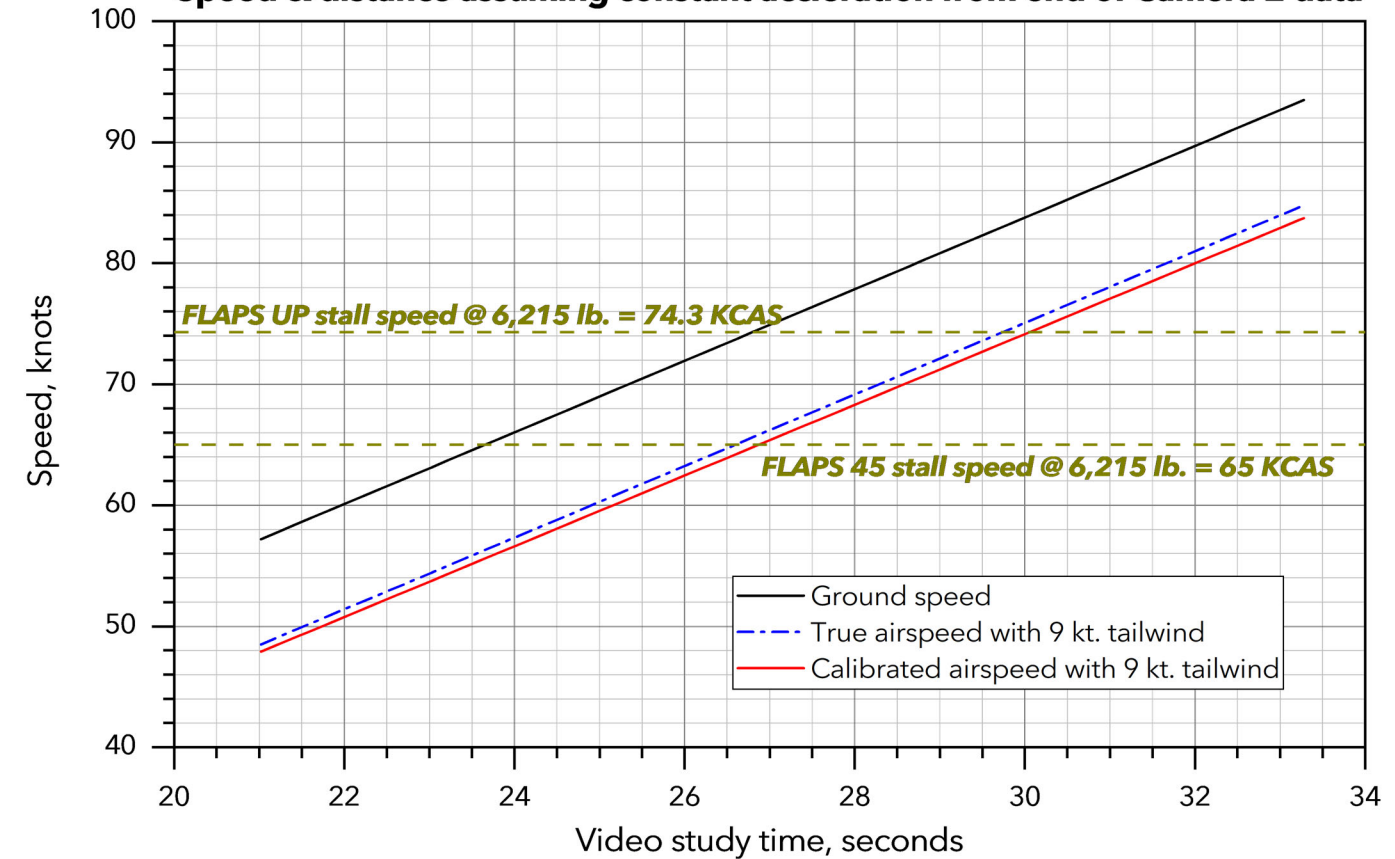
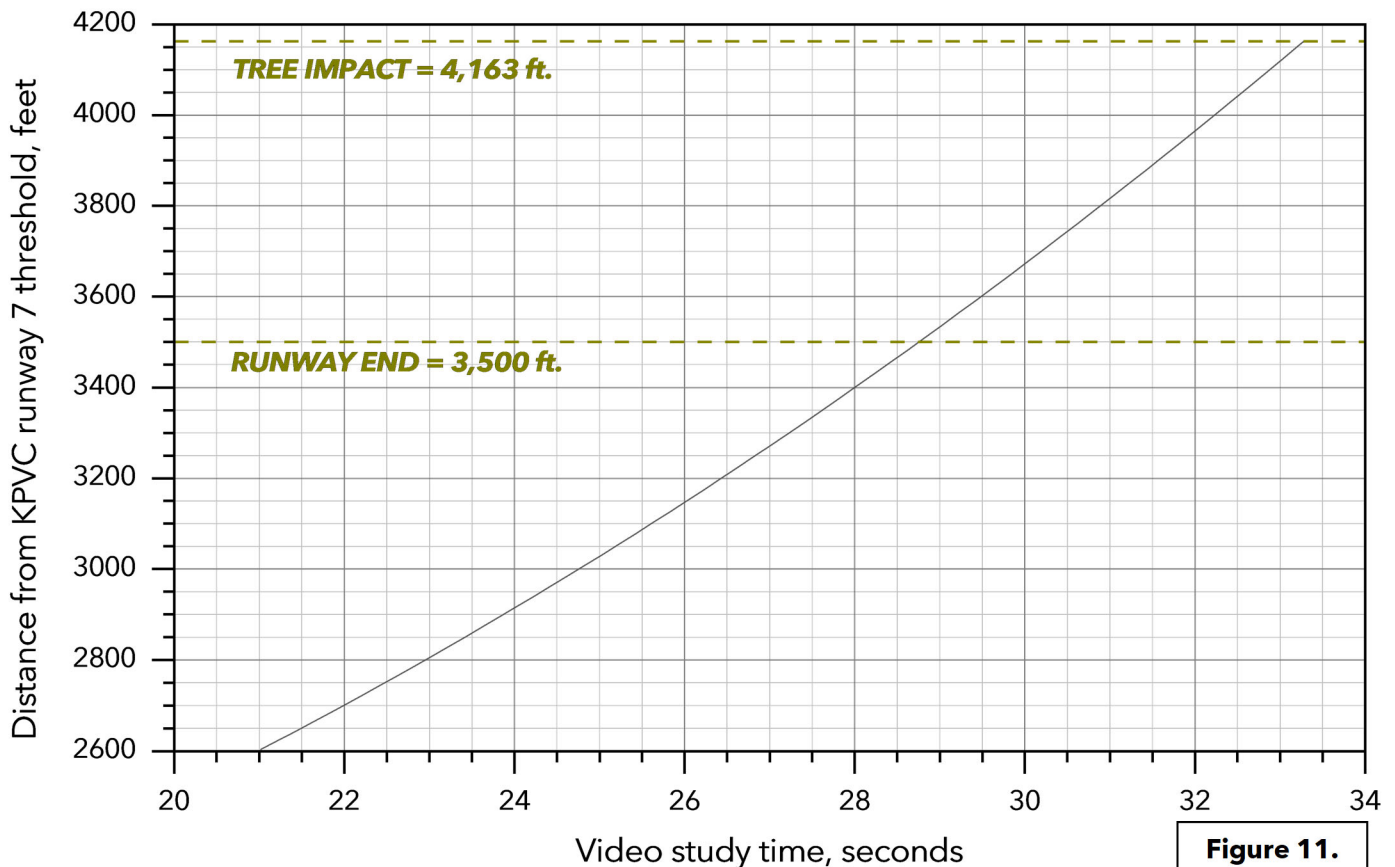
Figure 11.

lb. (the lowest possible airborne speed). The upper bound (84 KCAS) is the speed at tree impact computed as shown in Figure 11, and is also the best-angle-of-climb airspeed ( $V_x$ ) published in the POH/AFM.<sup>13</sup> The top plot of Figure 11 shows N88833's ground speed as a function of the *Video Study* time, starting at the speed of the last Camera 2 position point (57.2 kt.), assuming a constant acceleration of 5 ft/s<sup>2</sup>, and ending at the time of impact. The true airspeed and calibrated airspeed shown in Figure 11 are computed from the ground speed assuming a 9-knot tailwind.

The results in Figures 10a and 10b were computed with the METAR winds reported at 15:37 (210° at 10 knots, a 9 knot tailwind for runway 7), whereas the AWOS 1-minute data for 15:27 (closer to the landing time) recorded winds from 213° at 12 knots (an 11 knot tailwind). Thus, the actual tailwind was likely 2 knots greater than that used to compute the results shown in Figures 10a and 10b, which would affect the flight path angle relative to the Earth shown in the Figures slightly. In addition, the true and calibrated airspeeds shown in Figure 11 would be 2 knots lower with an 11 knot vs. 9 knot tailwind. (Additional weather data is presented in Section D.5 and Reference 6.)

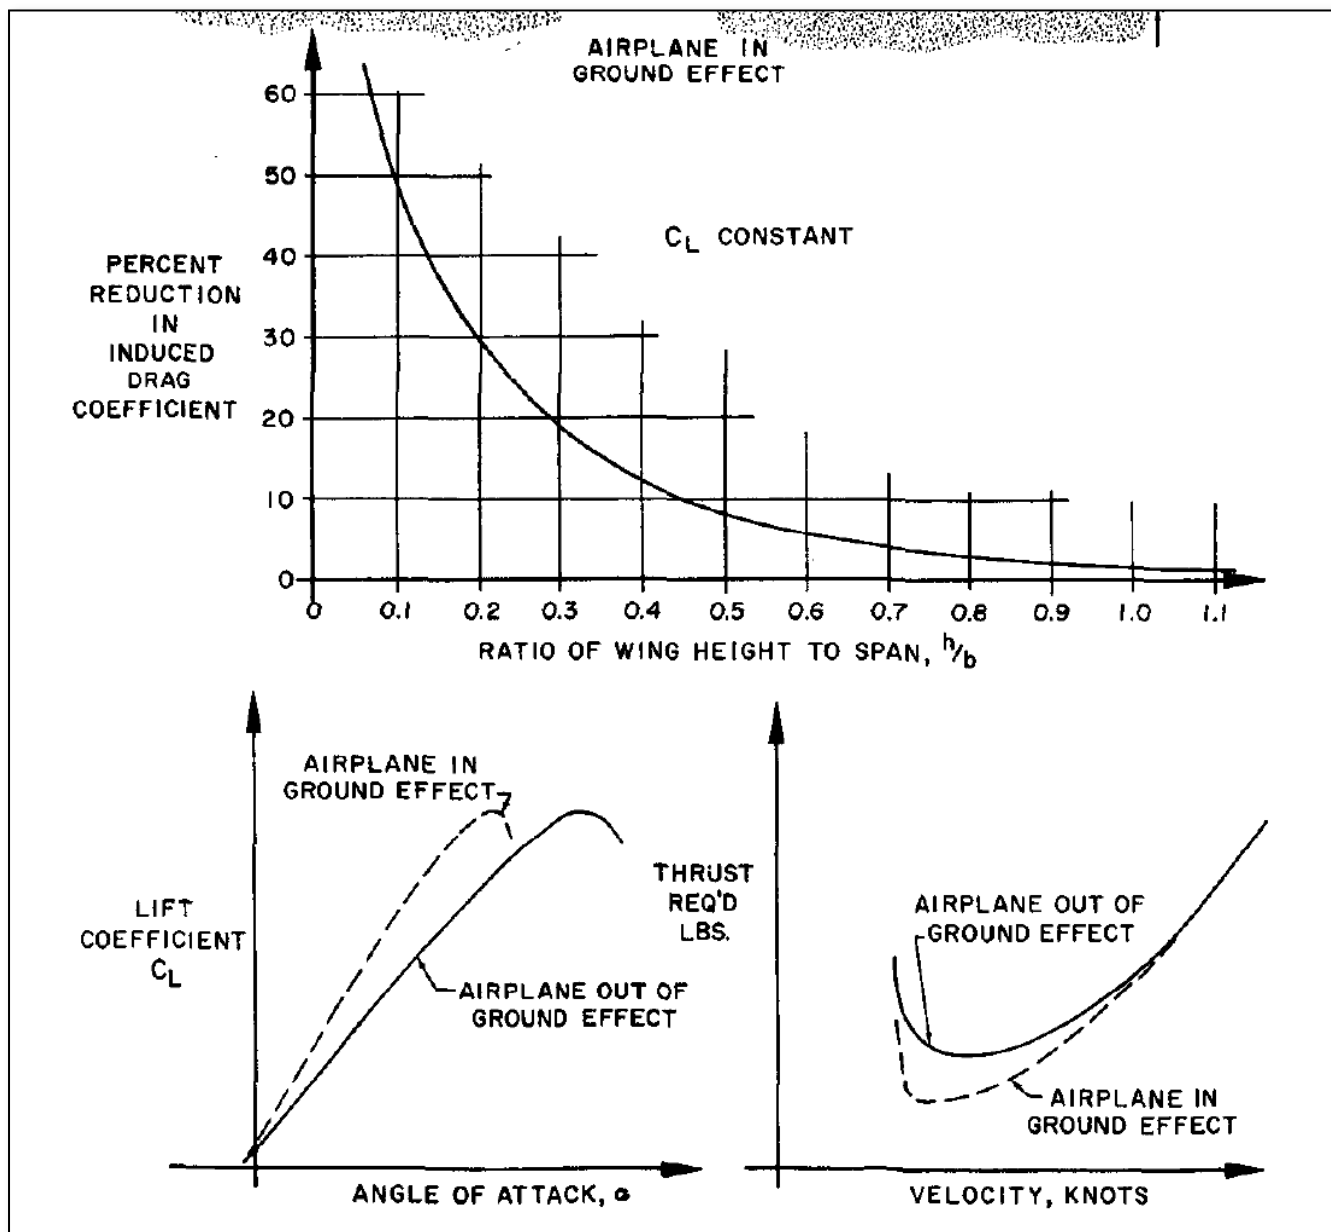
**Figure 12.** Ground effects on airplane aerodynamics (from Reference 7).

The physical basis and qualitative effects of ground-effect on an airplane's aerodynamics are well understood (see, for example, References 7-9). The airflow around the airplane cannot have a vertical component at the ground plane (i.e., air cannot flow into or out of the ground), and so the streamlines around the airplane are altered from what they would be in free air. Specifically, the downwash produced by the wing trailing vortices is reduced by the proximity of the ground plane, which in turn reduces the induced angle of attack and induced drag, and increases the  $C_L$  at a given  $\alpha$ . These effects are sketched in Figure 12, which is taken from Reference 7.

Figure 1 shows that with the airplane resting on its landing gear, the wing is about 3.4 ft. from the ground. With a wingspan of 44.12 ft., the corresponding wing height to wingspan ratio ( $h/b$ ) is about 0.076. Per Figure 12, ground effect would consequently reduce the induced drag by about 60% when the airplane is on the ground. Hence, the "no induced drag" line in Figure 7 (which represents a 100% reduction in induced drag) likely exaggerates the ground effect. At the tree impact height of 20 ft.,  $h/b \cong 0.5$  and Figure 12 indicates that the induced drag would only be reduced by about 10%. Nonetheless, ground effect improves acceleration on the ground and the initial climb rate because it reduces induced drag substantially.

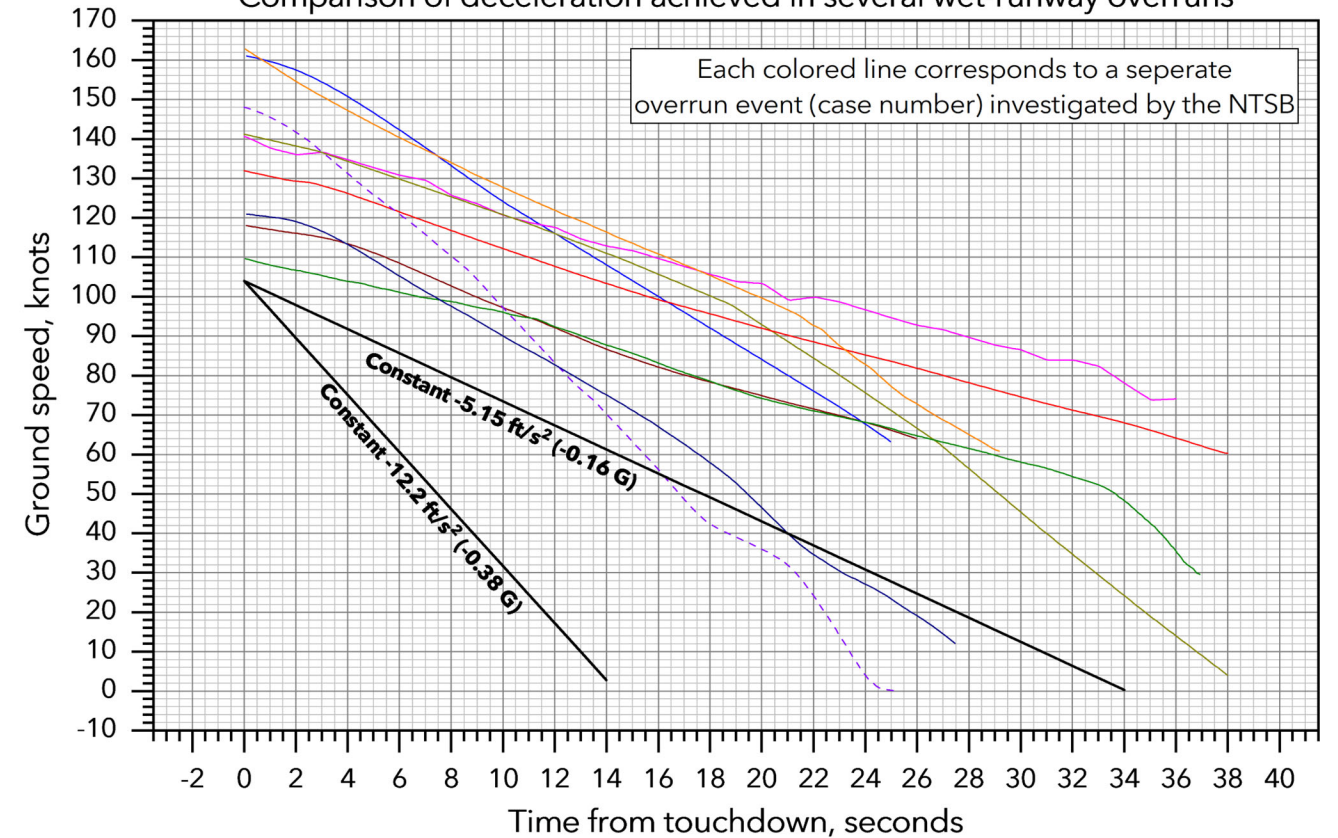
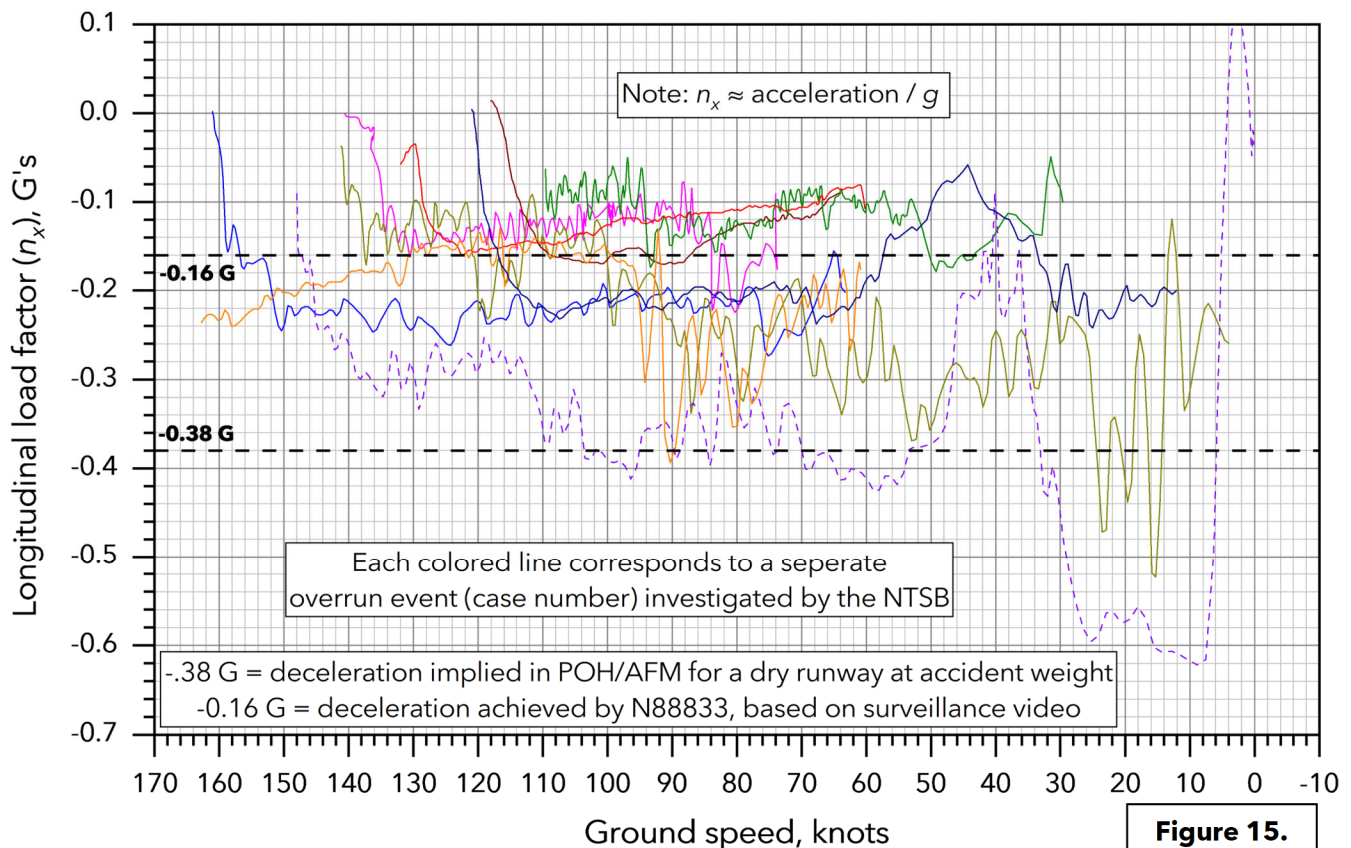
**Figure 15.**

Using  $V_0 = 86.4 \text{ knots} = 145.8 \text{ ft/s}$ ,  $V_1 = 0 \text{ ft/s}$ , and  $(x_1 - x_0) = 875 \text{ ft.}$  in Equation [34] gives a deceleration ( $-a$ ) of  $12.2 \text{ ft/s}^2 = 0.38 \text{ G}$ . The actual deceleration of the airplane following touchdown, as estimated from surveillance video evidence, is about  $5.15 \text{ ft/s}^2$ , or 0.16 G (see Table 1). This reduction in deceleration on a wet runway is not unexpected. Figure 15 compares the deceleration achieved during several wet-runway overrun events investigated by the NTSB. All of the events plotted in Figure 15 involve

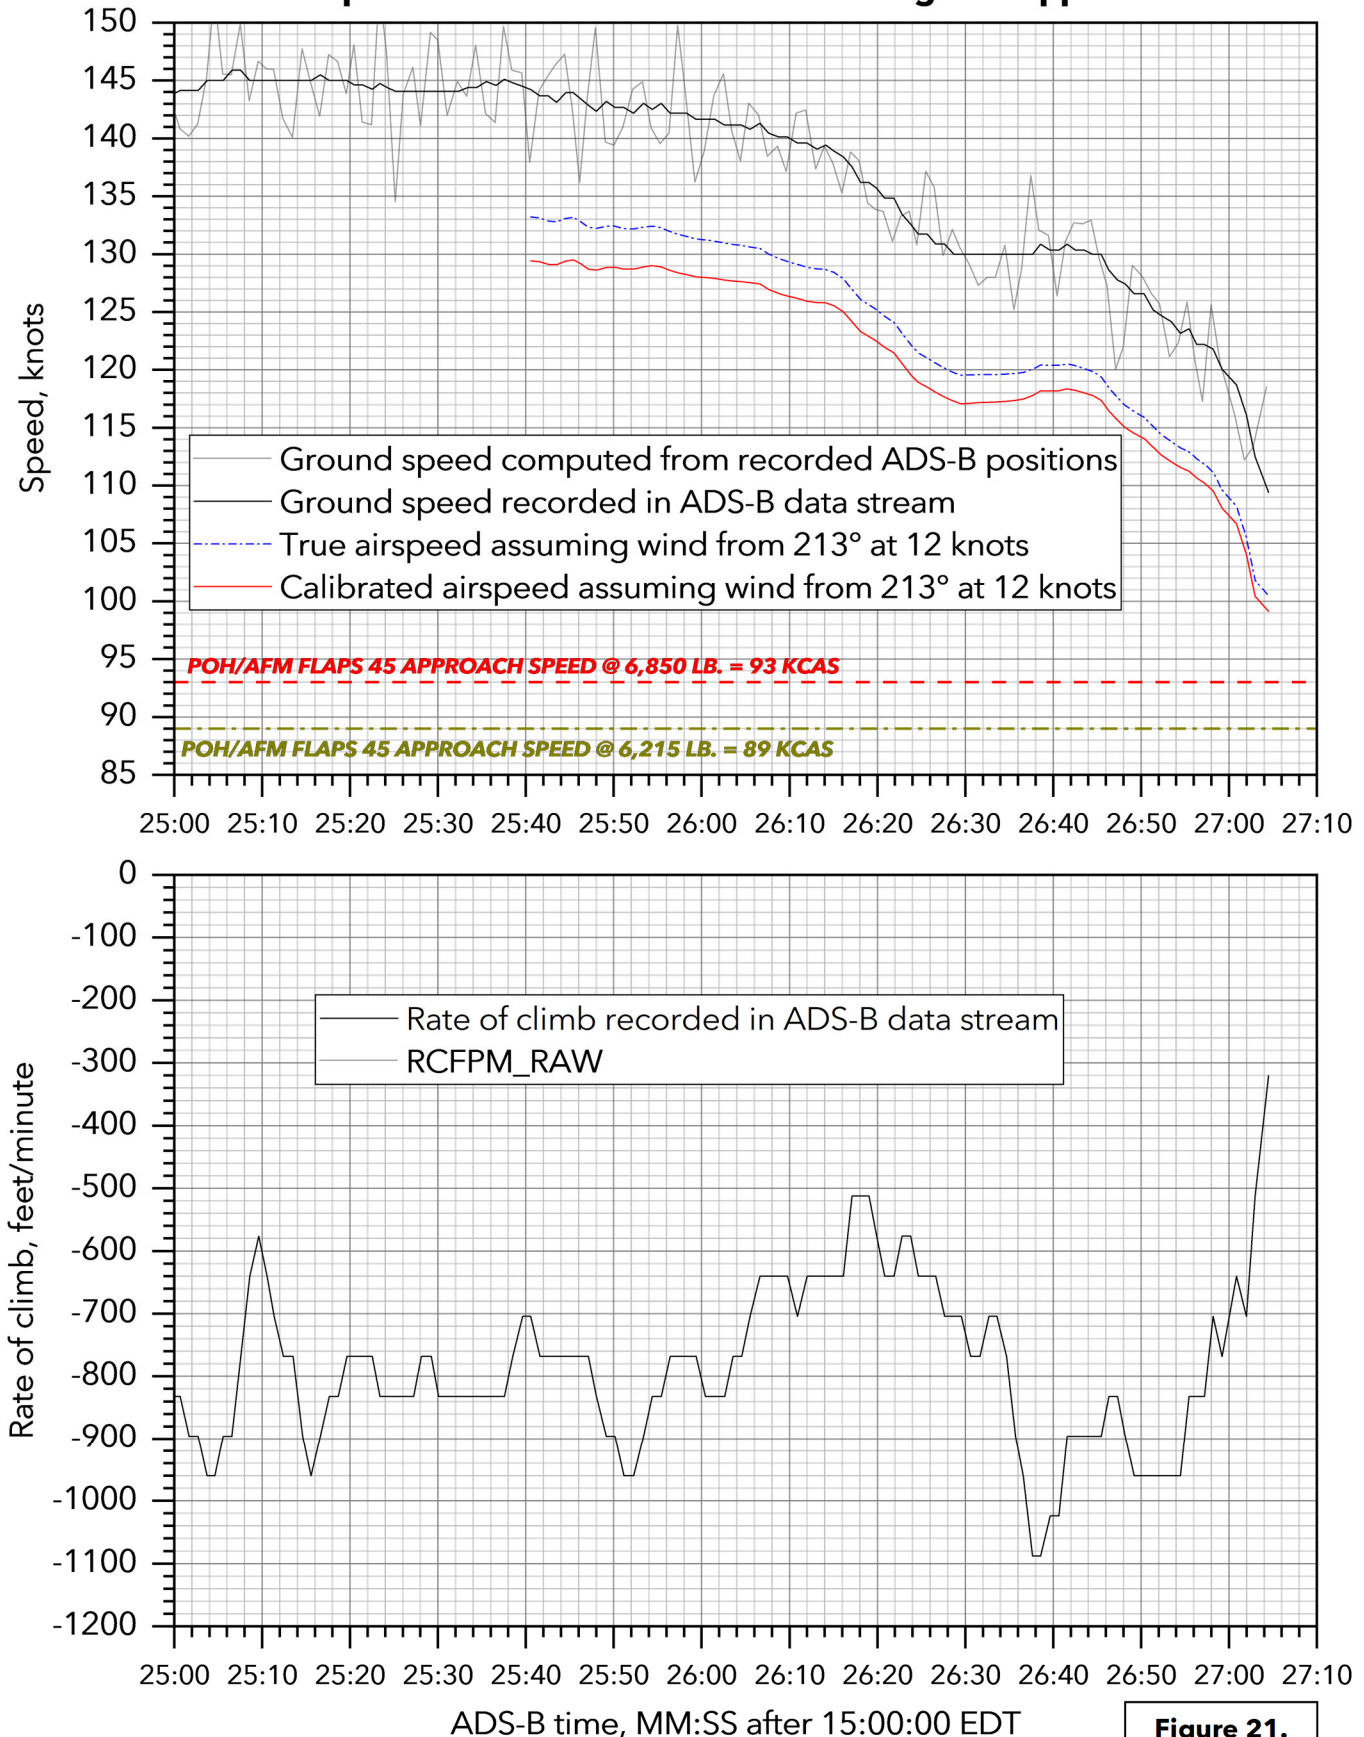
**Figure 21.**

As shown in Figure 21, during the accident approach the airspeed remained above 125 KCAS until about 15:26:16, as the airplane was descending through 650 ft. MSL. Consequently, above 650 ft. MSL the airspeed exceeded the 120 +5/-0 KIAS final approach segment target prescribed in the NPH. Figure 21 indicates that the ground speed from 15:25:00 to 15:25:40 (between 1,560 and 1,000 ft. MSL) was relatively constant at about 144 knots; for the indicated airspeed to be no more than 125 knots during this time would require a tailwind of 16 knots (accounting for a 3 knot difference between true and indicated airspeeds at altitude). This magnitude of tailwind is not consistent with the winds indicated by the HRRR model in Table 4.

<sup>21</sup> The final airspeeds shown in Figure 21 are about 3 knots higher than those cited here as a result of numerical artifacts associated with integrating the recorded ADS-B ground speed to get position, and then taking the derivative of the resulting position to get a ground speed from which the airspeeds are computed using the assumed wind. This effect is only notable for the last ADS-B data point.
