**NATIONAL TRANSPORTATION SAFETY BOARD**  
Vehicle Recorder Division  
Washington, DC 20594

## Video Study

| Aircraft: | Cessna 414, N8132Q |
| NTSB Number: | ERA21LA011 |

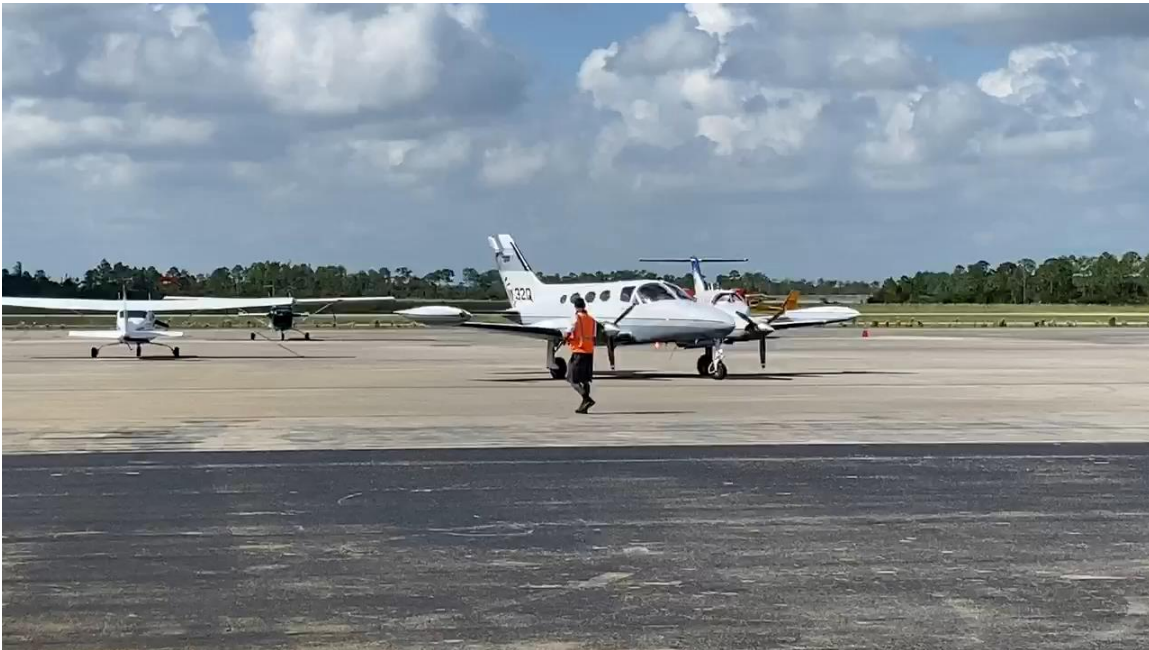
**Figure 1. A screenshot from video file IMG\_3210.mov. This shows the accident aircraft prior to the attempted flight.**

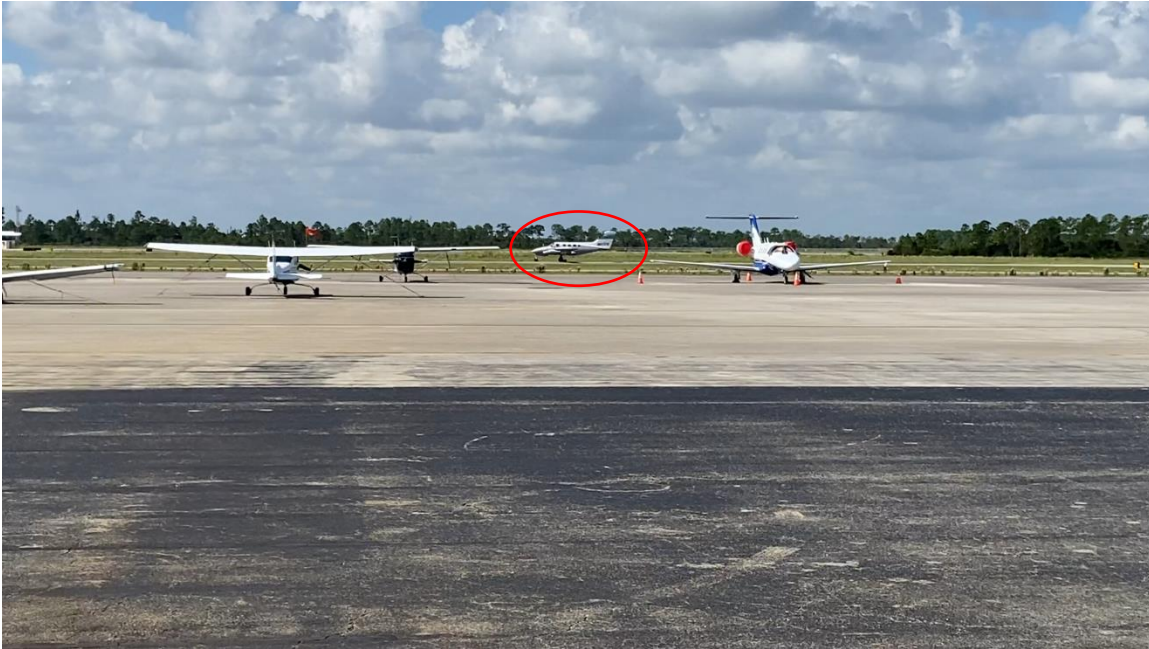
**Figure 2. A screenshot from video file IMG\_1405.mov. The accident aircraft is circled in red.**

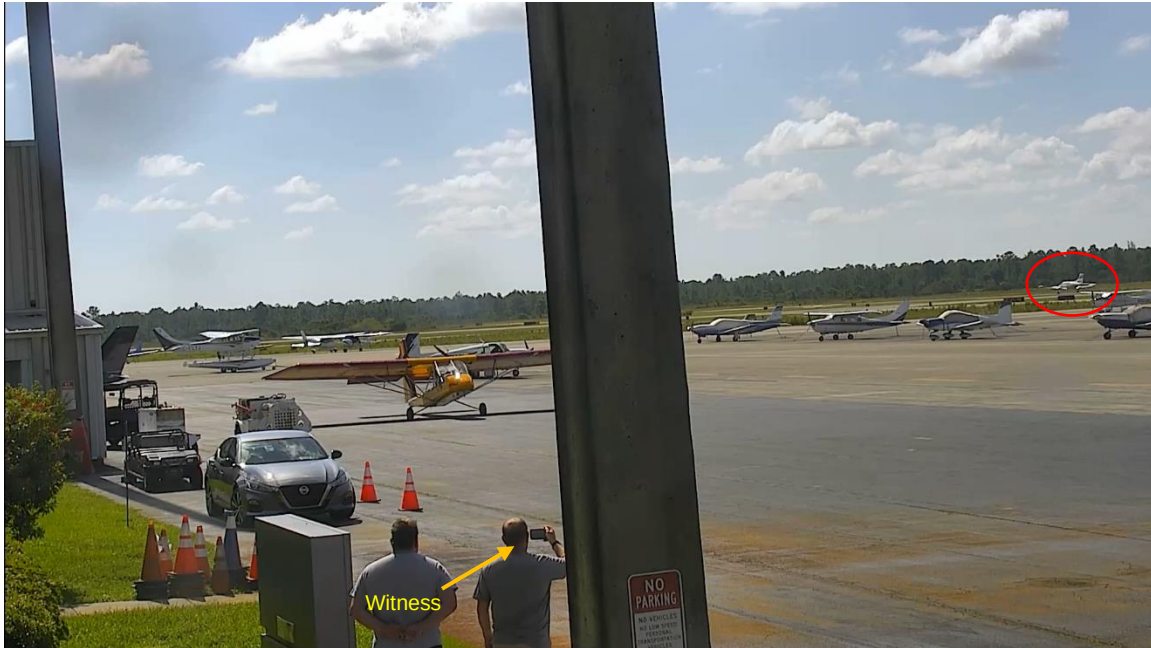
Figure 3. A screenshot from the North Ramp PTZ camera recording. The accident aircraft is circled in red. Text indicates the witness's position who recorded IMG\_1405.mov.

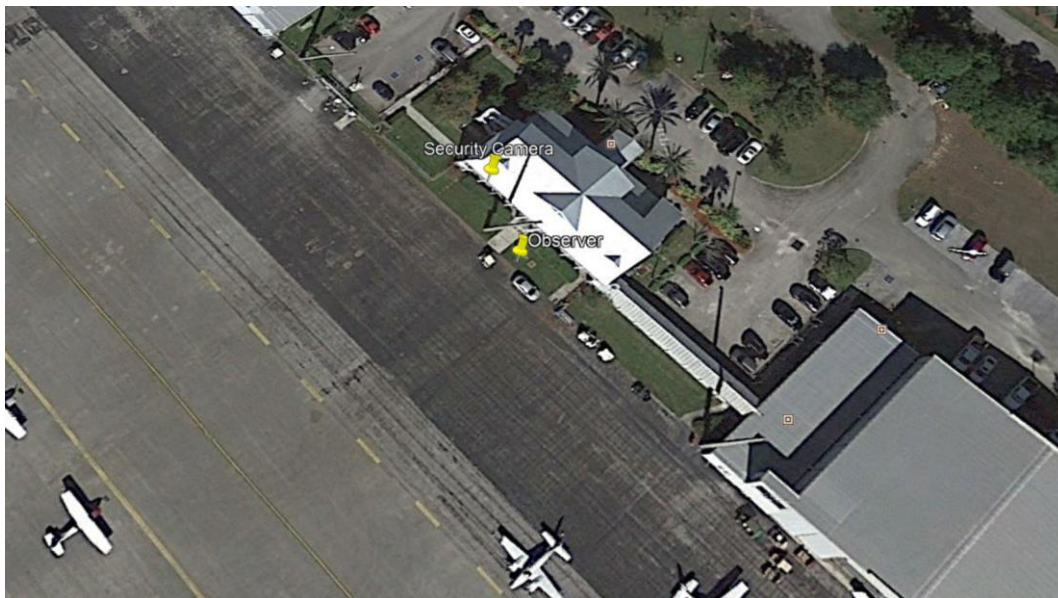
An attempt was made to determine the aircraft's average groundspeed during portions of takeoff roll. After review of all three video recordings, it was determined that IMG\_1405.mov recorded from the witness's position shown in figure 3 would be the best candidate for performing a calculation of the average groundspeed. Furthermore, the exact witness's position at the airport is indicated in figure 10.

Figure 10. Pins indicating the observer's position as well as the position of the East Ramp PTZ security camera.
