**NATIONAL TRANSPORTATION SAFETY BOARD**  
Office of Aviation Safety

**AIRWORTHINESS GROUP CHAIRMAN'S FACTUAL REPORT**

**ERA21LA065**

Operator: Private  
Location: Leesburg, Virginia  
Date: December 6, 2020  
Time: 1420 Eastern Standard Time (EST)  
Aircraft: Piper PA-46-600TP (M600), SN 4698111  
Registration: N282ST

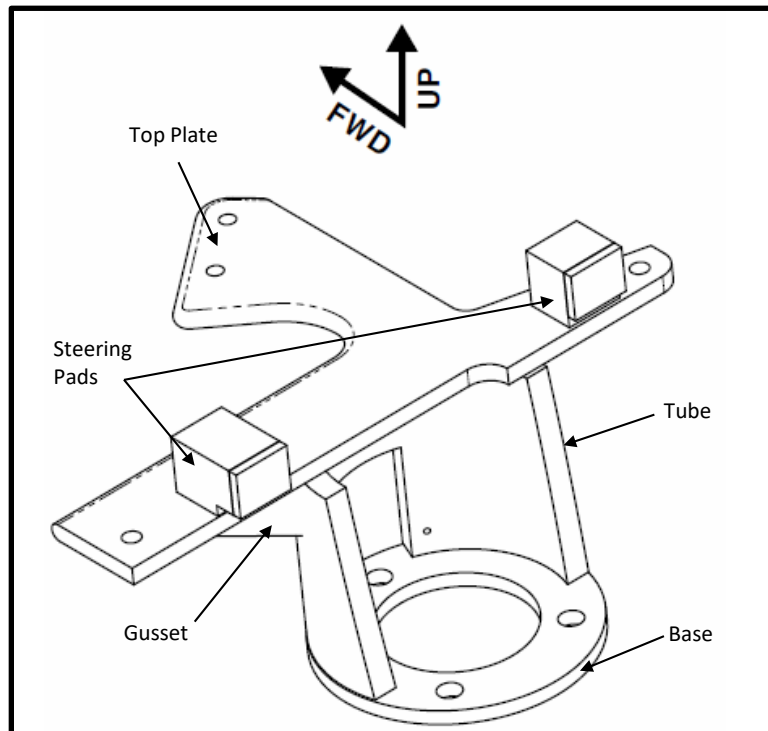
*Figure 10-Drawing of Steering Horn Assembly.*

(PN 85154-010 and -011) welded together in accordance with drawing 85154, Figure 10. The steering horn is attached to the NLG strut with 3 bolts through the base. A PN 83638-005 rub block is attached to the forward leg of the top plate, a PN 83638-002 roller (large) is attached to the left leg of the top plate, and a PN 83638-006 roller (small) is attached to the right leg of the top plate through the holes shown in accordance with revision C of the Nose Landing Gear Assy drawing 46N32A001. The two steering pads and two steering rollers interface with the steering arm to provide nose wheel steering with the NLG in the down position. The 85154-012 steering horn assembly was the same as used on the M500 airplane and was installed on M600 airplanes with serial number (SN) 4698001 to SN 4698135. Piper discovered alignment issues with certain steering horn assemblies installed on airplanes with SN 4698102 and above where the location of the steering pads and rollers was not consistent due to variances in the tolerance stack up. The alignment could be adjusted by machining the faces of the steering pads to achieve the necessary dimensional relationship between the pads and rollers. The incident airplane steering horn was reworked at the factory prior to delivery to align the pad faces with the rollers.

The steering horn assembly from the incident airplane was shipped to the NTSB Materials Laboratory for examination. See the NTSB Materials Laboratory Factual Report 21-009 in the public docket for the details of the examination. There was chipped and disbonded white paint noted in many areas with associated cracks in the paint film. There was some light corrosion noted on the exposed steel. No other anomalies were noted. The steering horn was shipped to Piper for a dimensional inspection. The following is a summary of the airplane manufacturer's inspection.
