Piper Aircraft, Inc.  
2926 Piper Drive  
Vero Beach, FL, U.S.A. 32960

# SERVICE NO. 1350 BULLETIN

Date: December 17, 2020

**NOSE LANDING GEAR STEERING HORN AND ARM  
ASSEMBLIES INSPECTION**

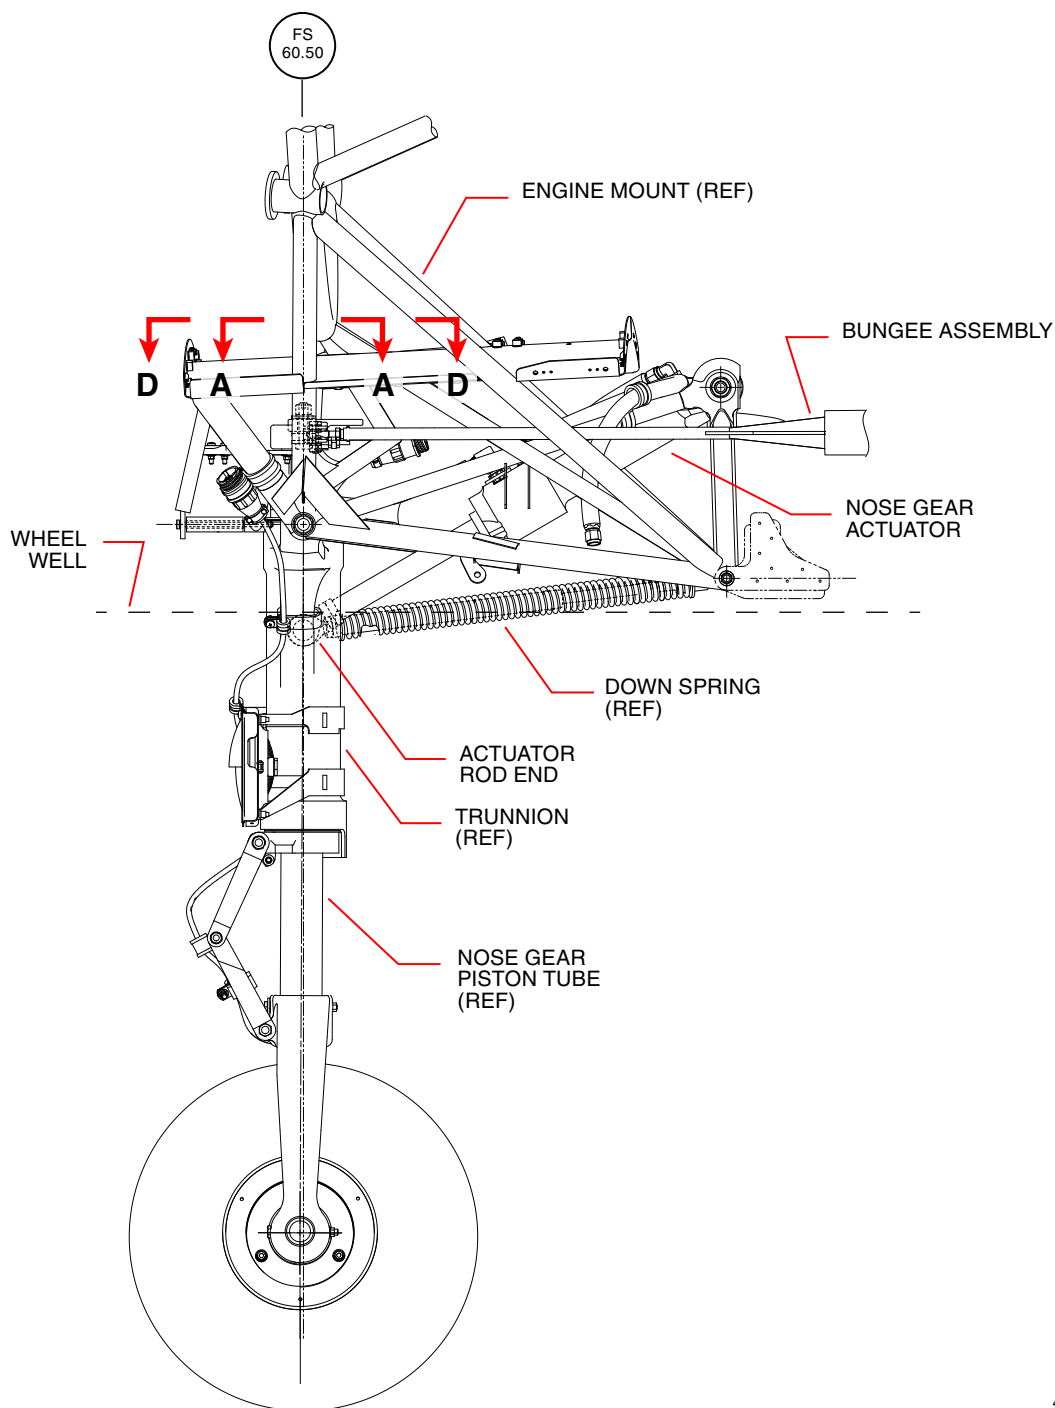
**Figure 1 – Sheet 1 of 5**  
Nose Wheel Steering Assemblies – Typical

- c. Remove the Nose Wheel Steering Horn Assembly, P/N 85154-012. Do not remove the two Rollers, P/N 83638-002 and P/N 83638-006, from the assembly.
3. Visually inspect the steering horn pads and rollers for any signs of damage.

- If there is any damage, other than minor nicks or other minor wear, then the steering horn assembly must be replaced, which will be accomplished in an upcoming step. Proceed to Step 5.

- If there is no visually apparent damage, then proceed to Step 4.
  4. Check if the steering pads and rollers are positioned correctly on the steering horn as shown in Detail C. Place the steering horn onto a flat surface, with the rollers facing the surface. Use a feeler gauge, or a shop aid of appropriate thickness, to determine if the parts are positioned as depicted in Detail C.

**NOTE:** Detail C provides the correct positioning of the rollers and pads on both the existing and replacement steering horn.

- If the steering pads and rollers are not positioned as Detail C shows, then the parts must be replaced, which will be accomplished in an upcoming step. Proceed to Step 5.
  - If the steering pads and rollers are positioned as Detail C shows, then it may not be necessary to replace the steering horn assembly and rollers. Proceed to Step 5.
5. Inspect the Arm Assembly, P/N 83626-004, for any signs of damage, especially in the areas where the steering pads make contact.

- a. Replace the steering horn assembly and rollers with the new, improved assembly.

- 1) Order one (1) Nose Wheel Steering Horn and Roller Assembly, P/N 46N32A009-801, which is shown in Figure 2. This new, improved assembly replaces, as one assembly, the existing steering horn assembly (which includes the steering pads) and steering horn rollers.

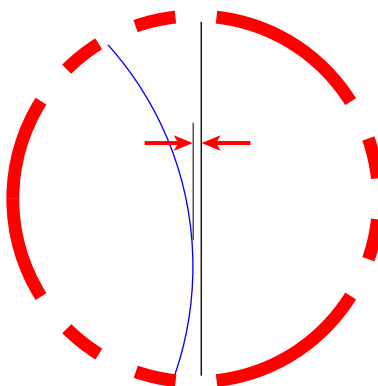
**DETAIL B**  
CLEARANCE BETWEEN STEERING ARM AND ROLLERS

Adjusting the rake angle affects the clearance between the steering arm and steering horn rollers, which requires that this clearance is checked, as provided under Item 3, below.

**NOTE:** The clearance between the steering arm and both of the rollers must be 0.010 – 0.030 inch.

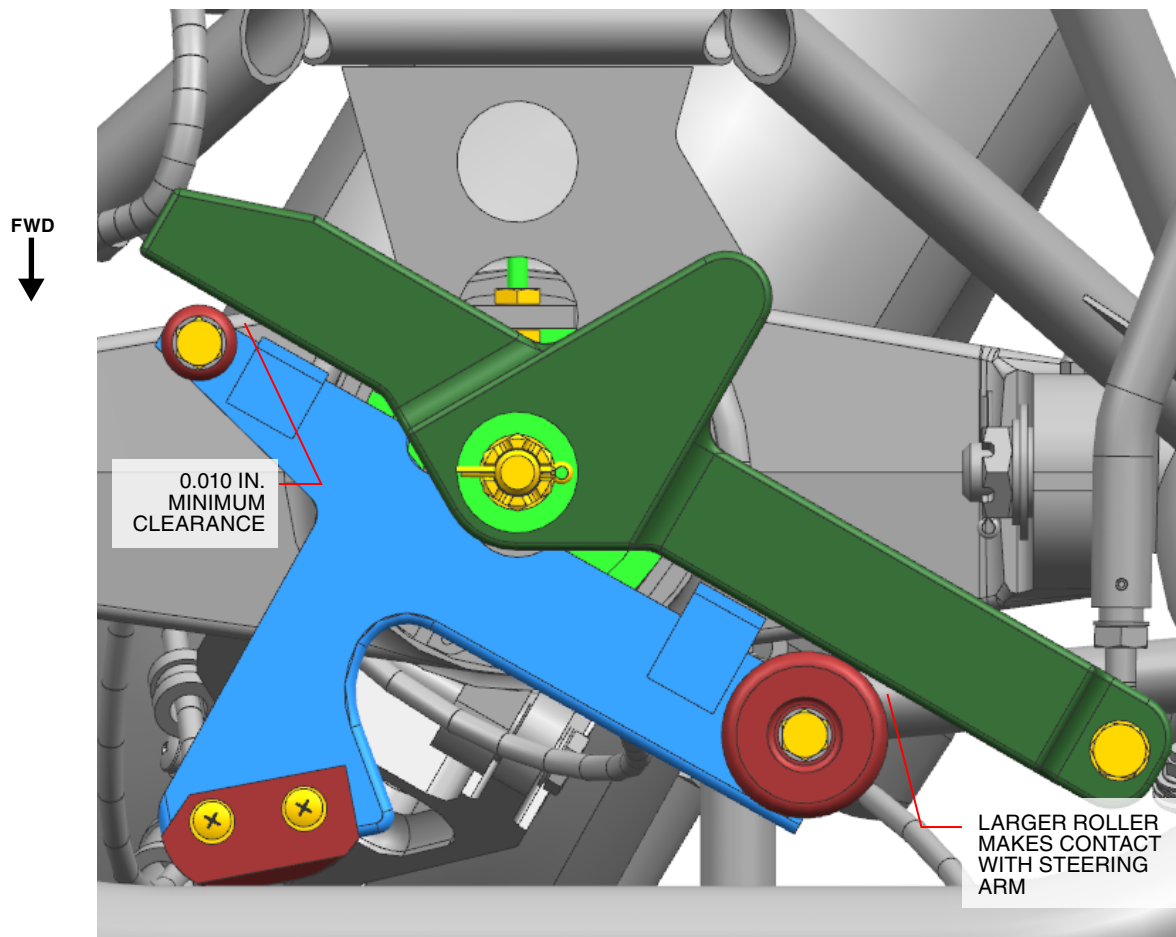
**Figure 3**  
Position of Steering Horn and Arm Assemblies – Right Rudder Pedal Pressed

- a) With the nose wheel off the ground and free to turn, and the right rudder pedal pressed firmly against the right forward stop, determine whether there is 0.010 in. minimum clearance between the steering arm and the small roller on the steering horn assembly, as shown in Figure 3.
- b) If the clearance is less than the minimum 0.010 in., then complete Steps c) and d) under Step 2), above. Increase the nose landing gear centered clearance per the steering arm adjustment procedure, Step 1), above. A 0.010 in. minimum clearance must be maintained for the small roller on the steering horn assembly at full right rudder pedal deflection.
- c) If Steps c) and d) under Step 2) were necessary, unlock the rudder pedals, then repeat Step a), above, to confirm that minimum clearance is achieved.

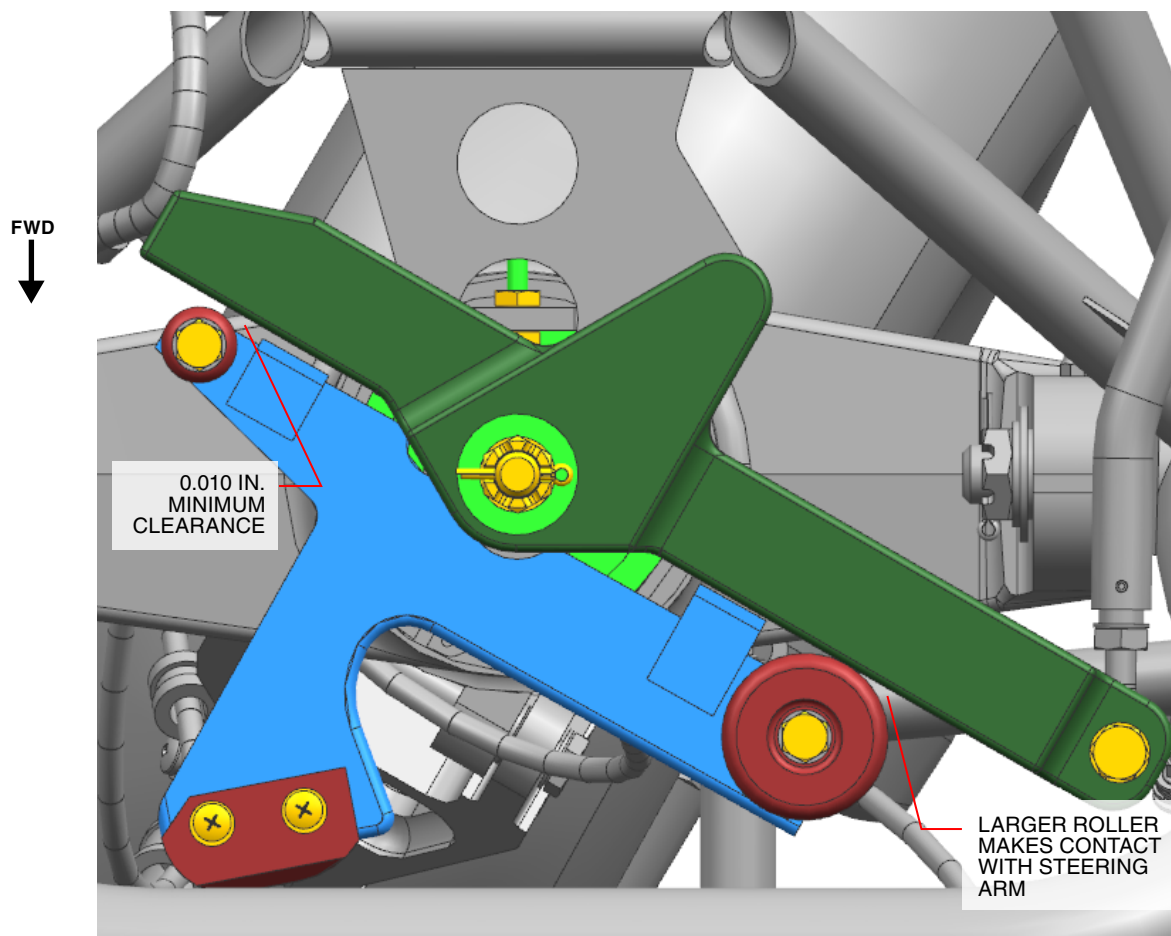
**Figure 3**  
Position of Steering Horn and Arm Assemblies – Right Rudder Pedal Pressed

- a) With the nose wheel off the ground and free to turn, and the right rudder pedal pressed firmly against the right forward stop, determine whether there is 0.010 in. minimum clearance between the steering arm and the small roller on the steering horn assembly, as shown in Figure 3.
- b) If the clearance is less than the minimum 0.010 in., then complete Steps c) and d) under Step 2), above. Increase the nose landing gear centered clearance per the steering arm adjustment procedure, Step 1), above. A 0.010 in. minimum clearance must be maintained for the small roller on the steering horn assembly at full right rudder pedal deflection.
- c) If Steps c) and d) under Step 2) were necessary, unlock the rudder pedals, then repeat Step a), above, to confirm that minimum clearance is achieved.

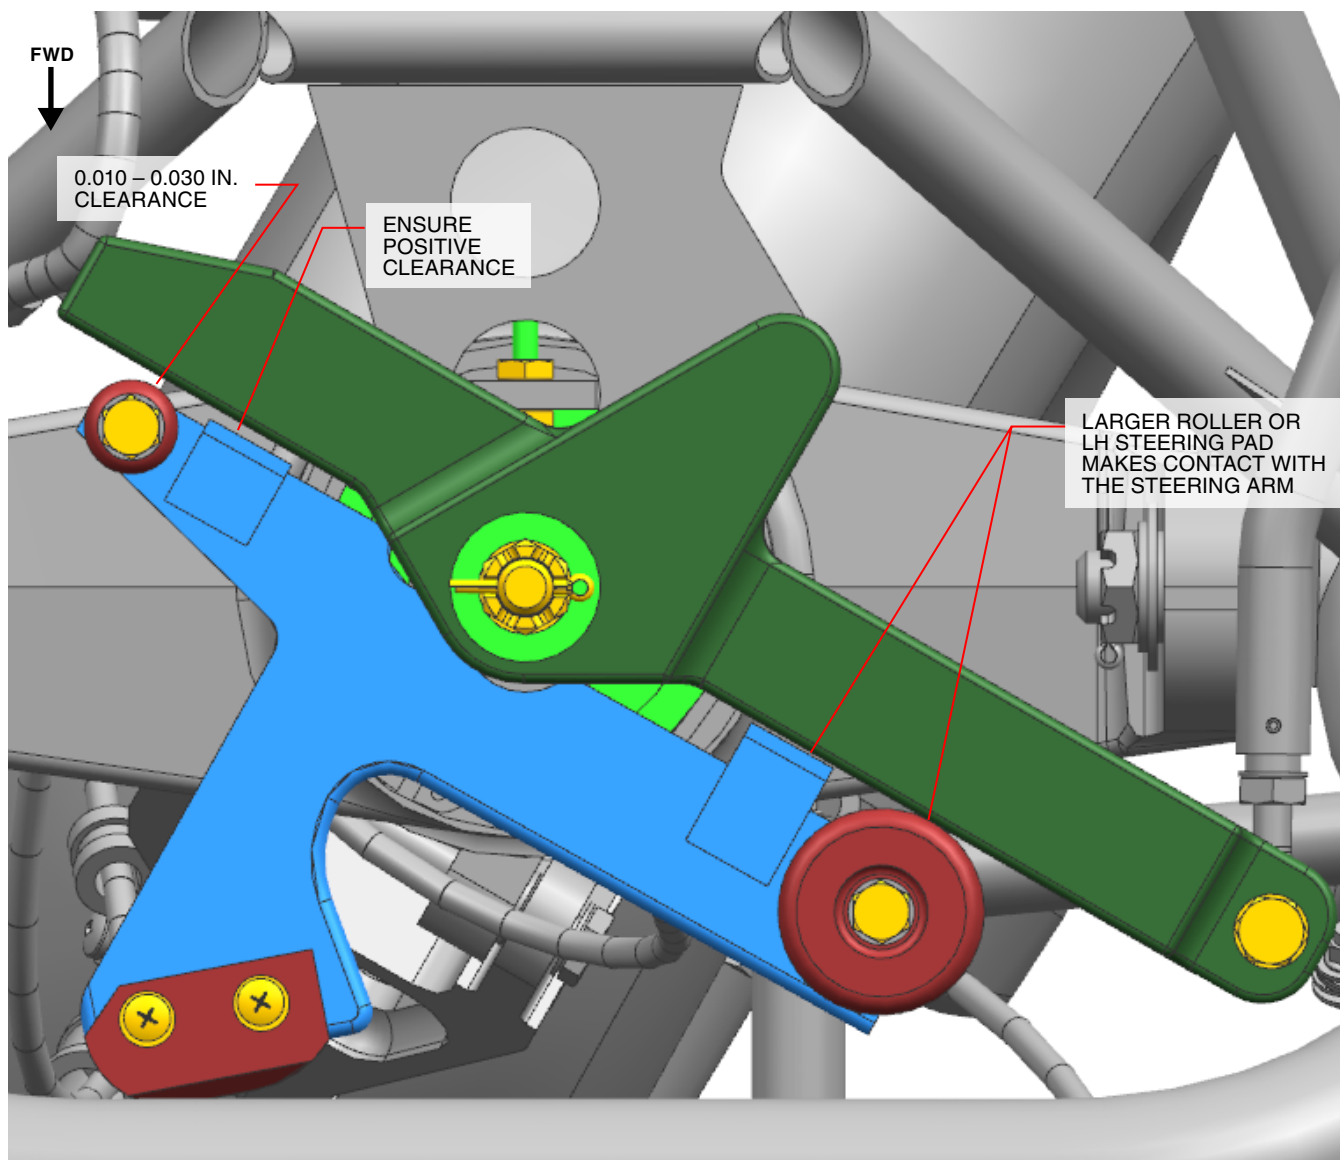
**Figure 3**  
Position of Steering Horn and Arm Assemblies – Right Rudder Pedal Pressed

- a) With the nose wheel off the ground and free to turn, and the right rudder pedal pressed firmly against the right forward stop, determine if there is: a 0.010 in. minimum clearance between the steering arm and the small roller, and a positive clearance between the steering arm and the right hand steering horn pad, on the steering horn assembly, as shown in Figure 3.

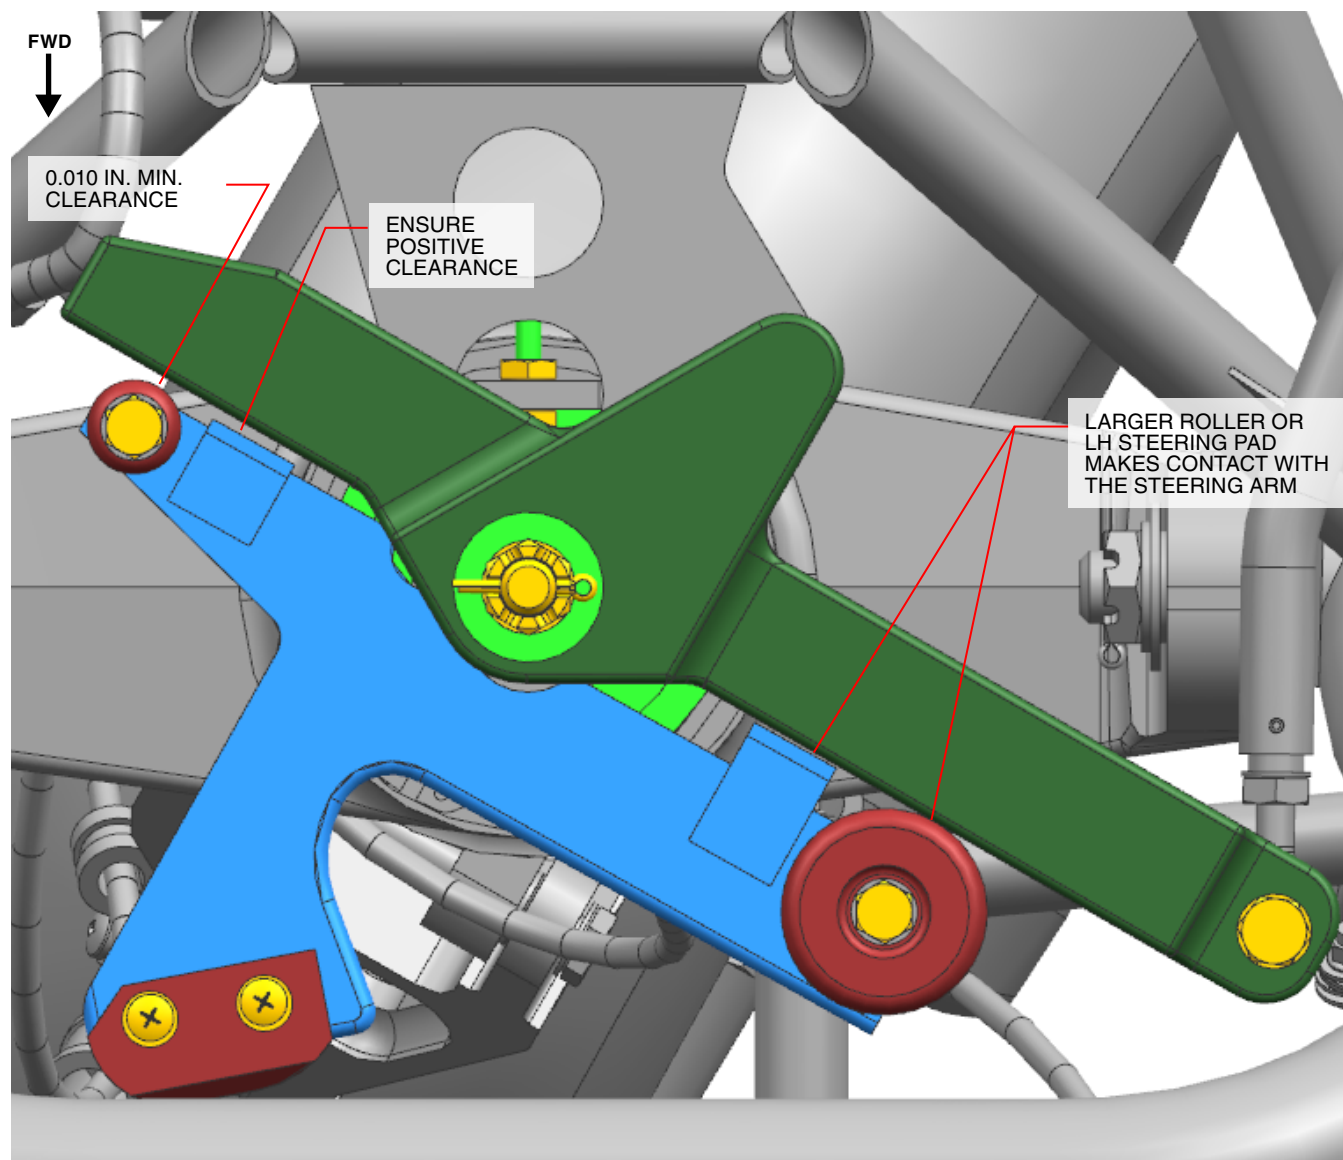
**Figure 3**  
Position of Steering Horn and Arm Assemblies – Right Rudder Pedal Pressed

- a) With the nose wheel off the ground and free to turn, and the right rudder pedal pressed firmly against the right forward stop, determine if there is: a 0.010 in. minimum clearance between the steering arm and the small roller, and a positive clearance between the steering arm and the right hand steering horn pad, on the steering horn assembly, as shown in Figure 3.

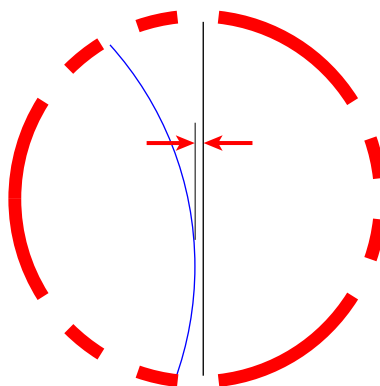
**DETAIL B**  
 CLEARANCE BETWEEN STEERING ARM AND ROLLERS

Adjusting the rake angle affects the clearance between the steering arm and steering horn rollers, which requires that this clearance is checked, as provided under Item 3, below.

**NOTE:** The clearance between the steering arm and both of the rollers must be 0.010 – 0.030 inch.

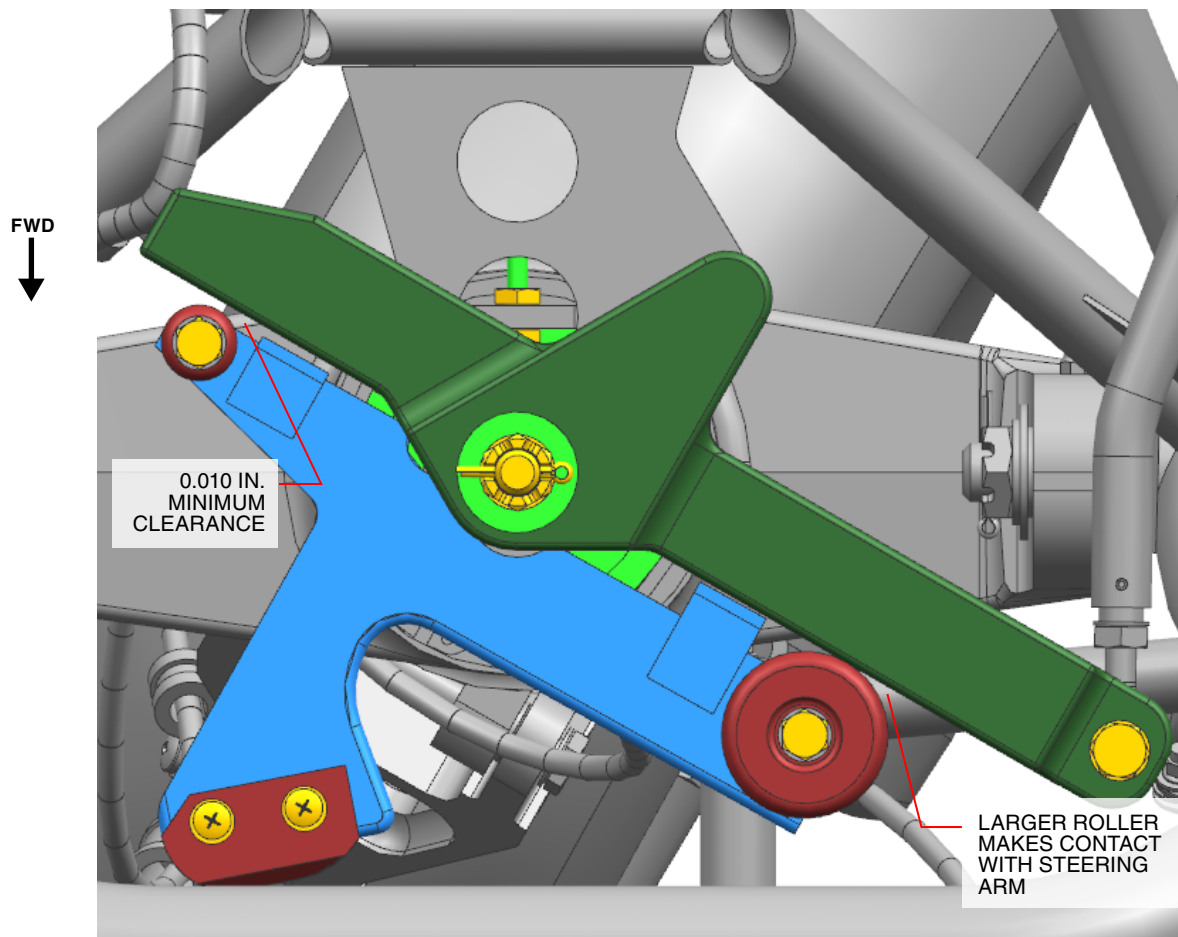
**Figure 3**  
Position of Steering Horn and Arm Assemblies – Right Rudder Pedal Pressed

- a) With the nose wheel off the ground and free to turn, and the right rudder pedal pressed firmly against the right forward stop, determine whether there is 0.010 in. minimum clearance between the steering arm and the small roller on the steering horn assembly, as shown in Figure 3.
- b) If the clearance is less than the minimum 0.010 in., then complete Steps c) and d) under Step 2), above. Increase the nose landing gear centered clearance per the steering arm adjustment procedure, Step 1), above. A 0.010 in. minimum clearance must be maintained for the small roller on the steering horn assembly at full right rudder pedal deflection.
- c) If Steps c) and d) under Step 2) were necessary, unlock the rudder pedals, then repeat Step a), above, to confirm that minimum clearance is achieved.
