# Safety Communique

January, 2012

**SUBJECT:** FLIGHT CONTROL CABLE SYSTEM INSPECTIONS

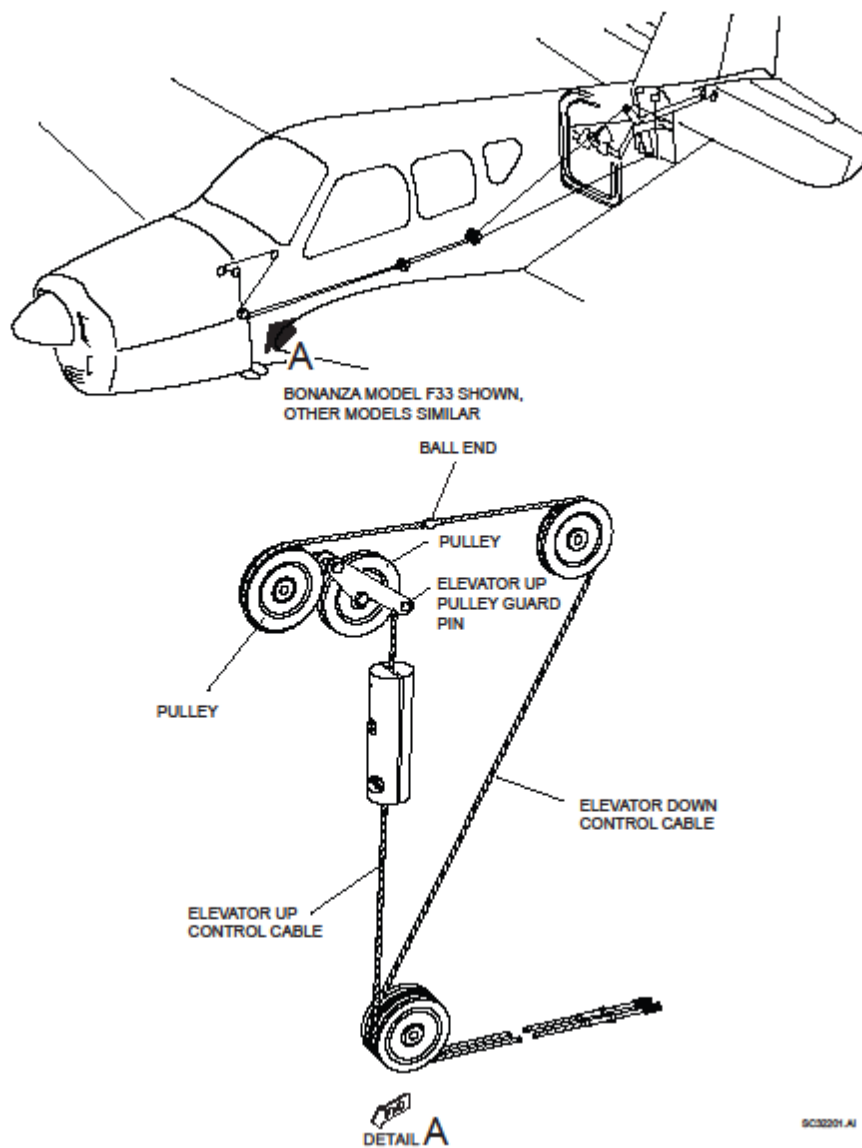
Forward Control Cable Assembly – Model F33  
Figure 2

HBC reminds owners/operators of the importance of doing a thorough flight control cable system inspection. Some areas of control cable routing require a deliberate inspection effort due to location and cable routing between pulleys. Refer to Figure 2 for an illustration of a

HBC recommends, when inspections are performed on flight control cable systems as instructed in the applicable airplane Shop or Maintenance Manual, that flight controls are operated through their full range so that cables move away from pulleys and all portions of the cables are exposed for inspection. Full control travel motion may require two persons, one to cycle controls and another to inspect cables during movement. Although the CASA ADs only affect the elevator control cable system, current HBC inspection guidelines apply to all flight control cables. Anywhere a cable is not visible, the flight controls should be manipulated so 100% of all cables can be inspected. During the inspection process, the inspecting individual shall also examine the cable runs for incorrect routing, fraying, twisting, or wear at fairleads, pulleys, anti-abrasion strips and guards. Inspecting individuals shall ensure there is no interference with adjacent structure, equipment, wiring, plumbing, and other controls. Cable systems shall not exhibit binding through full travel, and proper tension of cables shall be maintained.

HBC reminds owners/operators of the importance of maintaining corrosion preventive compound on control cables and applying proper lubricants to control cable system components as defined in the applicable airplane Shop or Maintenance Manual. Replace control cables showing evidence of corrosion.
