## **ERA21LA071 Examination Summary**

**Date of accident:** December 12, 2020  
**Location of accident:** San Mateo, FL  
**Aircraft registration:** N11TG  
**Aircraft type and S/N:** Silverlight AR1, S/N 0041  
**Engine type and S/N:** Rotax 914UL, S/N 9577246  
**NTSB number:** ERA21LA071  
**Date of Report:** February 24<sup>th</sup> 2021

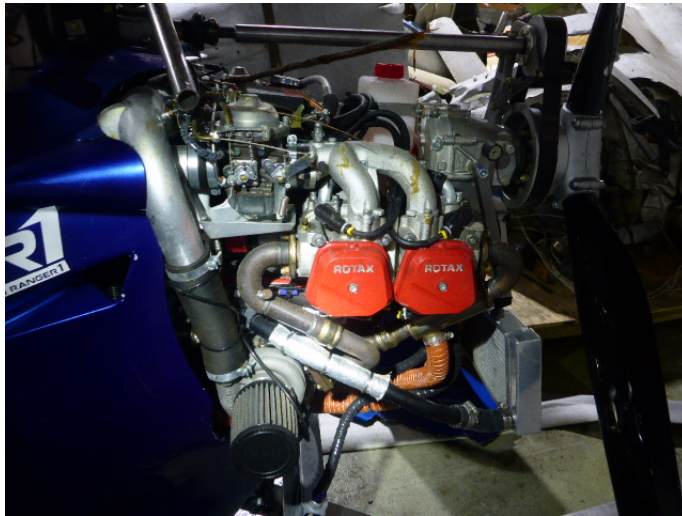
Figure 7. Left side of engine.

- Engine in good physical condition.
- One of the 3 propeller blades was broken about 11” outboard of the blade root.
- The other two propeller blades remained attached to the hub and undamaged.
