## **Mooney Accident – Additional Panel Testing**

Testing was conducted on November 30, 2021 at the Naples site of Parker Aerospace. The purpose of the testing was to determine if there was leakage between the aircraft panel and the gravity fill adaptor and/or between the gravity fill adapter and the cap.

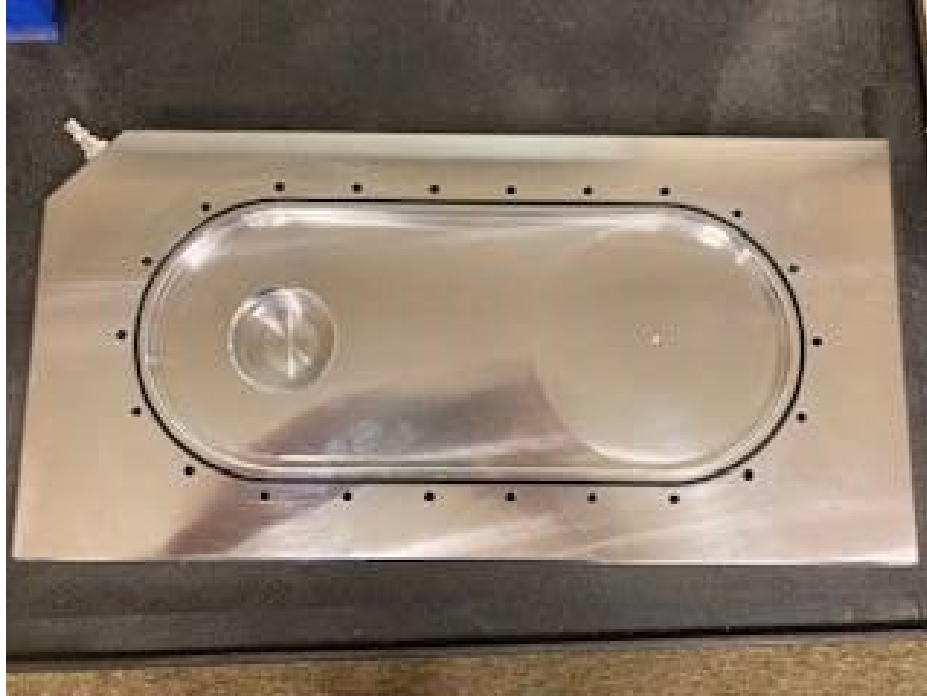
Figure 1: Test Fixture

1. It was determined that removal of the remaining sealant from the Left panel flanges was not necessary to obtain a good seal between the panel and test fixture. The o-ring seal provided an adequate seal. See Figure 1.

1. It was determined that removal of the remaining sealant from the Right panel flanges was not necessary to obtain a good seal between the panel and test fixture. The o-ring seal provided an adequate seal. See Figure 1.

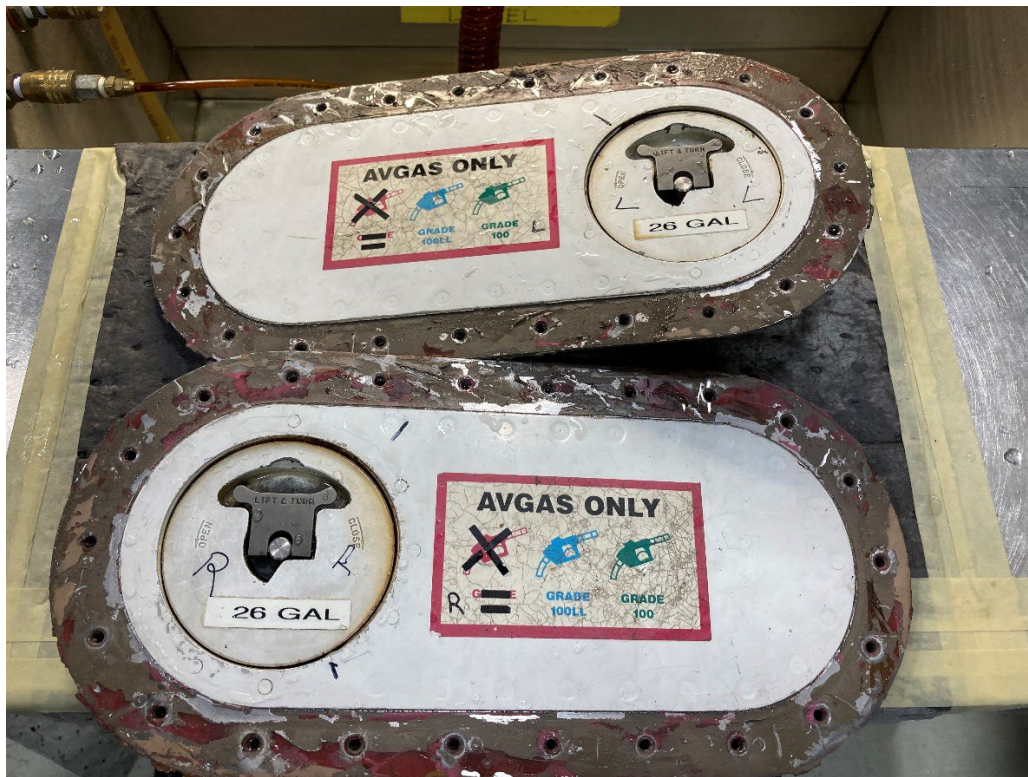
Figure 2: Panel Assy's

2. The Left cap was installed into the Left panel (Figures 2 & 3). The assembly was then installed into the test fixture and submerged under water in the test stand.

2. The Right cap was installed into the Right panel (Figures 2 & 3). The assembly was then installed into the test fixture and submerged under water in the test stand.
