## RECORD OF CONVERSATION

**Date: May 3, 2021**  
**Person Contacted: Sean Flanders**  
**NTSB Accident Number: ERA21LA201**

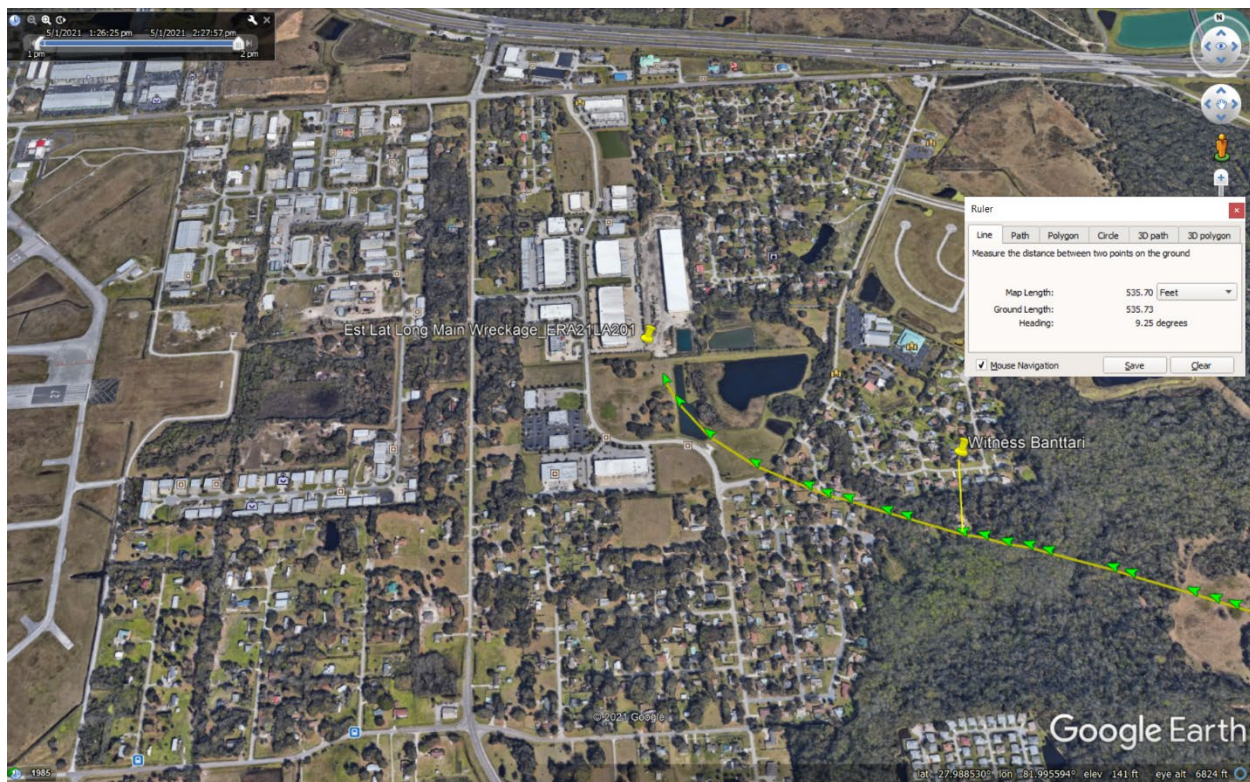
On the date and time of the accident, he was at his address which during the call he accessed Google Earth and the latitude and longitude were 27.986680° north and -081.988721° West. His location was north of the ADS-B flight path and specifically about 536 ft and 009° from the ADS-B flight target at 1427:41, when the airplane was flying in a west-northwesterly direction (Figure 1). He had just arrived home and was taking items out of the trunk of his car. Because he had lived at that location for 20 years, he was accustomed to sometimes seeing low flying aircraft when landing on runway 27 at Lakeland Linder International Airport (LAL), Lakeland, Florida. He indicated that this time the airplane was, “low low” and was not on a base leg and not on approach.” He pulled out his iPhone 12 Pro Max and as the airplane came closer to his

Figure 1: Google Earth Plot Depicting ADS-B Flight Path, Witness and Approach End of Runway 27 at LAL locations.

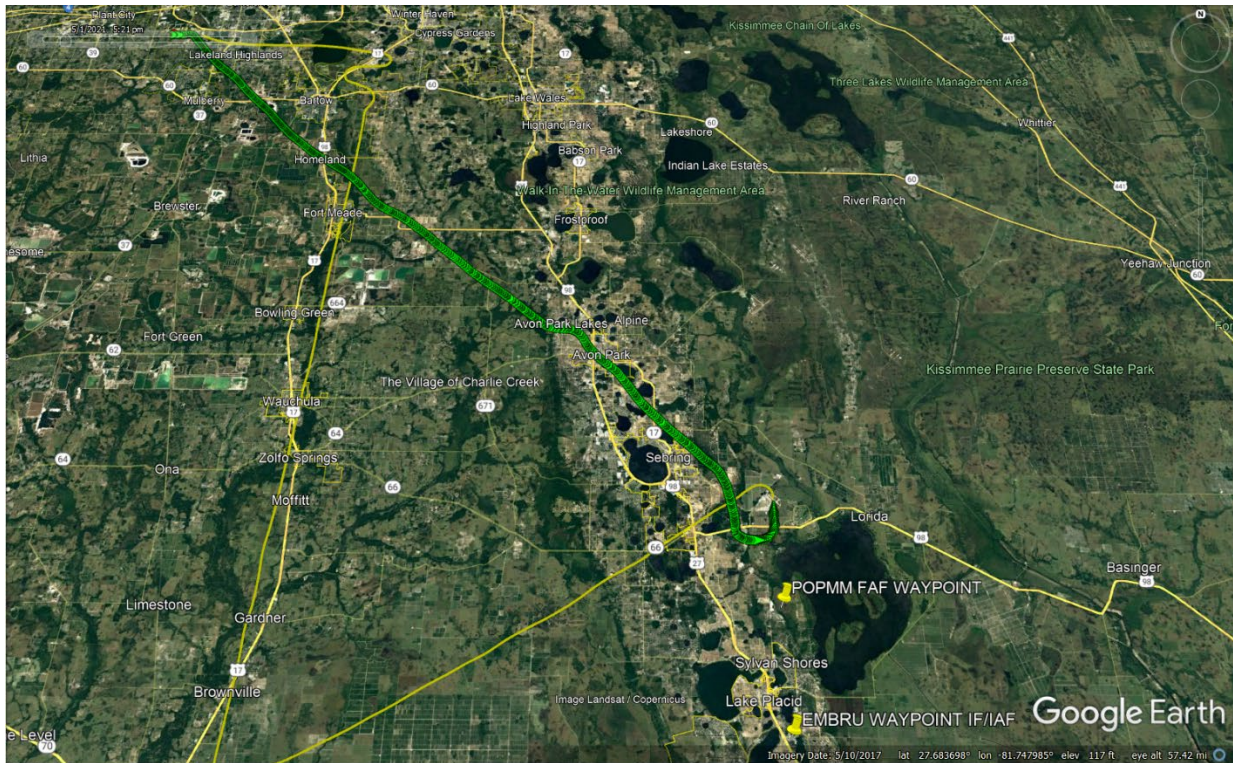
Figure 1: Google Earth Plot of ADS-B Targets of 1<sup>st</sup> Leg Takeoff, Approach, and Landing. Note the IF/AIF and FAF Locations as depicted.

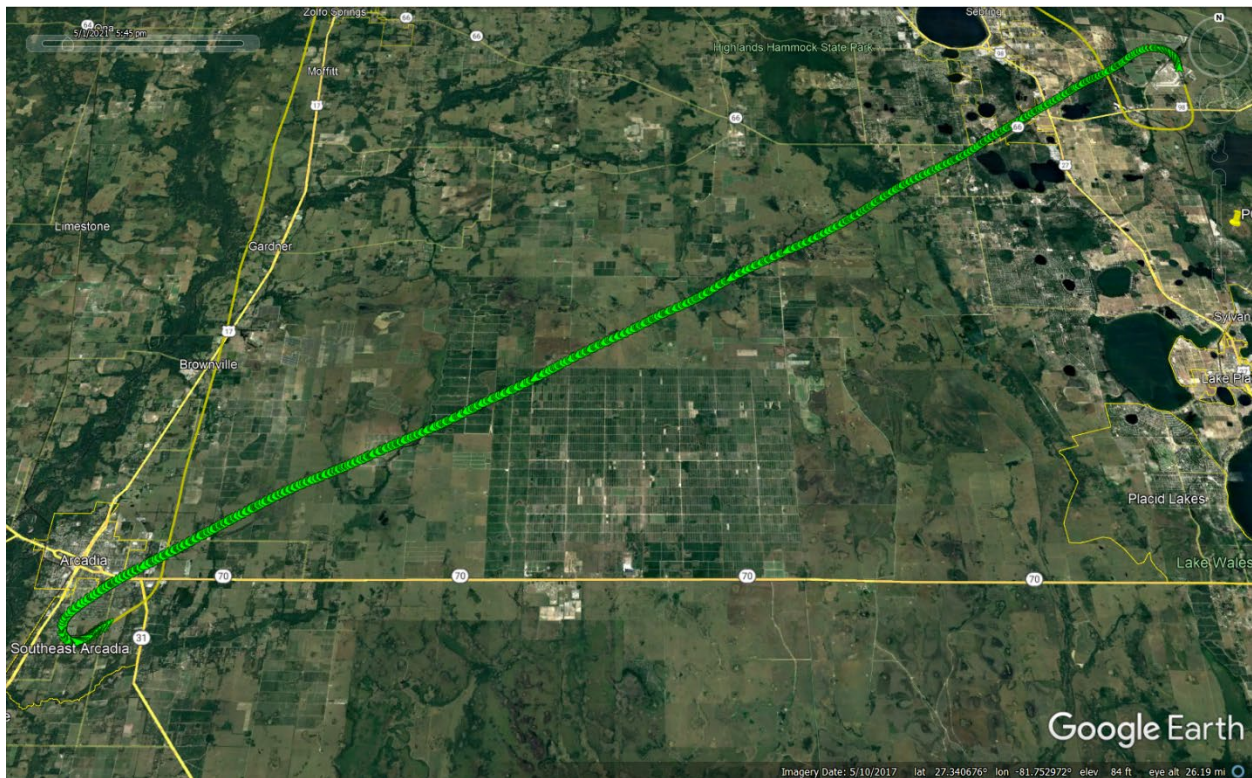
Figure 2: Google Earth Plot of ADS-B Targets of 2<sup>nd</sup> Leg Takeoff, Approach and Landing.

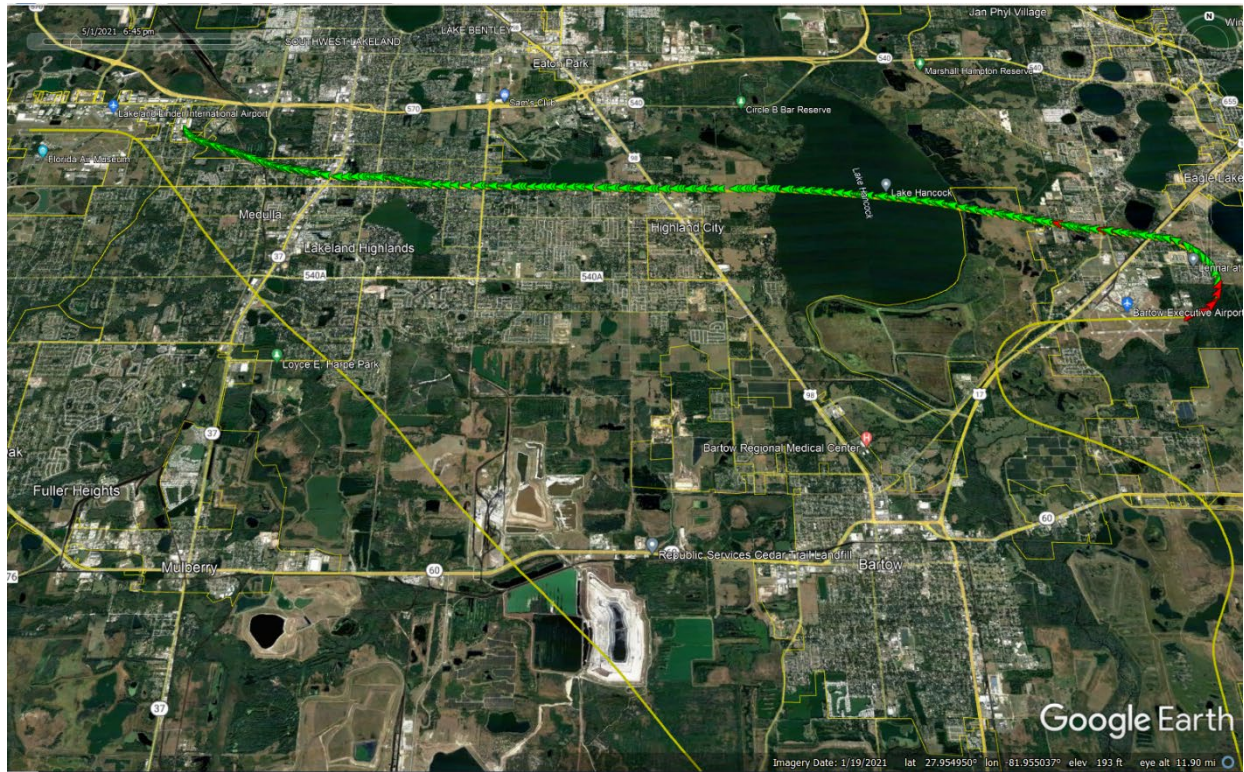
Figure 3: Google Earth Plot of ADS-B Targets Flying into KLAL; Accident Flight.
