**National Transportation Safety Board**  
Office of Research and Engineering  
Washington, D.C. 20594

## Airplane Performance Study

**Location:** Hiddenite, North Carolina  
**Date:** August 9, 2021  
**Time:** 1735 GMT (1335 EDT)  
**Airplane:** Diamond DA-42-L360, N906ER  
**NTSB Number:** ERA21LA322

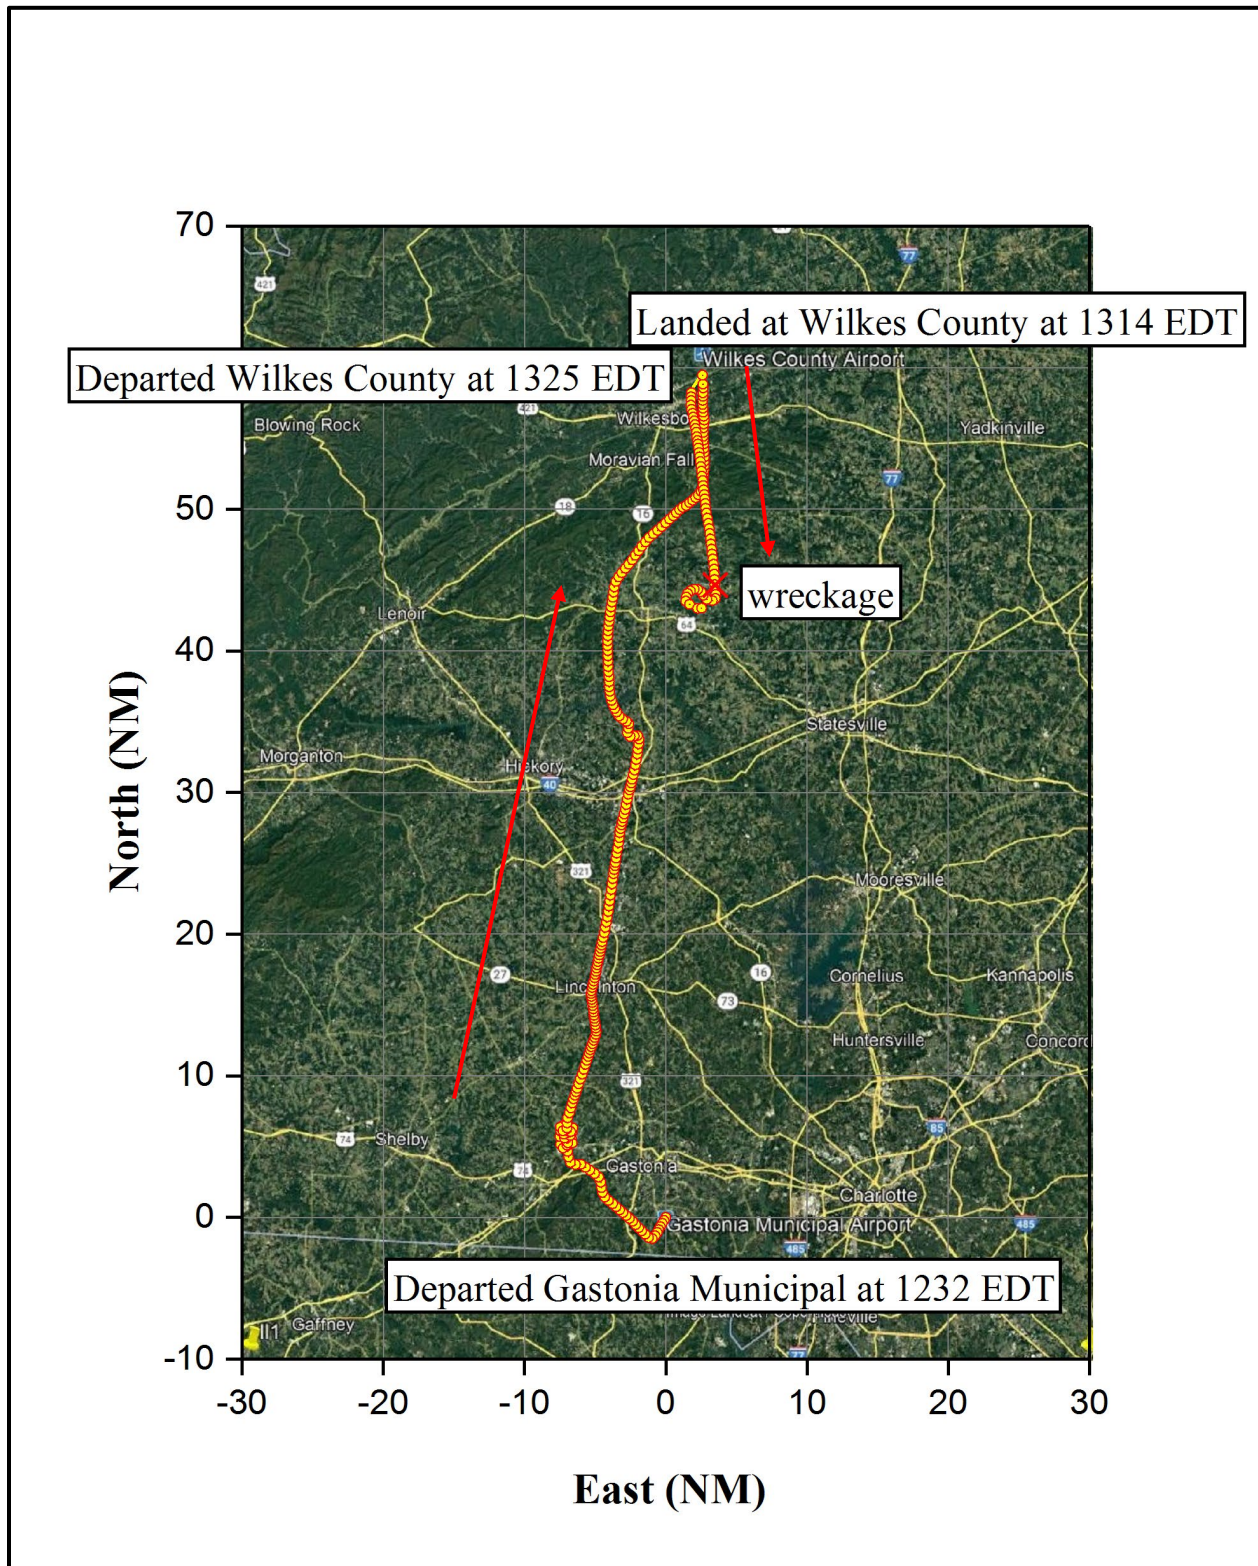
The flight instructor and private pilot departed Gastonia Municipal Airport (AKH), Gastonia, NC, at approximately 1232 EDT and completed several maneuvers and simulated emergency procedures during the instructional flight to Wilkes County Airport (UKF), North Wilkesboro, NC. See Figure 1.

**Figure 1: The Instructional Flight Departed Gastonia Municipal Airport with a Stop at Wilkes County Airport. The Accident Happened After Leaving Wilkes County.**

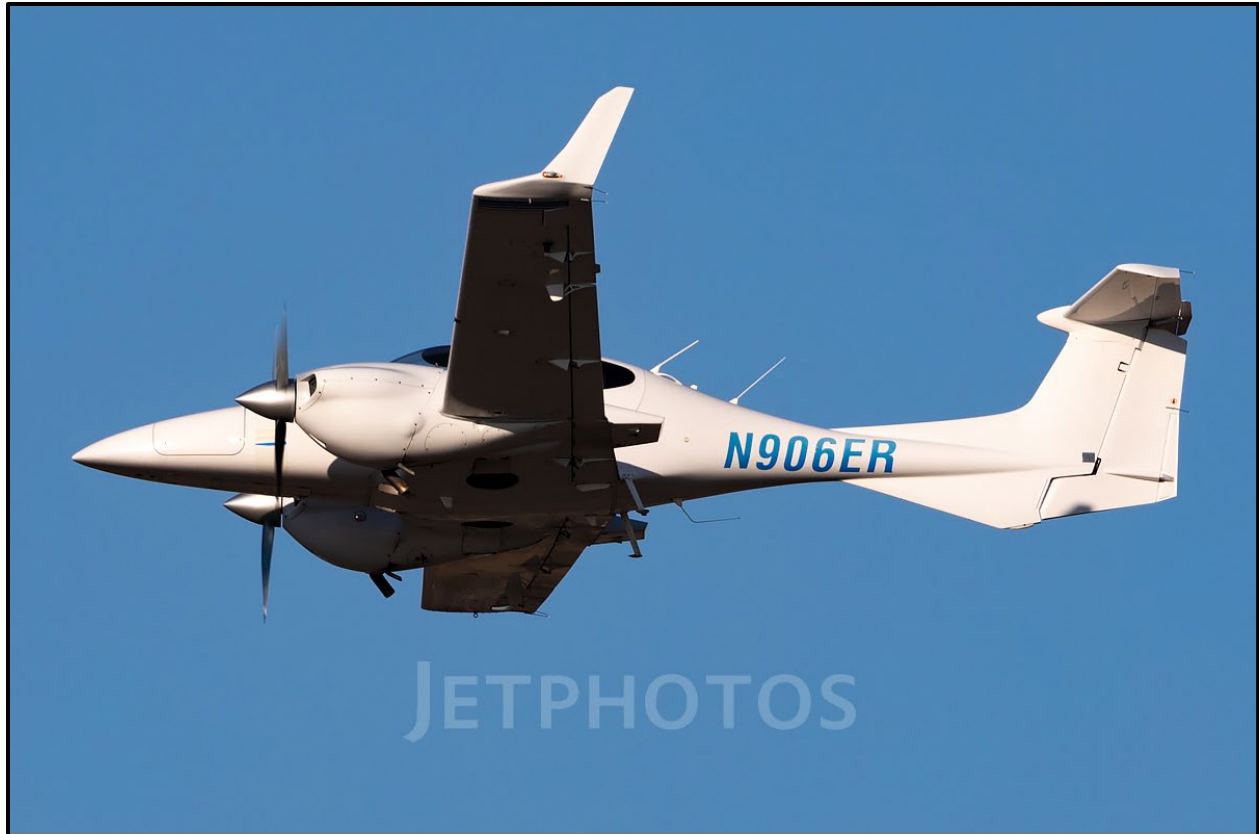
A picture of the accident airplane, a Diamond DA-42-L360, is shown in Figure 2. The airplane was manufactured by Diamond in 2007 and is registered to Heavy Metal Air, LLC.

**Figure 2: Accident Airplane, N906ER, a Diamond DA-42-L360**

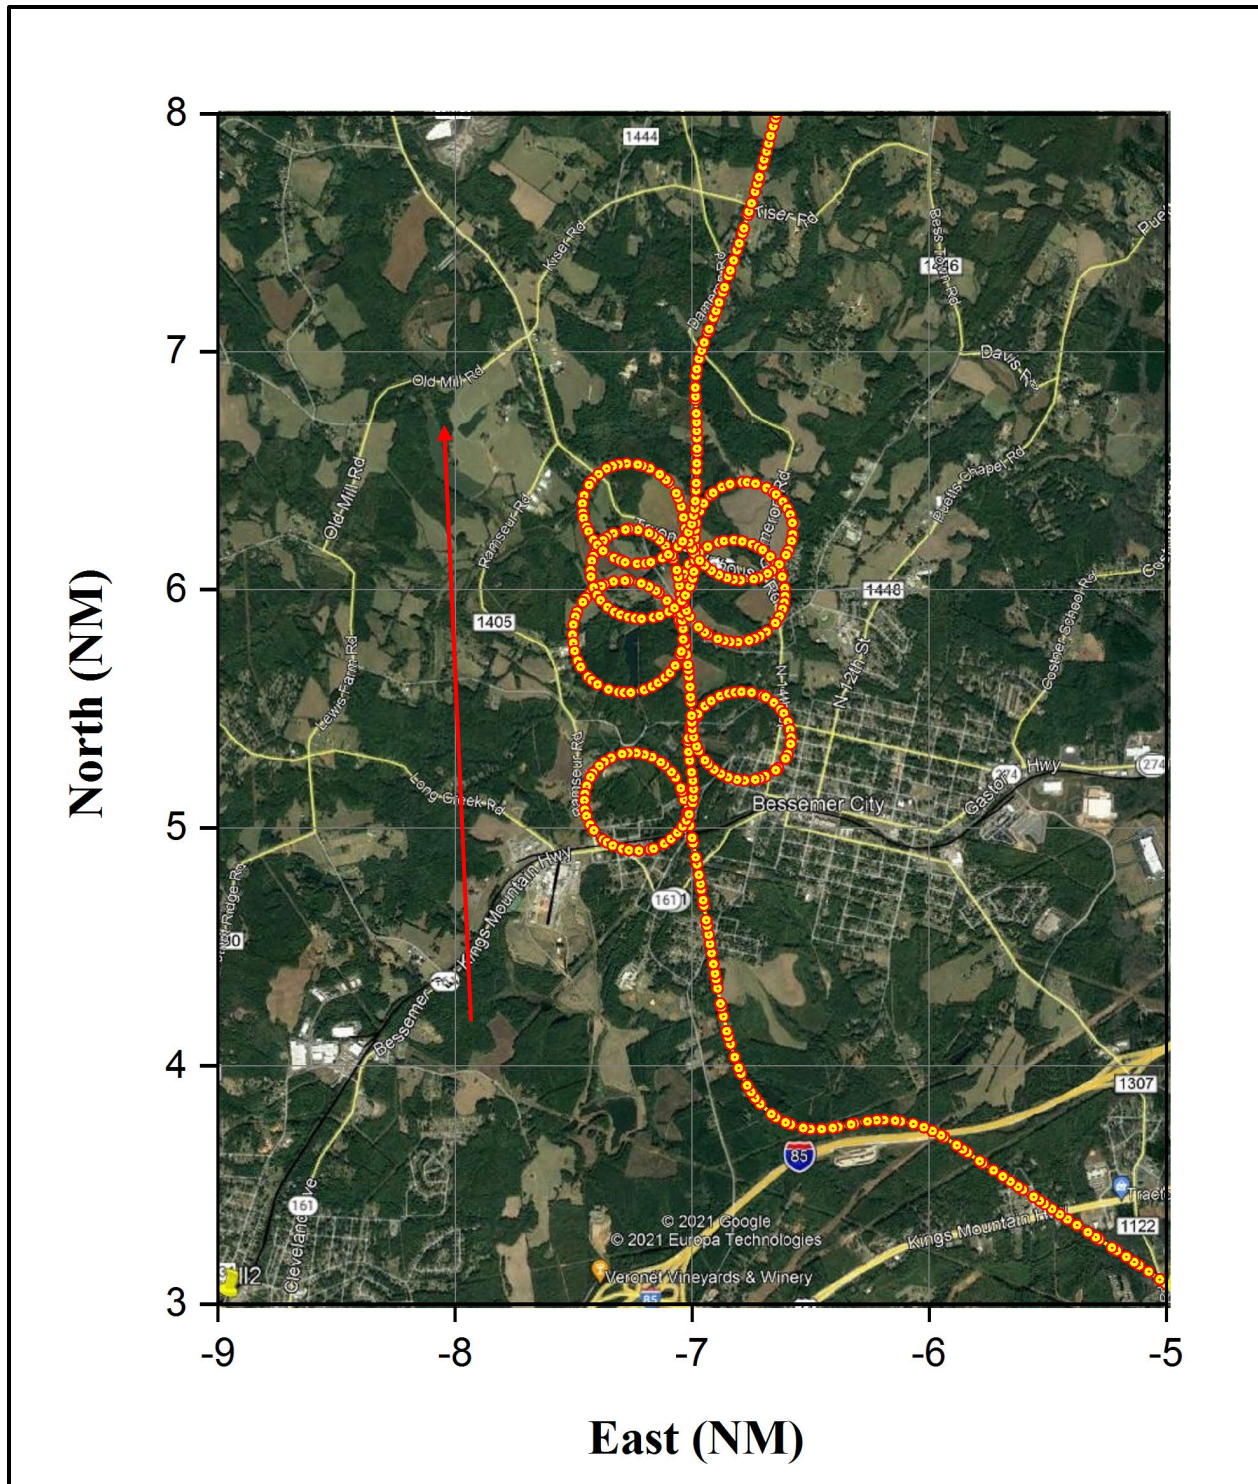
Figure 3 shows a portion of the ADS-B ground track for the instructional flight to Wilkes County Airport. The figure includes three sets of 360° turns at constant altitude that appear to be "eights along a road" or "turns around a point". Both are ground reference maneuvers designed to teach a pilot to fly a desired ground track while maintaining coordinated flight<sup>3</sup>. See Figures 4 and 5.

Figure 3: ADS-B Data Show the Airplane Performing 360° Turns during the Flight from Gastonia Municipal to Wilkes County Airports
