# NATIONAL TRANSPORTATION SAFETY BOARD

## MATERIALS LABORATORY FACTUAL REPORT

Report No. 21-103

Place : Port Orange, Florida  
Date : 08/21/2021  
Vehicle : Enstrom Helicopter Corporation Model 280C  
NTSB No. : ERA21LA339  
Investigator : Daniel Boggs

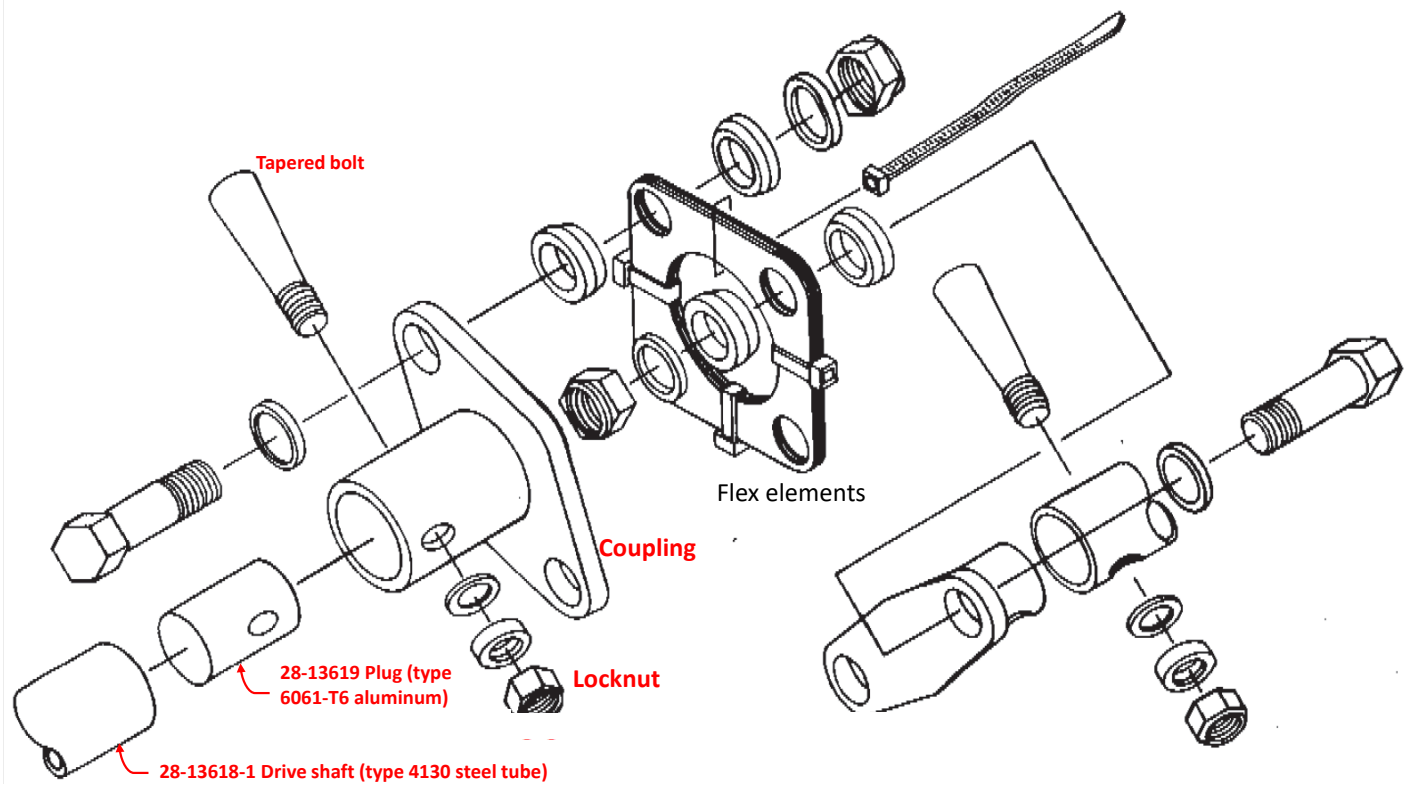
Figure 2 A sketch showing an exploded view of the drive coupling and drive shaft assembly, referenced from the Enstrom F-28F/280F Series Maintenance Manual. The submitted components are indicated by red annotation.
