## **Engine Investigation Report**

**Rolls-Royce Corporation  
Model 250-C20  
Engine CAE-800953BA**

**DAT Aircraft LLC – MD-369HS  
Ash, North Carolina**

**Accident date: 17 September 2021  
Wreckage exam date: 16 November 2021  
Engine exam date: 19 April 2022  
Report date: 17 January 2023  
NTSB Case: ERA21LA368**

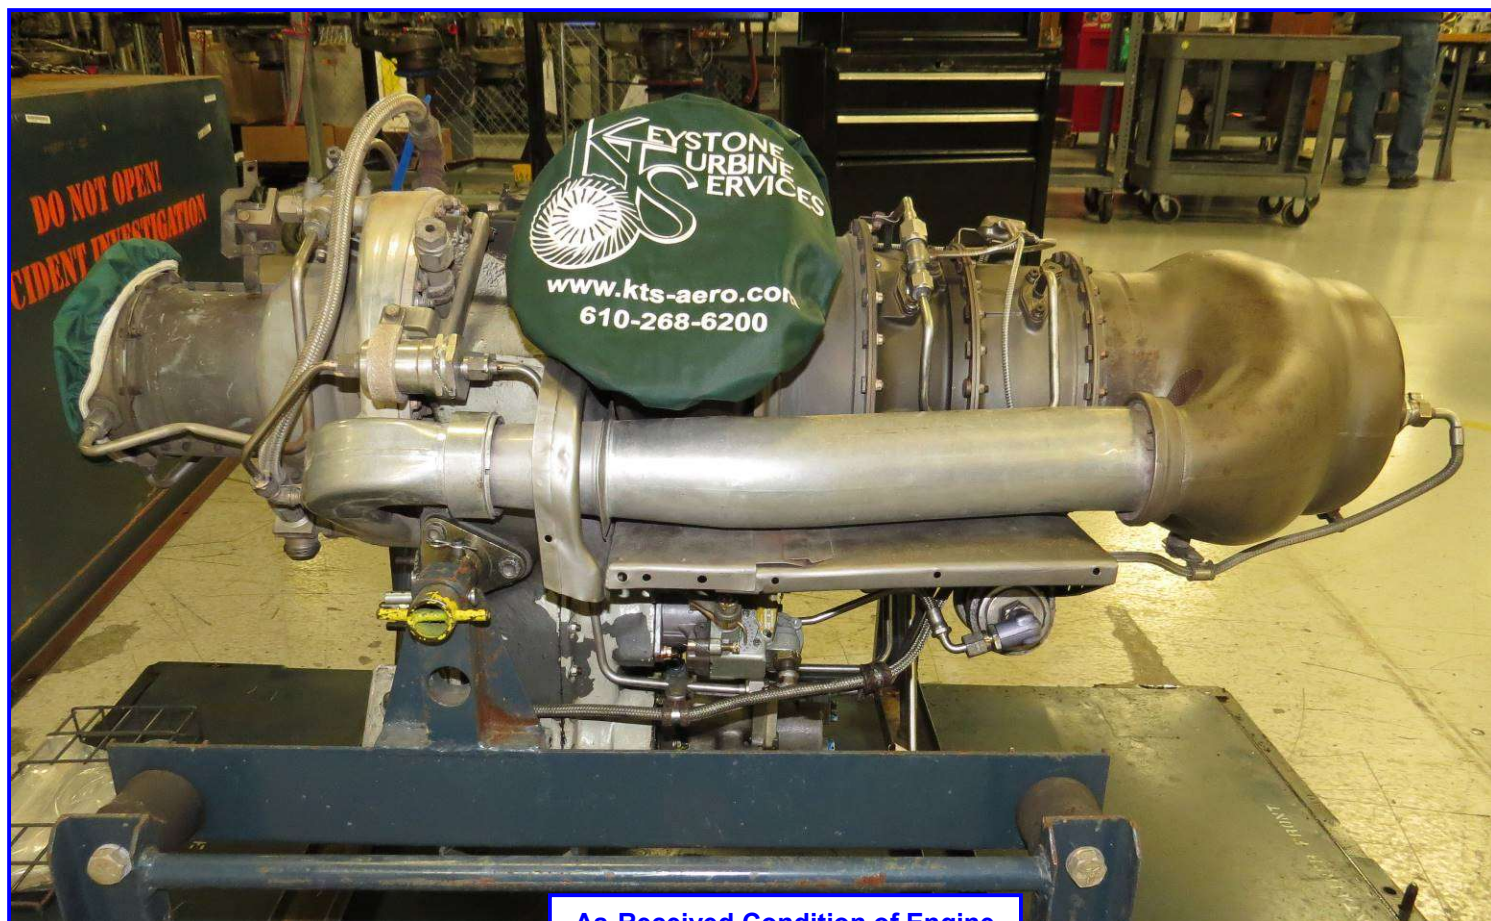
**As-Received Condition of Engine**

A check of the Pc system was conducted using shop air at the inlet side of the Pc air filter at 80 psi. A soapy water solution was applied to the Pc system B-nuts and rigid tubing. Pressure was then reduced to 20 psi to check for leakage at the governor diaphragm. No leaks were detected anywhere throughout the system. Both magnetic chip plugs were removed with no findings.

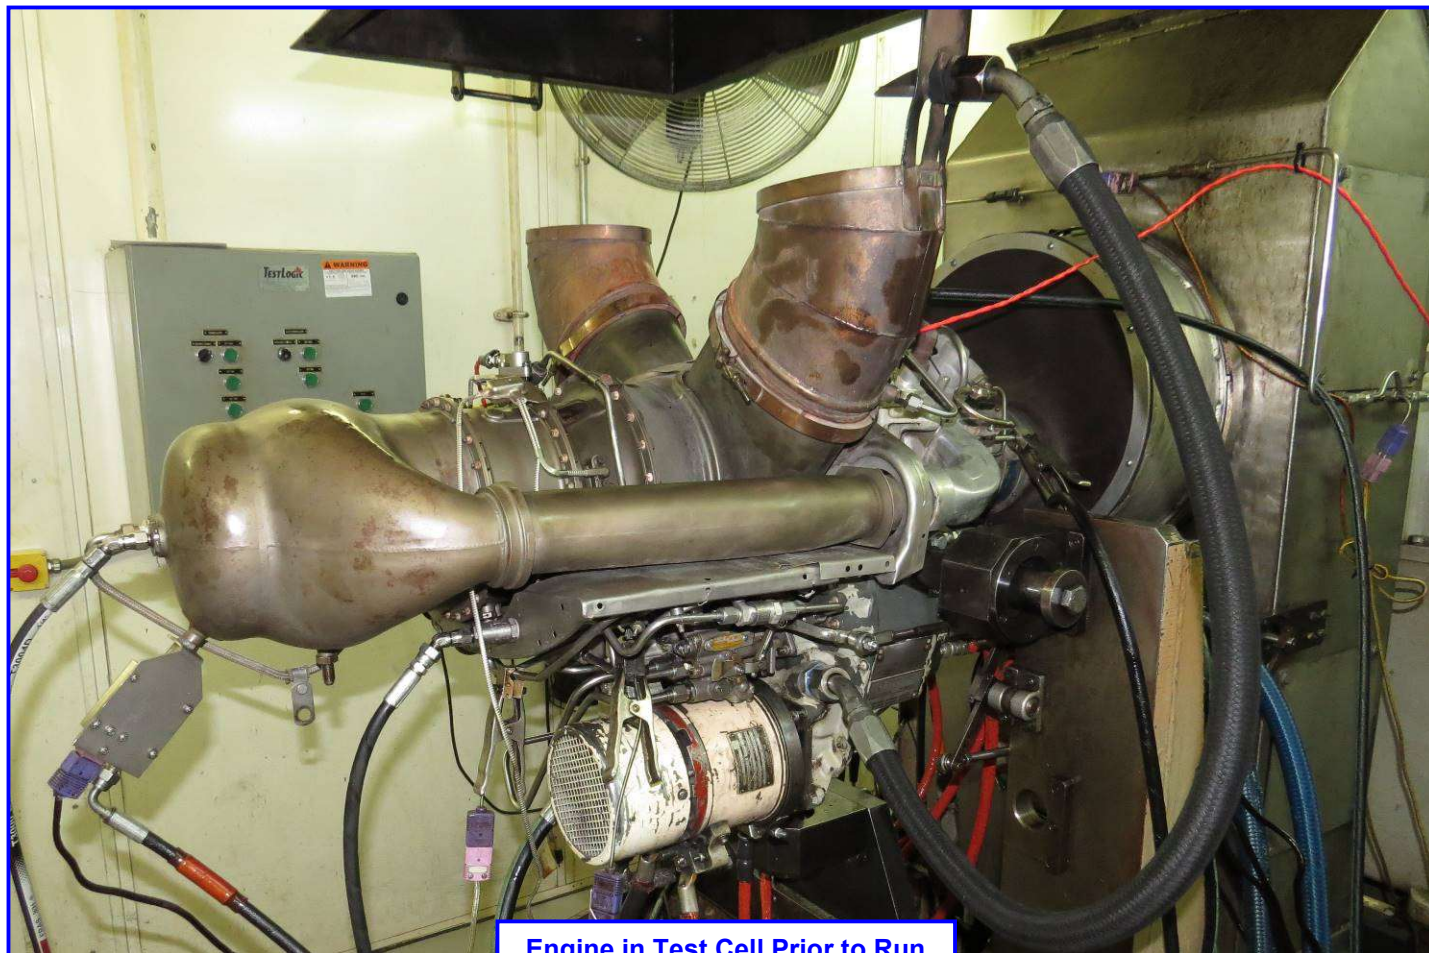
Engine in Test Cell Prior to Run

The engine successfully started but was unable to achieve 100% N2 speed even with no load applied and was going over temperature (above 1460°F) in the process. The burner drain valve was replaced due to an observed air leak. Replacing the valve had no impact on engine performance. Also of note was that the engine was not hitting an N1 speed where the bleed valve should have been closing. Further engine testing was terminated and follow-on troubleshooting performed.

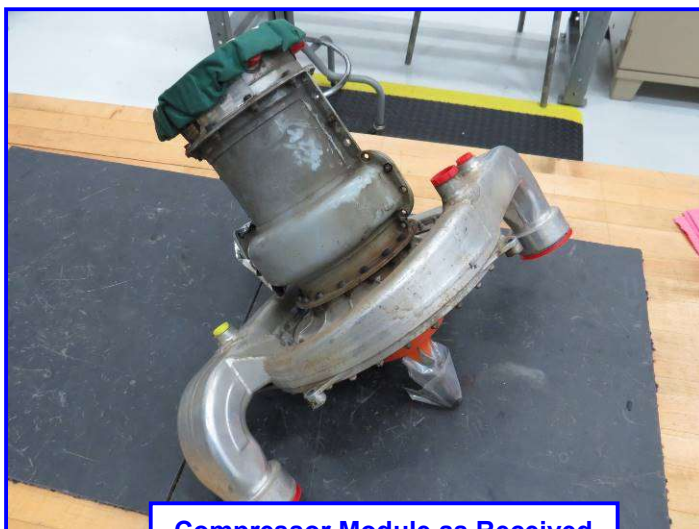
Compressor Module as Received

It was noted during the removal of the opposite case half, from that removed on the test stand at Keystone, that several of the split-line bolts adjoining the aft flange to the compressor front diffuser were significantly rusted and required rotary tool grinding for removal.
