# National Transportation Safety Board

ERA21LA384

## WRECKAGE EXAMINATION

Airplane: Cessna 150M, Registration N4100V

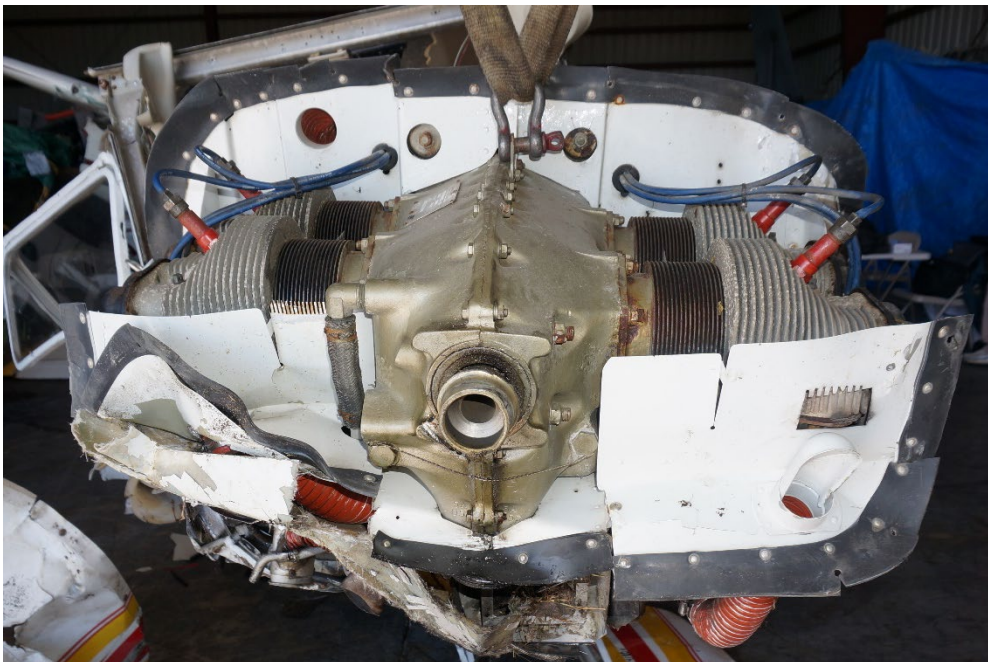
**Figure 11 Engine View from Front**

Engine crankshaft and valve train continuity were confirmed by rotating the crankshaft by hand and observing its rotation at the front and rear of the engine, and noting motion of all valve rocker arms. Thumb compression and suction was observed for all four cylinders. The crankcase was intact and contained about 4 quarts of oil, and oil was present in each cylinder's valve rocker box.
