# National Transportation Safety Board

ERA22FA010

## WRECKAGE EXAMINATION

Location: Cornwall, New York  
Date: October 10, 2021  
Time: 1357 eastern daylight time  
1757 UTC  
Helicopter: N637HP, Robinson R44 II

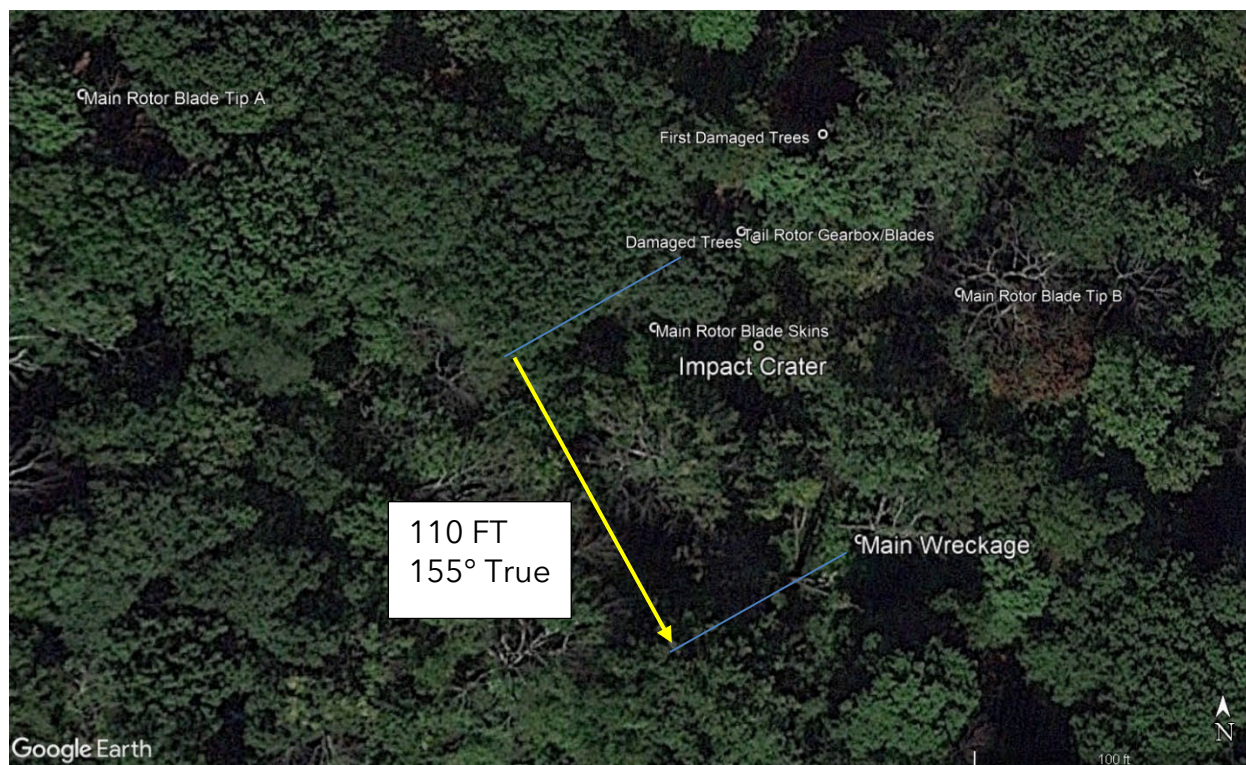
**Figure 2 - Wreckage Diagram**

The helicopter came to rest in a hilly wooded area. The primary wreckage path was about 110 ft long, oriented on a heading of about 155° true (168° magnetic). It began with a section of damaged trees at the base of which was the tail rotor gearbox (with blades attached) and ended at the main wreckage. The main wreckage came to rest against a fallen tree about 60 feet south of the first point of ground impact (impact crater) which was a two-foot-deep crater in the soft dirt, approximately 5 feet wide and 9-10 feet long. The crater had portions of several components associated with the belly of the fuselage, landing gear, and lower part of the engine. Located in the immediate area around crater were the empennage, fuselage pieces, tail rotor driveshaft, landing gear components, and engine components. There were no

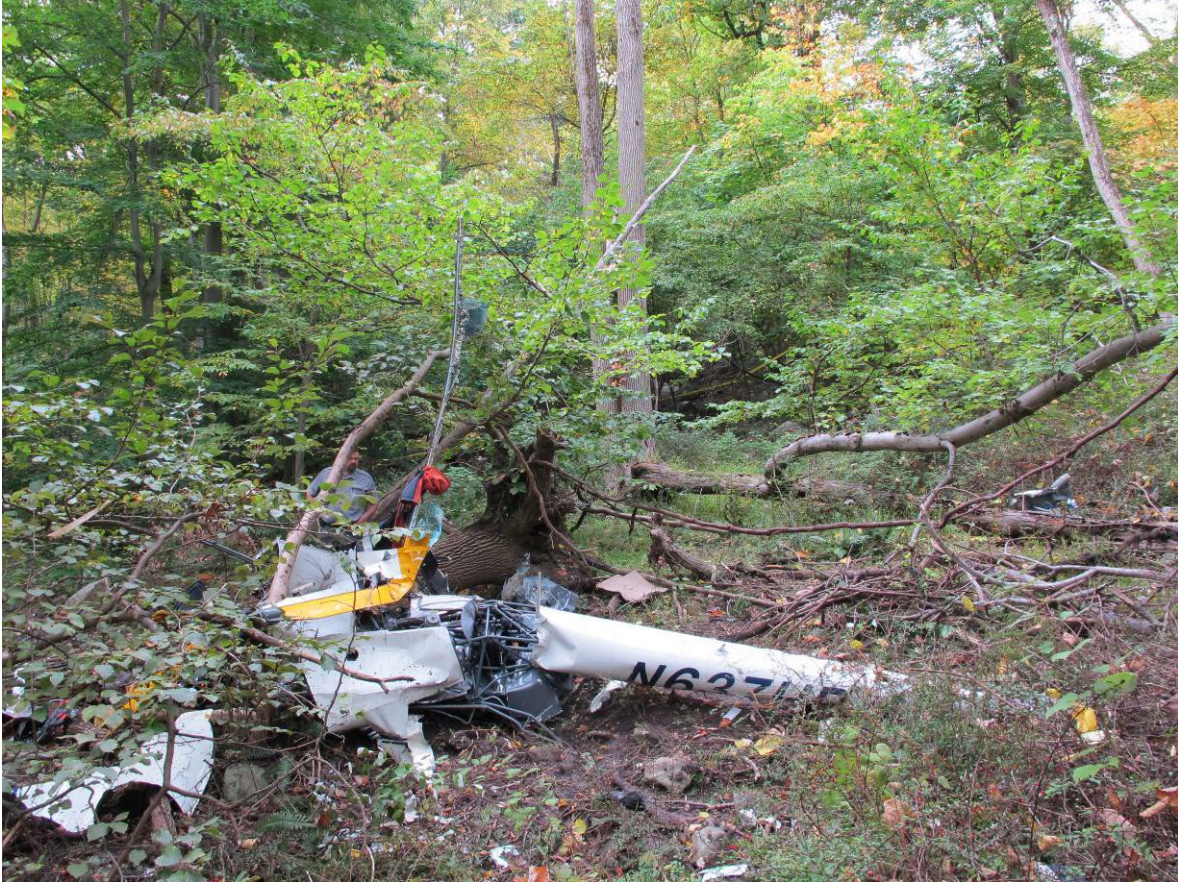
**Figure 5 - Left Side of Fuselage**

The airframe sustained severe impact damage. The cabin structure and fuselage cowlings were crushed from the nose to the rear seats. All 4 seats were separated from the structure. The upper and lower frame tubes were bent, deformed, and had several disconnects including a complete separation of the frame tubes around the main rotor gearbox. Remnants of all four doors were found in the debris path or with the main

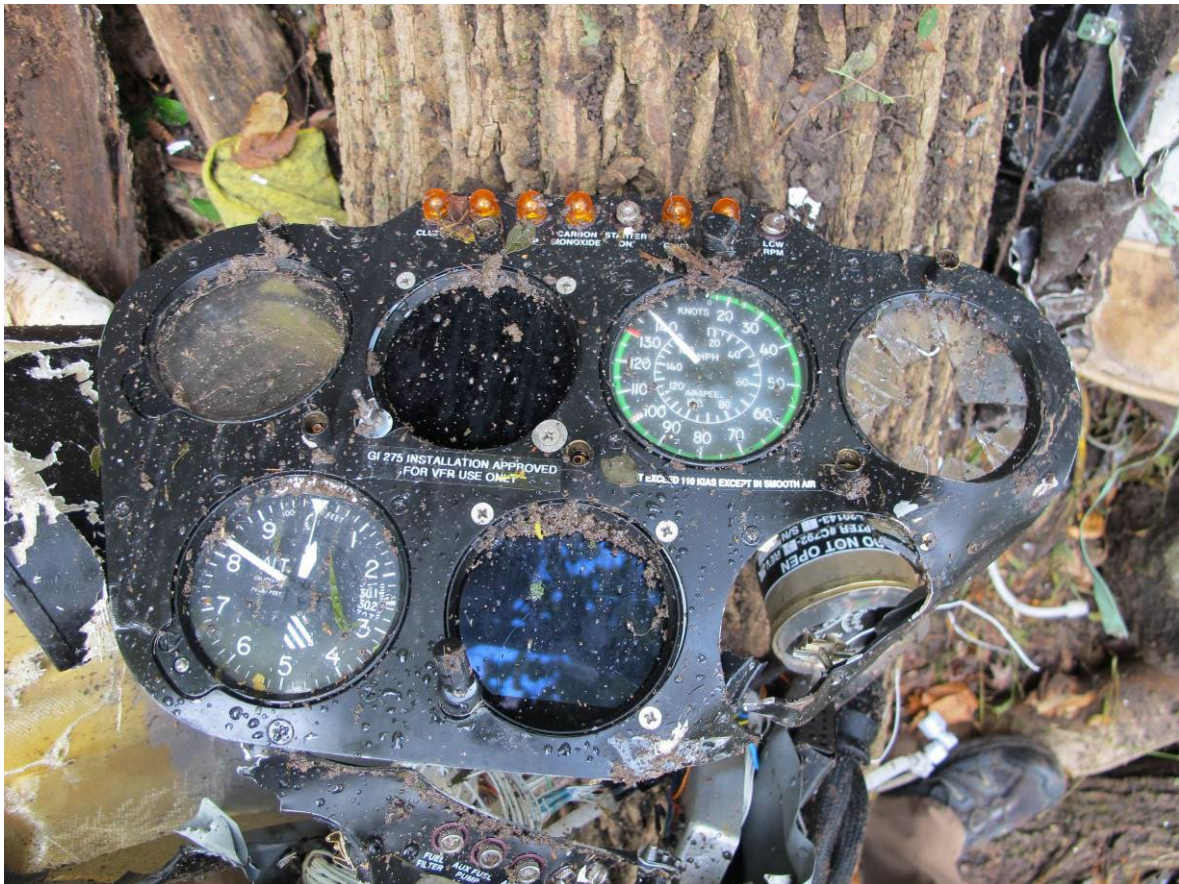
Figure 8 - Upper Instrument Panel

The upper and lower consoles along with the avionics panel were damaged and components separated. Both front seat belts were unbuckled, the aft right seat belt was buckled, and the aft left seat belt condition could not be determined. Damaged remnants of several tablet devices were found in the debris field.

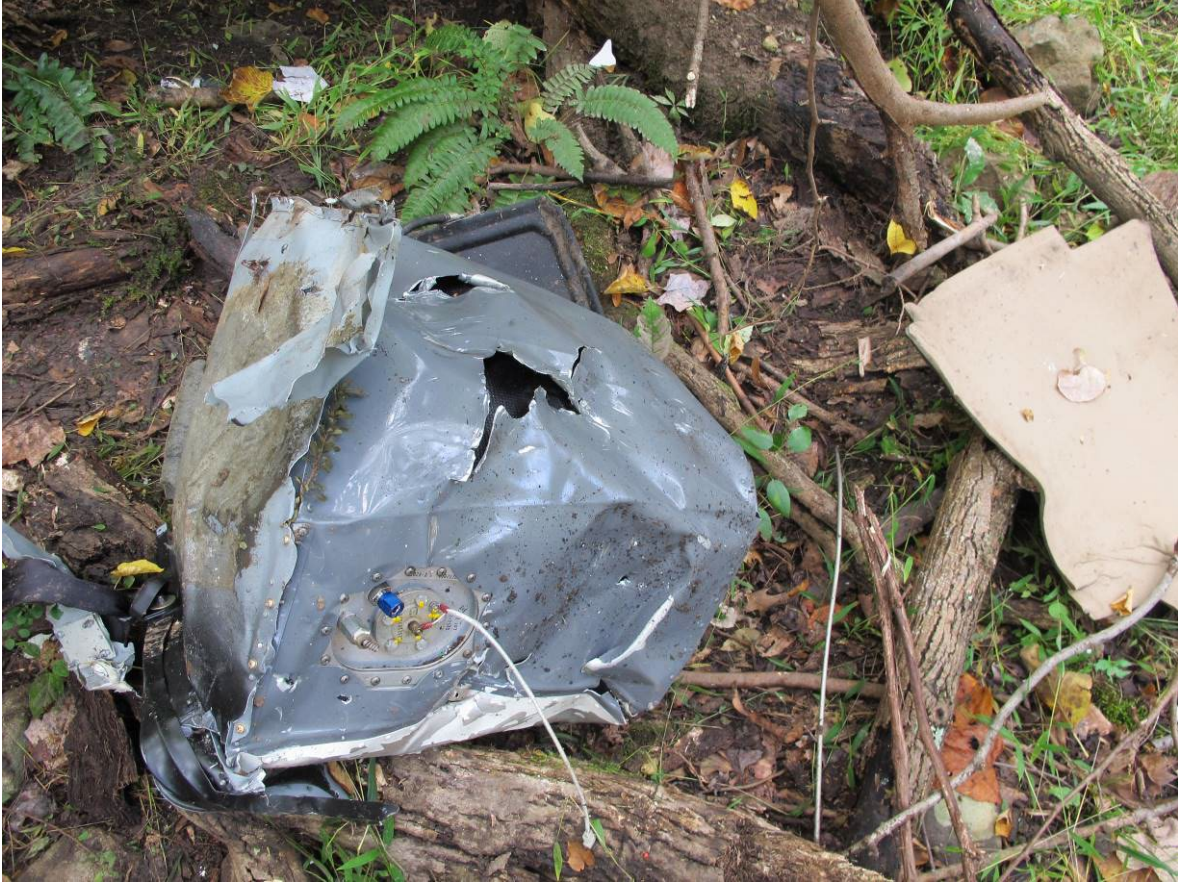
**Figure 15 - Auxiliary Fuel Tank Shell**

The auxiliary fuel tank was separated from the airframe and tethered by the aft right seat belt. The shell was compromised in several places but the bladder had only one small tear. A trace amount of fuel was drained from the auxiliary tank, it was blue in color and had the aroma of 100LL aviation fuel. The filler cap remained secure on the filler neck. The finger strainer was clear. The outlet fitting was fractured.

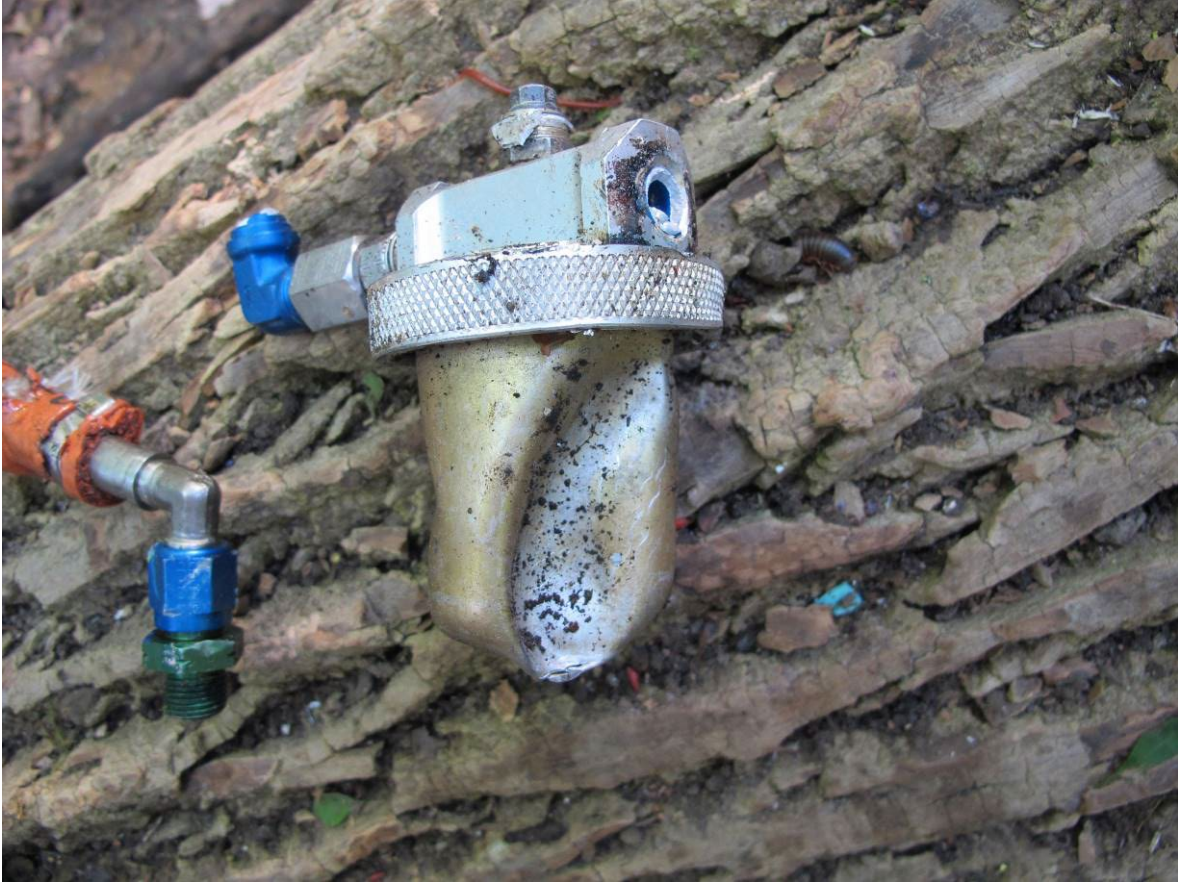
**Figure 17 - Gascolator**

The gascolator was separated from the auxiliary fuel pump and both were separated from the firewall. The gascolator bowl was dented and cracked. The bowl retaining ring had to be cut for removal. The gascolator screen and bowl had a small amount of debris inside, the screen was unobstructed, no fuel was present.

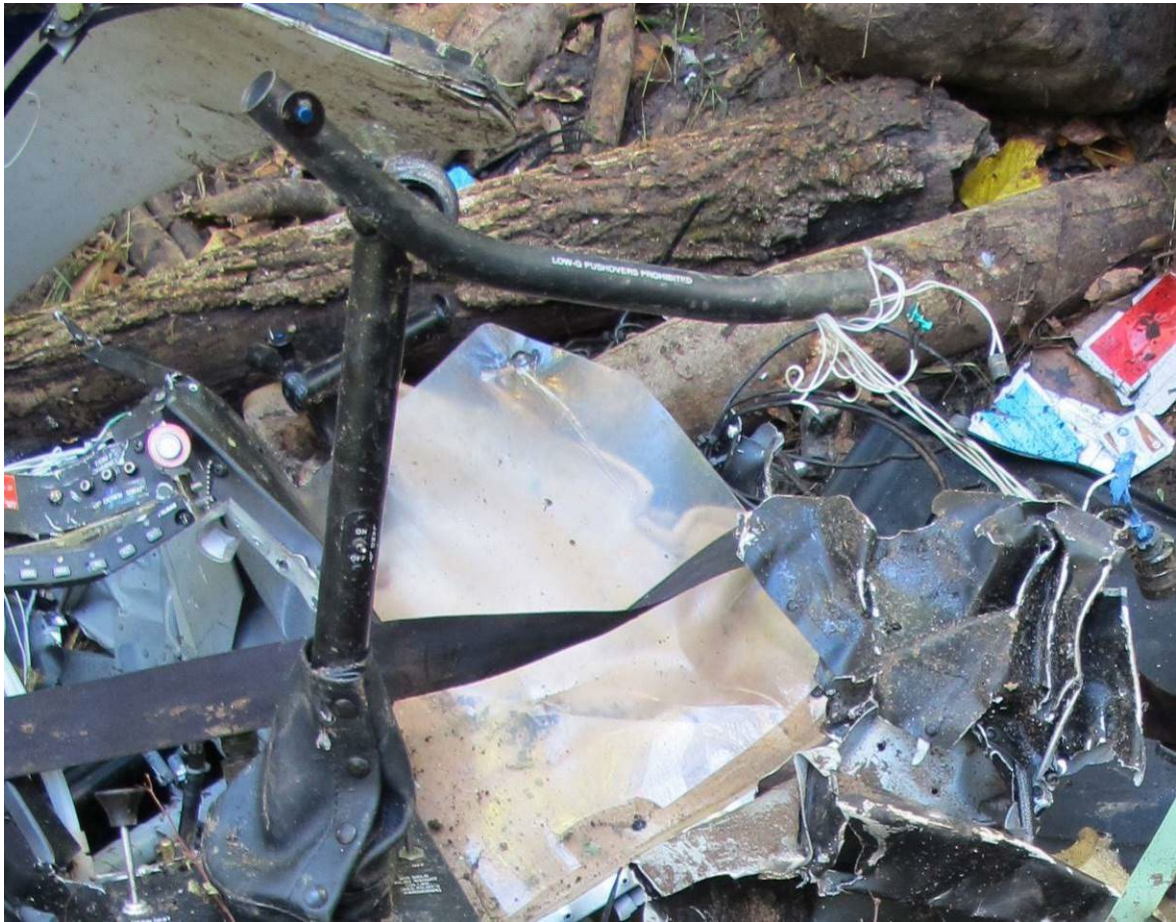
**Figure 20 - Cyclic Control**

The pilot's cyclic grip was separated from the cyclic crossbar. The collective control was separated from the structure along with the collective friction slider which appeared to be in a collective full up position. The friction knob was positioned beyond its normal travel. The pilot's (right-side) tail rotor pedals were positioned with the left pedal forward. The copilot's (left-side) removeable controls were not installed and were recovered within the debris field.

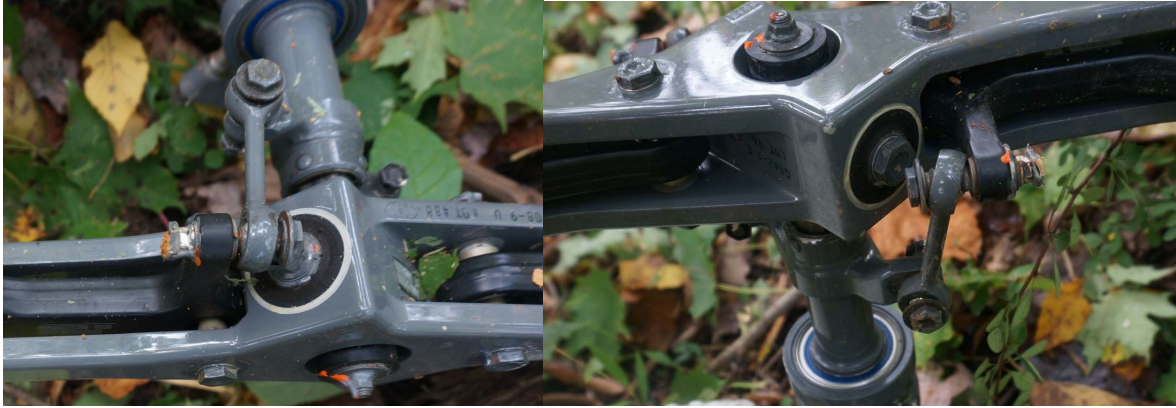
**Figure 25 - Tail Rotor Pitch Change Links**

Flight control continuity could not be confirmed due to impact damage, and some system portions were not located. All control linkage ends remained attached. Nearly all control tubes were fractured in one or more locations consistent with overload. All three hydraulic servos moved smoothly in both directions when the input control tubes were moved by hand. The tail rotor pitch change slider was free to slide along the tail rotor gearbox output shaft. Both main rotor pitch change links were fracture separated at their upper rod ends. One link was also fracture separated at its lower end, and the link was found in a puncture hole in the cabin ceiling.

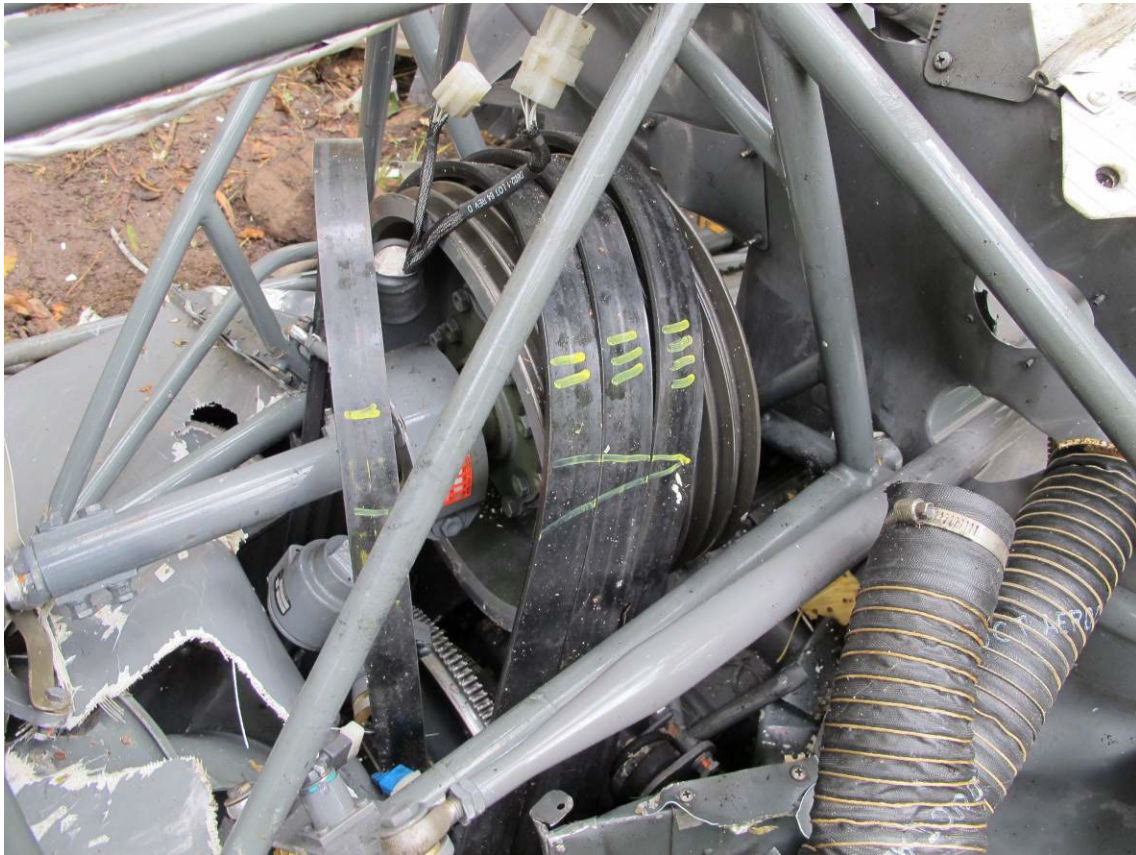
**Figure 28 - V-Belts on Upper Sheave**

The grooves in the lower sheave (mounted to the engine crankshaft) had excessive wear with sharp edges. The wear in the grooves of the upper sheave (which drives the rotor system) was unremarkable although it did sustain impact damage. All four V-belts were out of their grooves and laying across the upper sheave. Each belt had a raised crease down the center of the backing indicating the belts were riding much deeper in the grooves of the lower sheave due to the worn grooves. The friction surface of the belts appeared normal. Two of the belts sustained impact damage to their backing.

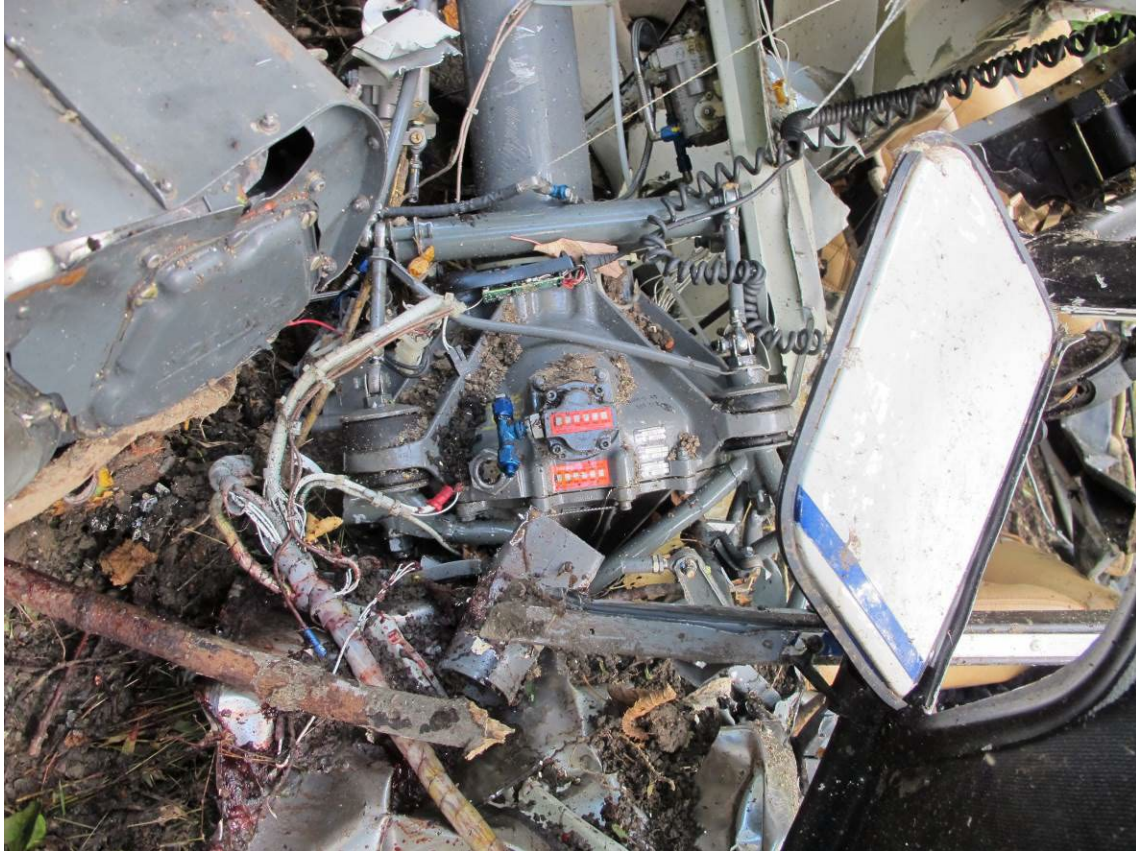
**Figure 32 - Main Rotor Gearbox**

The forward flex coupling was bent, and one arm of the main rotor gearbox input yoke was fractured and remained attached to the flex plate. The other ear of the flex plate was fractured from the input yoke. The surface of the fractures were angular and jagged.

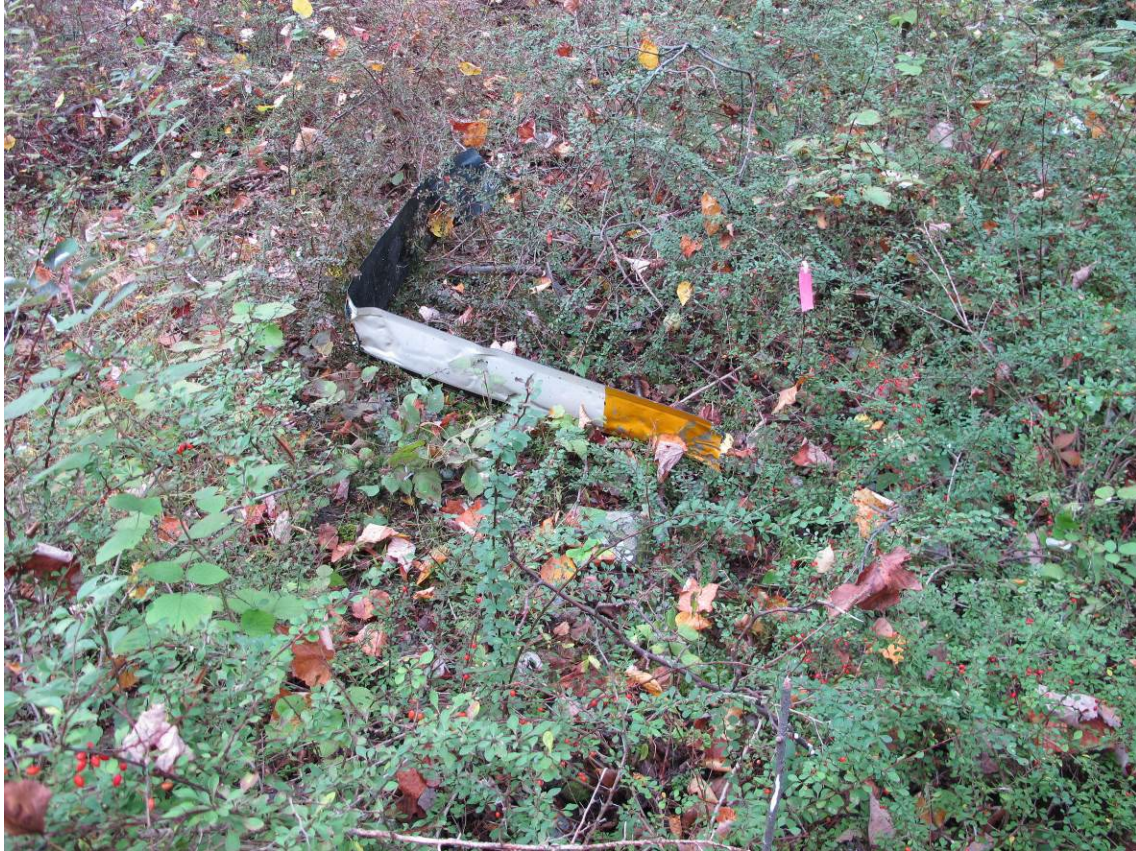
**Figure 39 - Mid-Section of Main Rotor Blade S/N 10122**

The inboard four feet of main rotor blade serial number 10122 remained attached to the hub. The outboard section was fractured in several places. The surface of the fractures in the spar and skin sections were angular and jagged. The surface of the fractures of the skin to spar joints had layers of adhesive that remained adhered. About 2 ft of blade length from an area inboard of the tip, and the outer most 6 inches of the tip, were not recovered.

Some blade remnants were found with wood debris in the leading edge and/or brown chordwise streaks consistent with tree material.

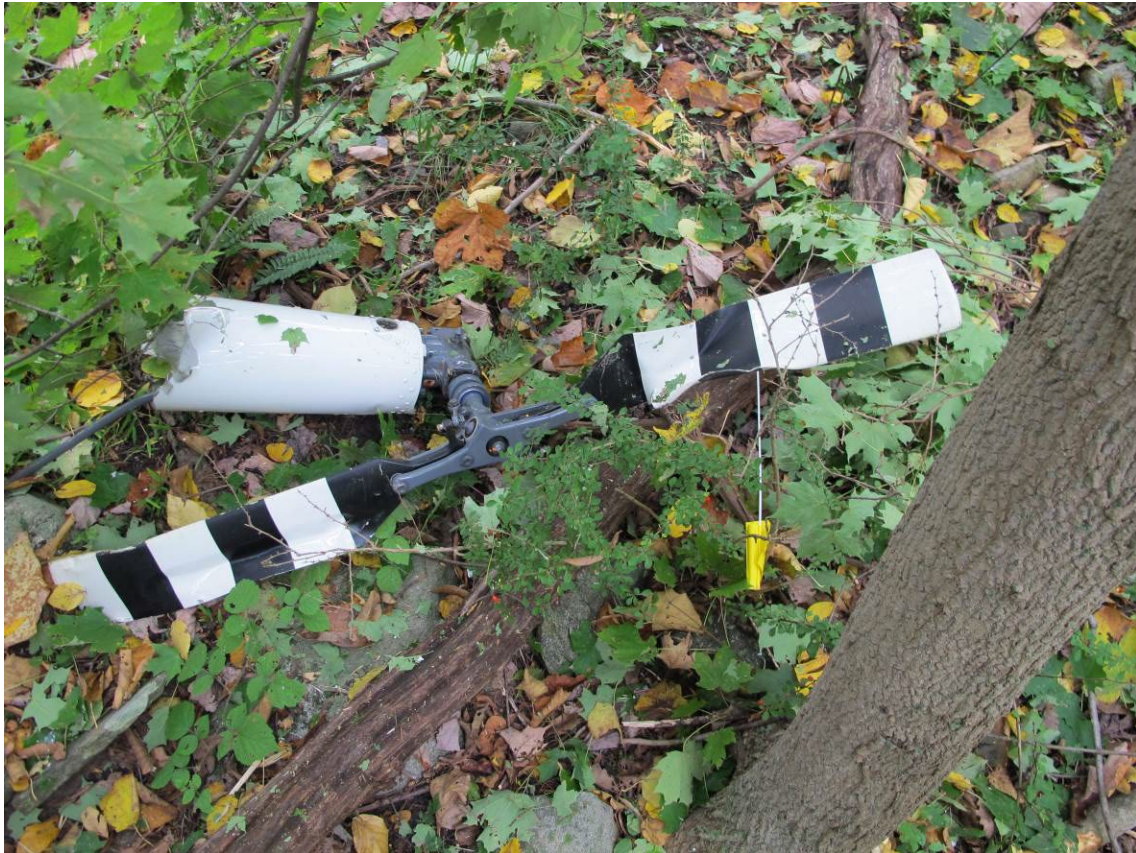
**Figure 42 - Tail Rotor Gearbox and Blades**

The tail rotor gearbox remained attached to the separated aft section of tailcone. Oil, blue in color, was visible in the sight gauge. The output shaft was straight. The output shaft was rotated by hand more than 360° with no anomalies confirming continuity back through the input yoke.

Both tail rotor blades remained attached to the hub/gearbox and were dented on both their leading and trailing edges.

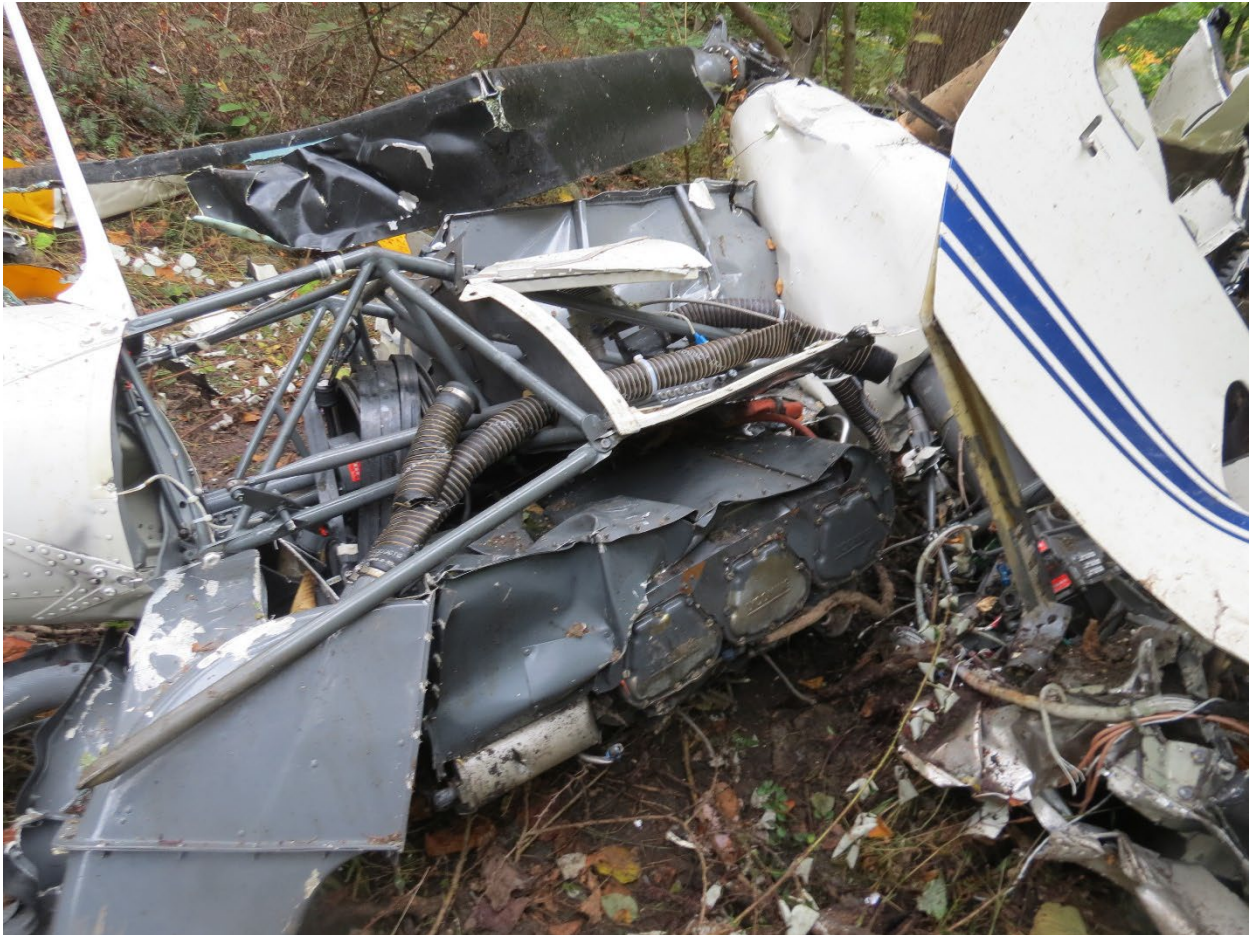
**Figure 44 - Engine as Found**

The engine came to rest upright with the engine mounts fractured. It remained partially attached to the fuselage through cables, wiring and hoses.

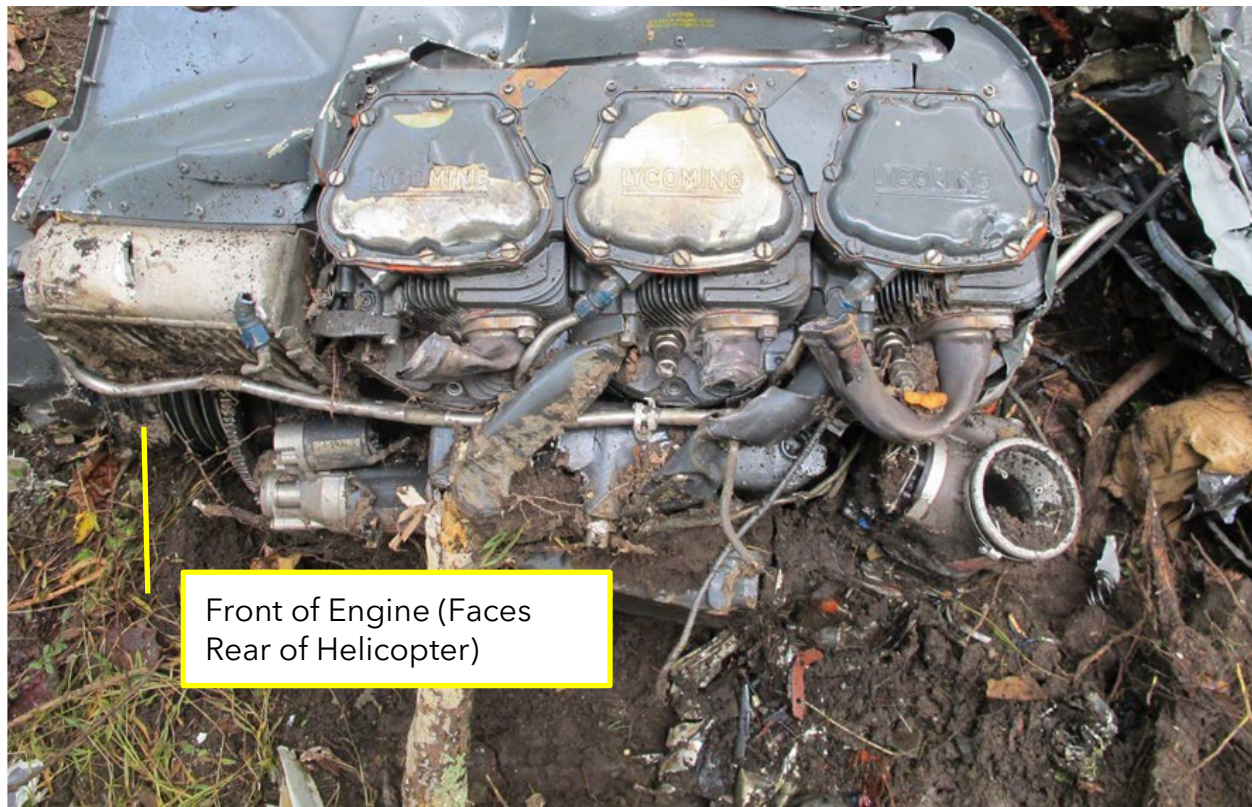
**Figure 46 - Engine - View of Left Side (Note: The engine Faces Rearward in in the Helicopter)**

All cylinder induction and exhaust tubes were damaged, some were crushed, fractured or separated from the engine.

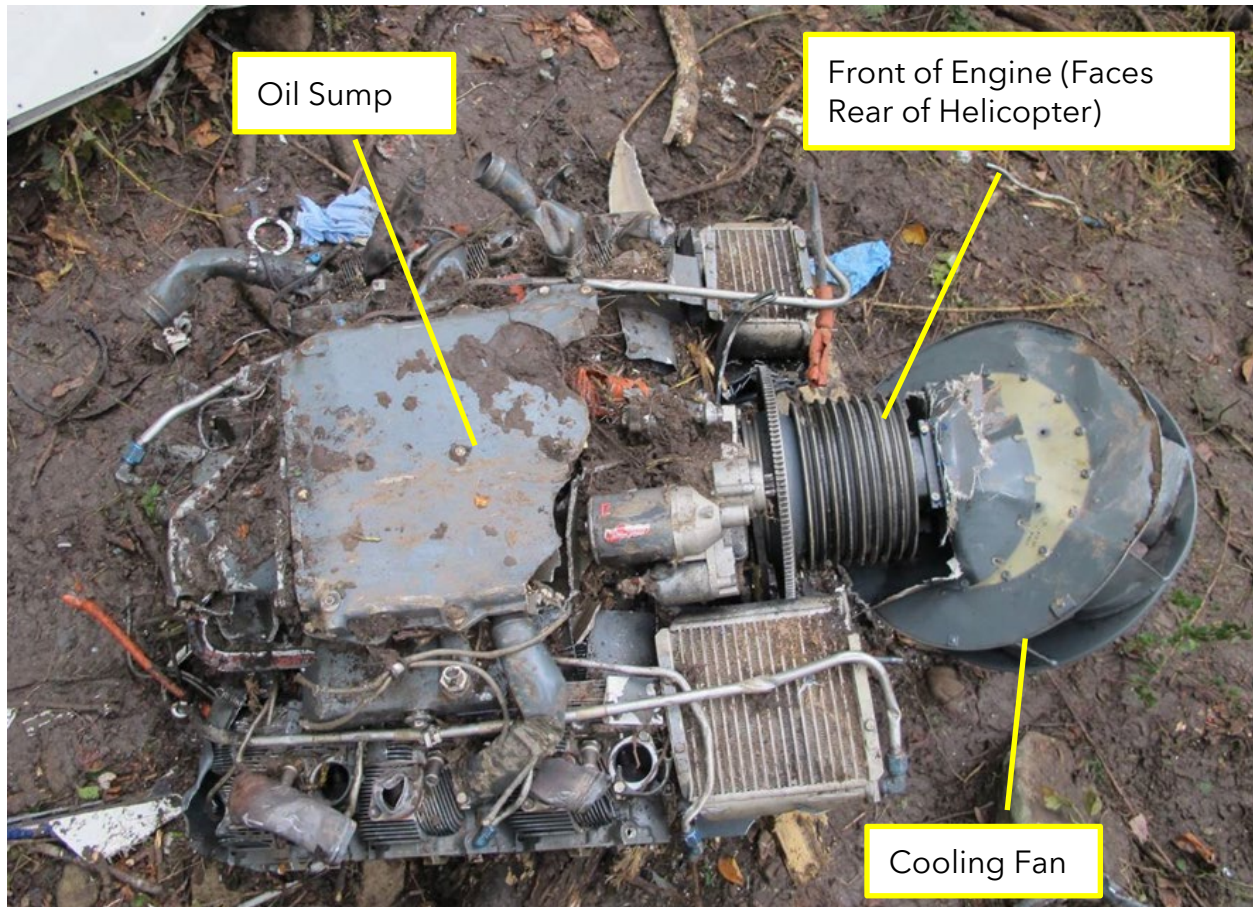
**Figure 47 - Engine - View of Bottom**

The oil sump was damaged and partially separated from the crankcase.

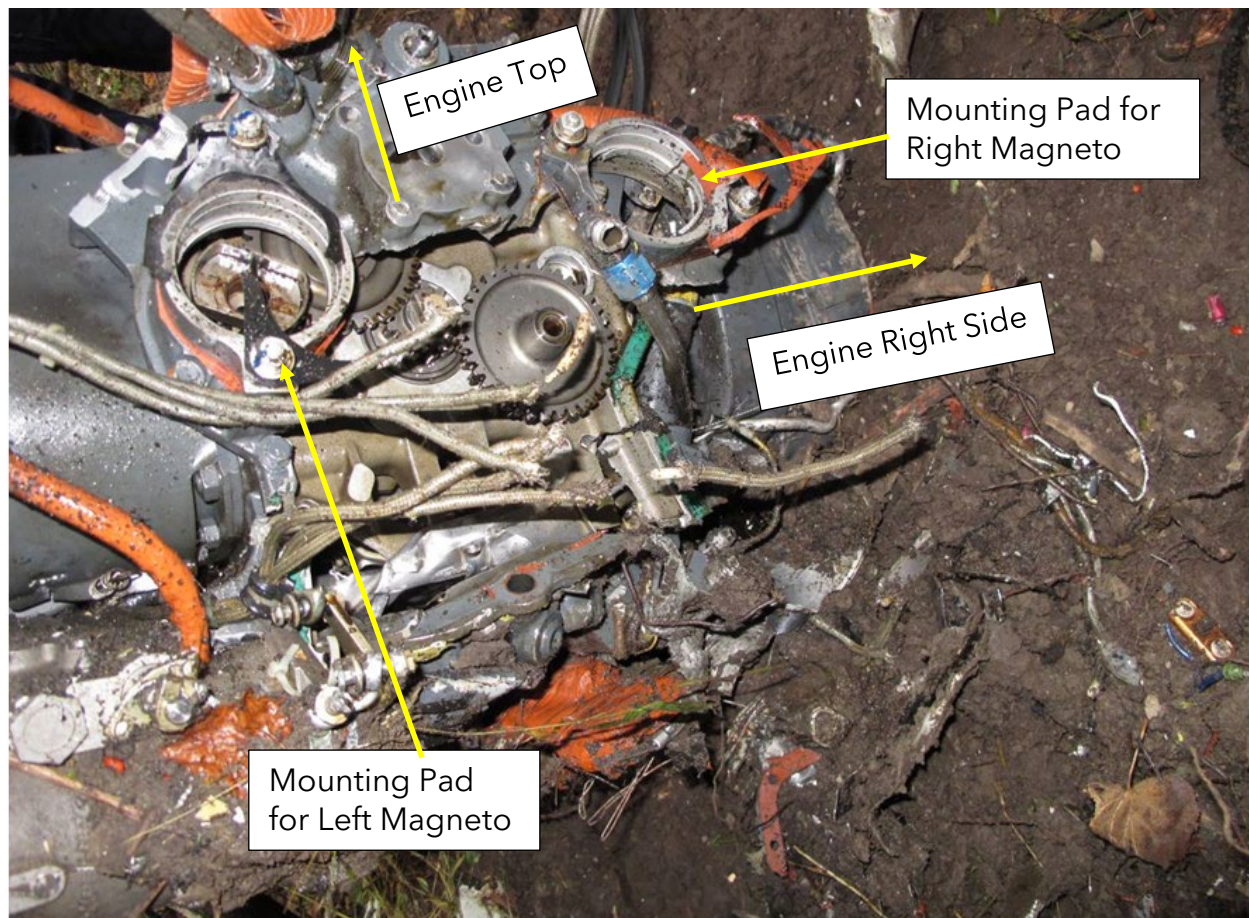
**Figure 48 - Engine - View of Rear (Accessory Section)**

The accessory case at the rear of the engine was impact damaged and most of the cover was separated and fragmented.

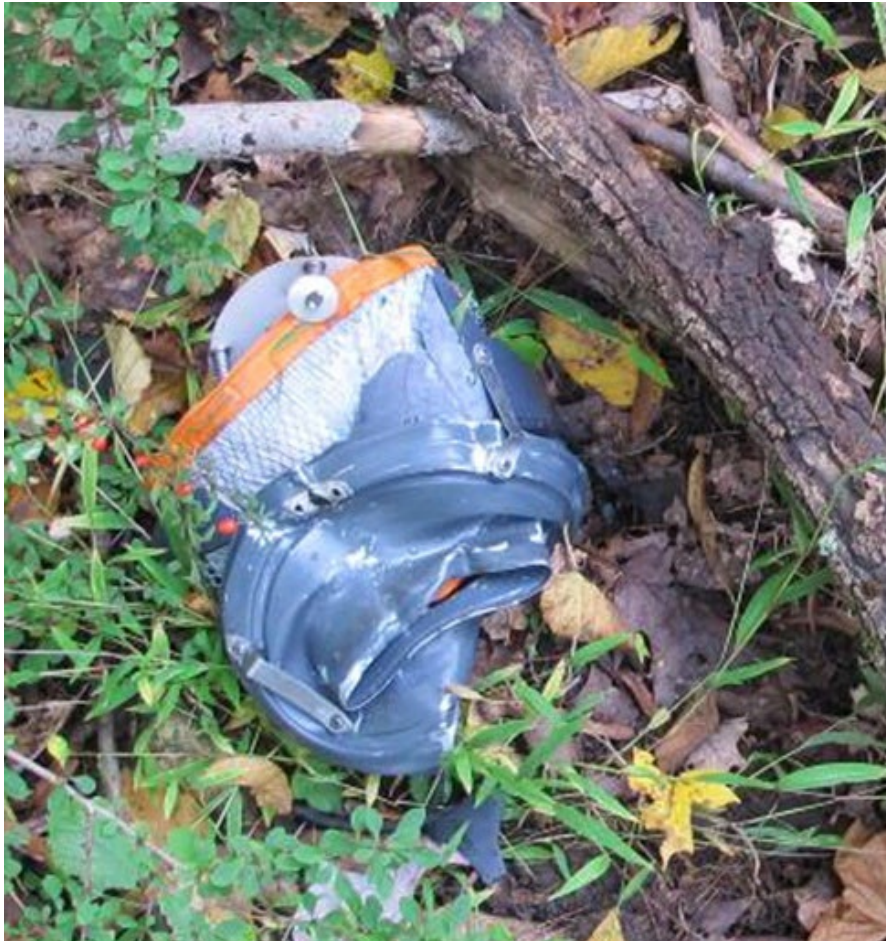
**Figure 50 - Engine Air Filter**

The air filter was separated from the engine, crushed, and the filter element was partially dislodged. No debris was found in the filter element.

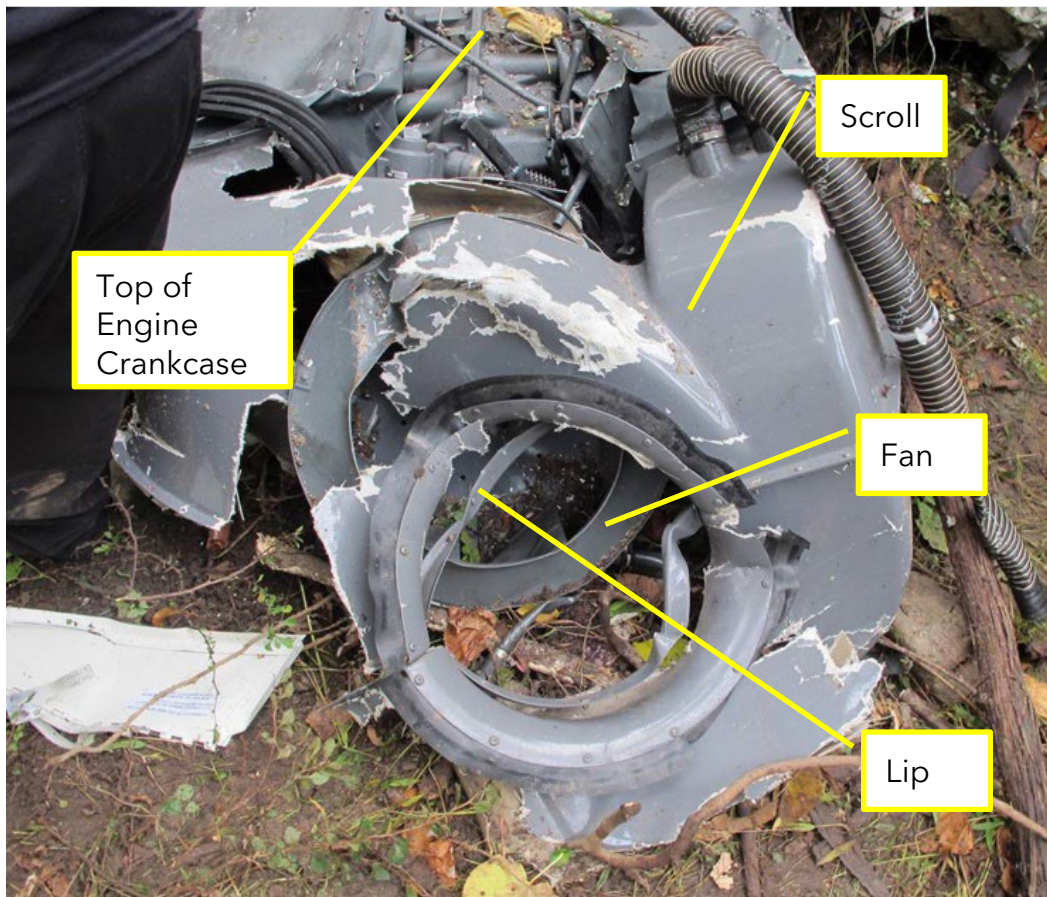
**Figure 51 - Cooling Fan and Scroll**

The fiberglass scroll that surrounds the cooling fan as severely impact damaged. No scoring marks were found on the inside of the scroll on the outer edges of the cooling fan. A 3 inch score mark was found on the inside of the metal fan lip, which lines the inside of the hole at the rear of the scroll.

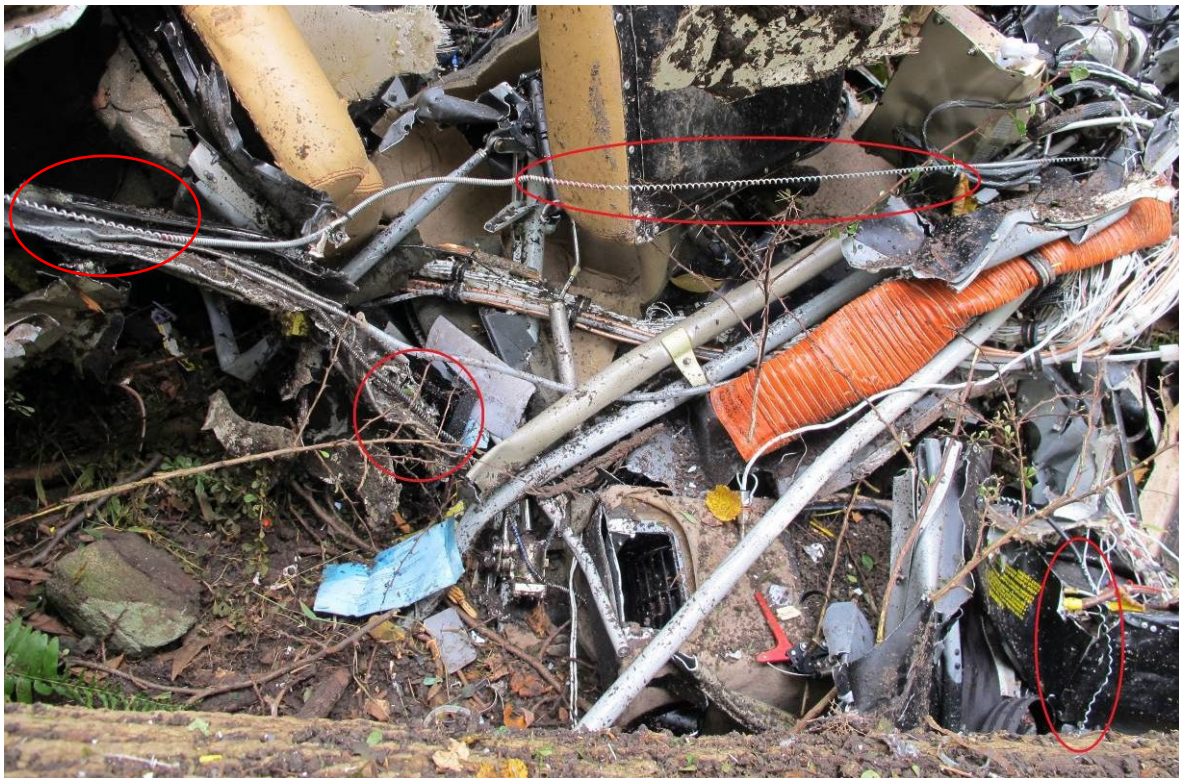
**Figure 59 - Mixture Control Wire Sheathing Stretched Areas**

The fuel injector servo was impact separated from the engine and partially fragmented. The throttle control rod end was fractured. A portion of the rod end remained attached to the servo throttle control arm. The mixture control cable wire was not attached to the servo mixture control arm. The bolt and attachment hardware which is to secure the cable wire to the servo mixture control arm was not present. The control wire sheath remained attached to its mounting bracket, the bracket was bent outward from the servo body. Lengths of the sheathing were stretched in several locations. The mixture arm was bent inward toward the servo housing and was positioned at the full lean (idle cutoff) position. The servo fuel inlet screen was removed and was absent of debris. Liquid with color and odor consistent with 100LL aviation gasoline drained from the servo when the screen was removed. The servo regulator section was partially disassembled and no damage to the internal rubber diaphragms or other components noted. The regulator cover brass plug was secure.

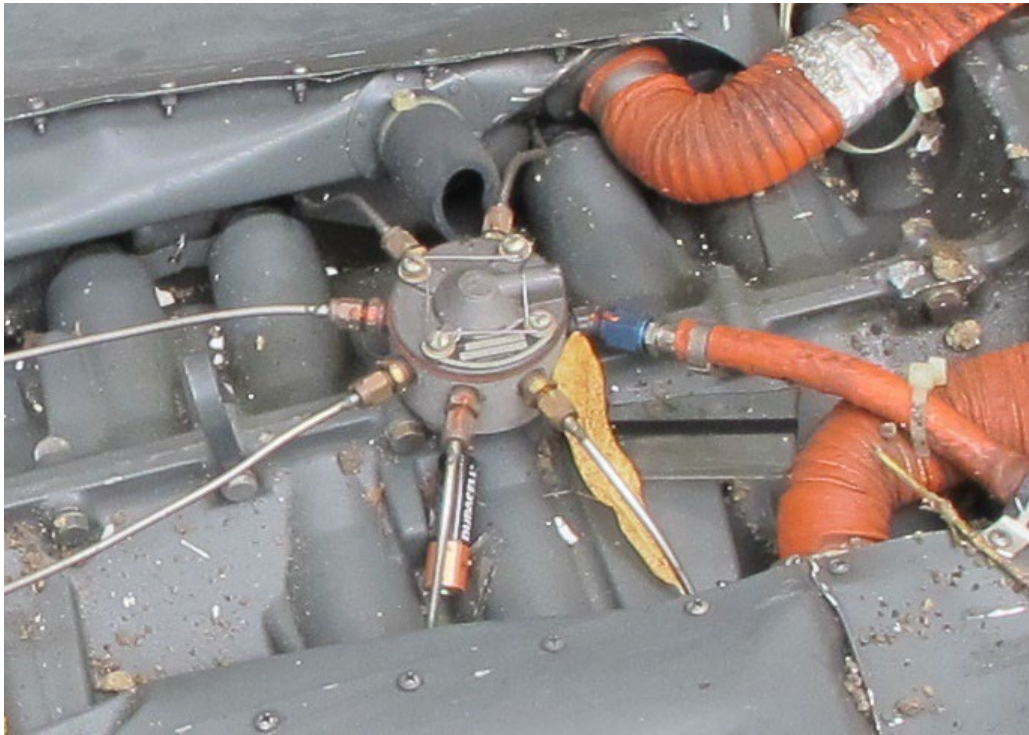
**Figure 62 - Flow Divider as Found**

The flow divider remained attached to the engine and no damage was noted. The injector lines were secure. The flow divider was partially disassembled and no debris or damage to the rubber diaphragm observed. The injector nozzles were unobstructed. No fuel was present in the flow divider or the injector lines.
