## Air Safety Investigations Aircraft Incident/Accident Technical Report

| Aircraft Incident/<br>Accident Information | Year: 1985 | Make: Cessna | Model: T210R |
| | Serial number: 21064922 | | Registration: N6209U |
| Chief Air Safety Investigator: Henry J. Soderlund | | Report #: ASI-21-DL-T | Report date: 04-26-22 |

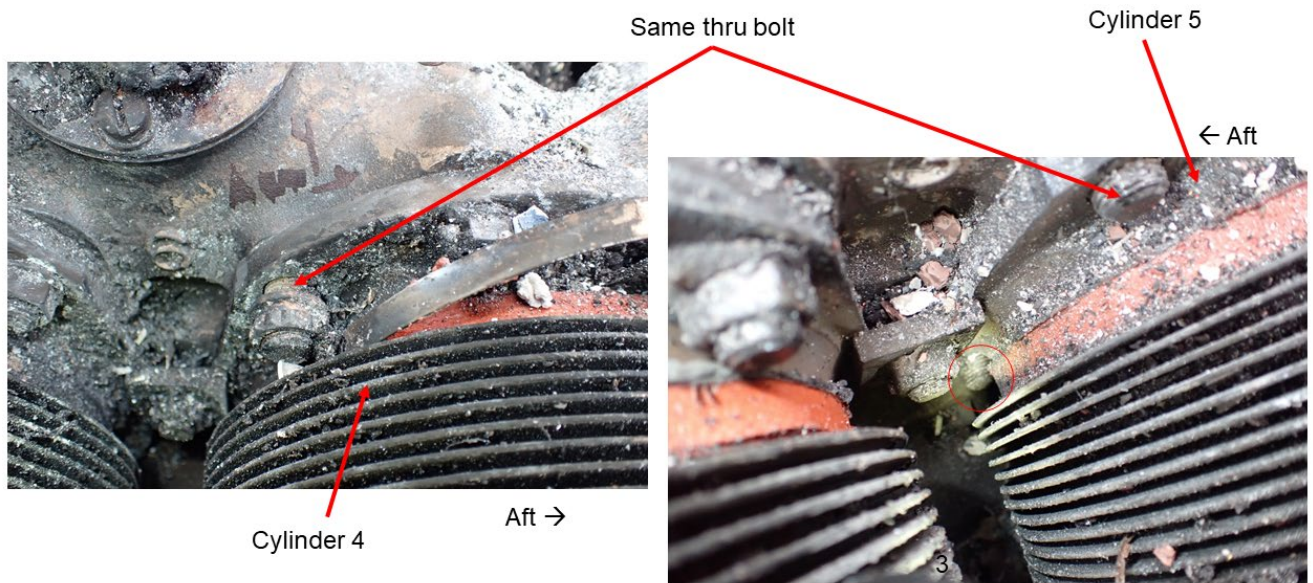
Cylinder 4 – Connecting rod separated at crankshaft, piston end intact, broken at crankshaft, piston top clean

Cylinder 4 – Borescope  
Piston

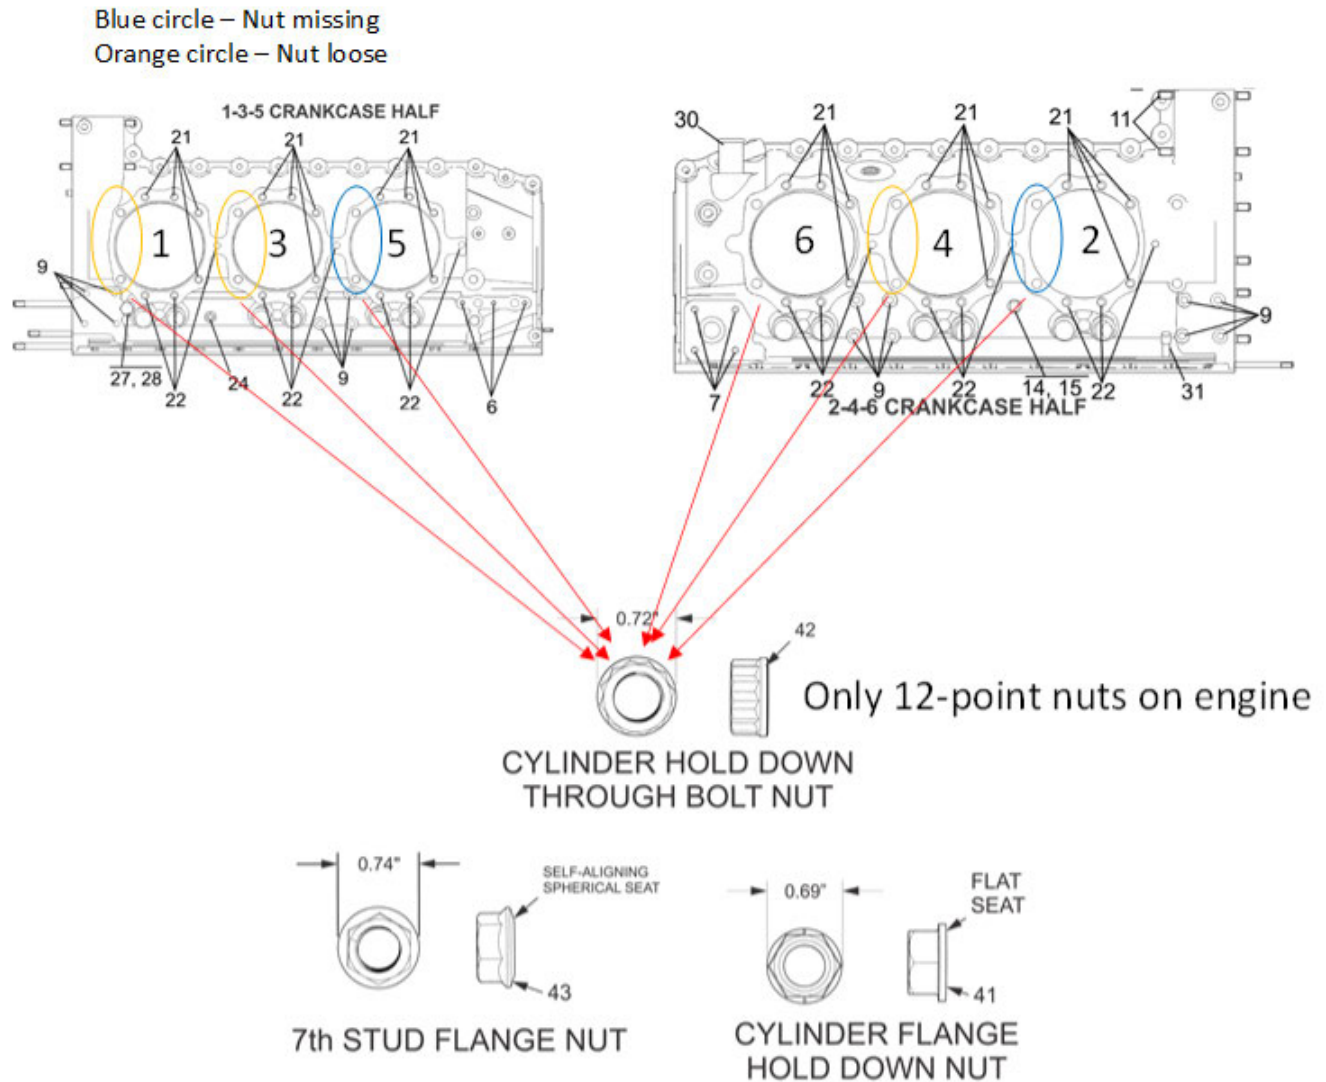
The four thru bolts connecting cylinders 5 and 4 and cylinders 3 and 2 were each missing a nut. The thru bolts on the aft side of cylinder 1 were loose.

Through bolts on top  
and bottom of  
crankshaft bearings
