**Aircraft Accident/Incident Report No.: 211210-2**

**Date of Accident:** December 10, 2021

**Aircraft:** Swearingen SA226-AT

**Written by:** Les Doud  
Air Safety Investigator – Hartzell Propeller Inc.

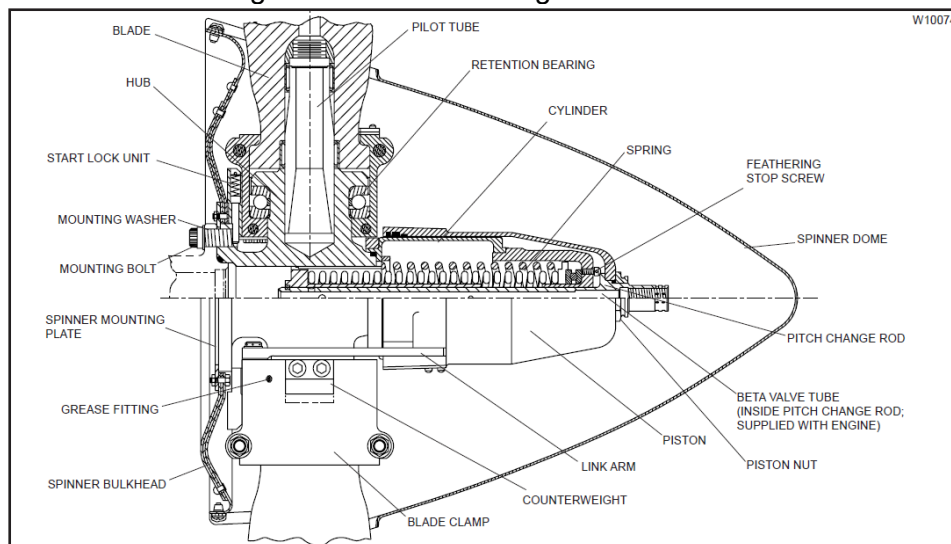
**Position** Right

**“As Received” Condition:** The propeller as-presented was securely attached to the propeller shaft flange (Photo #4) with all mounting hardware present, secure and lock-wired. The hydraulic unit (cylinder, piston and feathering spring assembly) had separated during the impact sequence and was recovered at the crash scene. The propeller exhibited remarkable heat damage, charring and sooting. All three blades remained attached to the hub/clamps and the counterweights were intact. All three blades were partially consumed by a post-crash fire and were in a feathered position. The mostly-intact blade was in a low pitch position and could be partially rotated by hand force. The spinner dome was 90+% consumed by a post-crash fire, only a fragment remained attached to the bulkhead. The de-ice slip ring potting compound was consumed and the rings separated from the platter and were loose around the propeller shaft.
