# National Transportation Safety Board

ERA22FA086

## POWERPLANTS

Group Chair's Factual Report

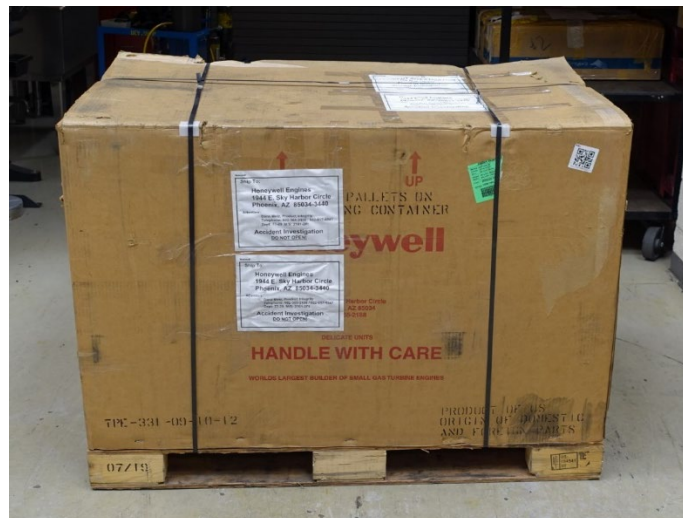
The engine was secured in a cardboard shipping box in the Honeywell Product Integrity Laboratory when the investigation team arrived (**Photos 4-7**). All external engine surfaces were sooted and had an ashy appearance with localized areas of dark discoloration consistent with post-crash fire exposure. The thermal damage was most severe from the 1 to 6 o'clock positions. The discoloration pattern and the shape of resolidified molten metal indicated the engine came to rest at the 3 o'clock position. There was no evidence of radial uncontainment or penetrations through the engine cases. Approximately 70 degrees of the outer diameter of the propeller mount flange was separated, including two bolt holes and a dowel pin (**Photo 8**). The propeller shaft was seized and could not be rotated by hand. The 3<sup>rd</sup> stage turbine blades could be rotated approximately 15 degrees by hand with heavy resistance. The 1<sup>st</sup> stage compressor impeller vanes visible through the inlet and the 3<sup>rd</sup> stage turbine blades visible through the exhaust were complete.

Photo 4- Engine Shipping Box, as Received at Honeywell

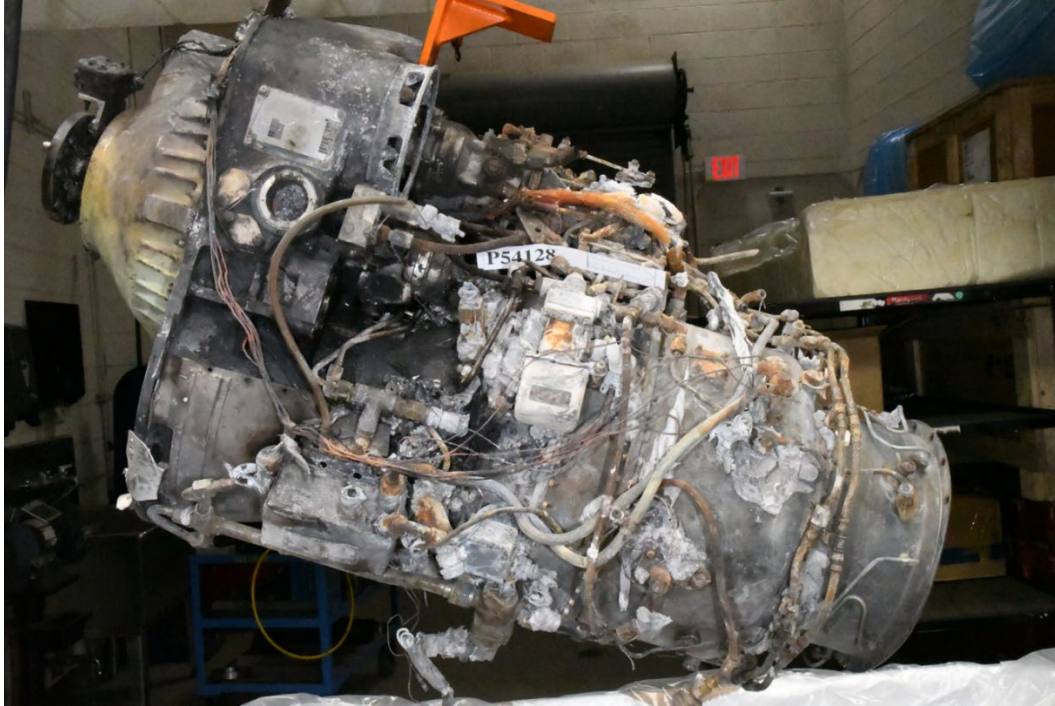
Photo 5- Left Side of Engine, as Received (Upside Down Relative to Installed Orientation)

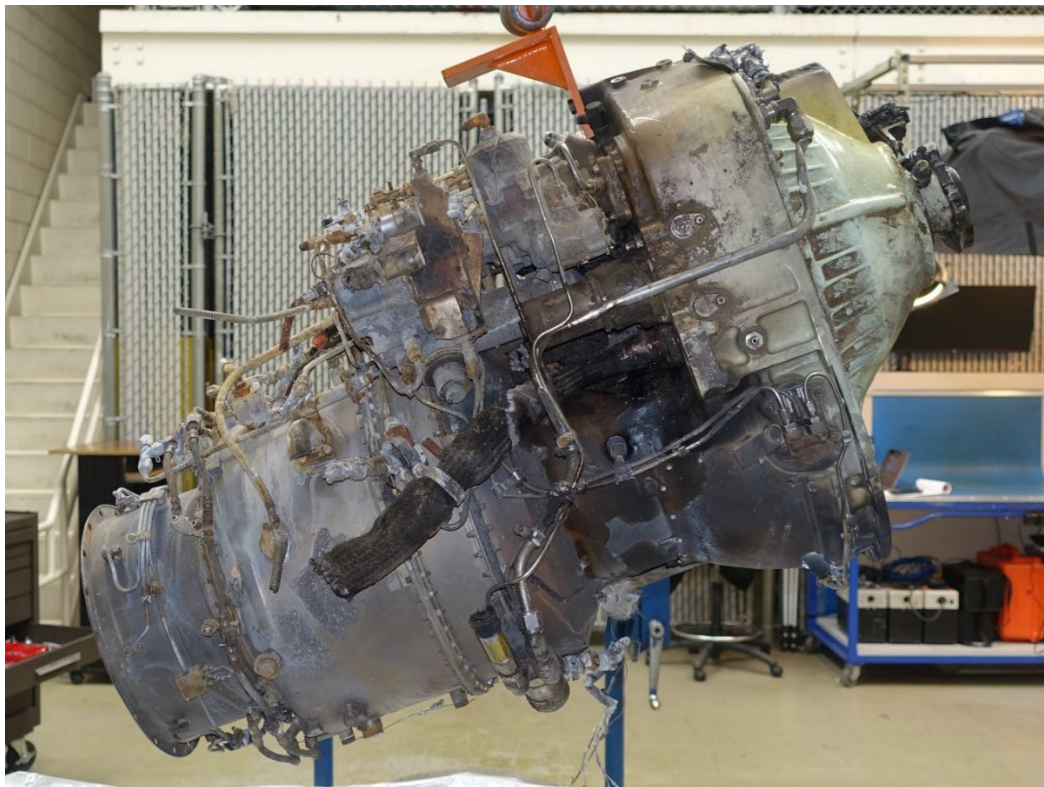
Photo 6- Right Side of Engine, as Received (Upside Relative to Installed Orientation)

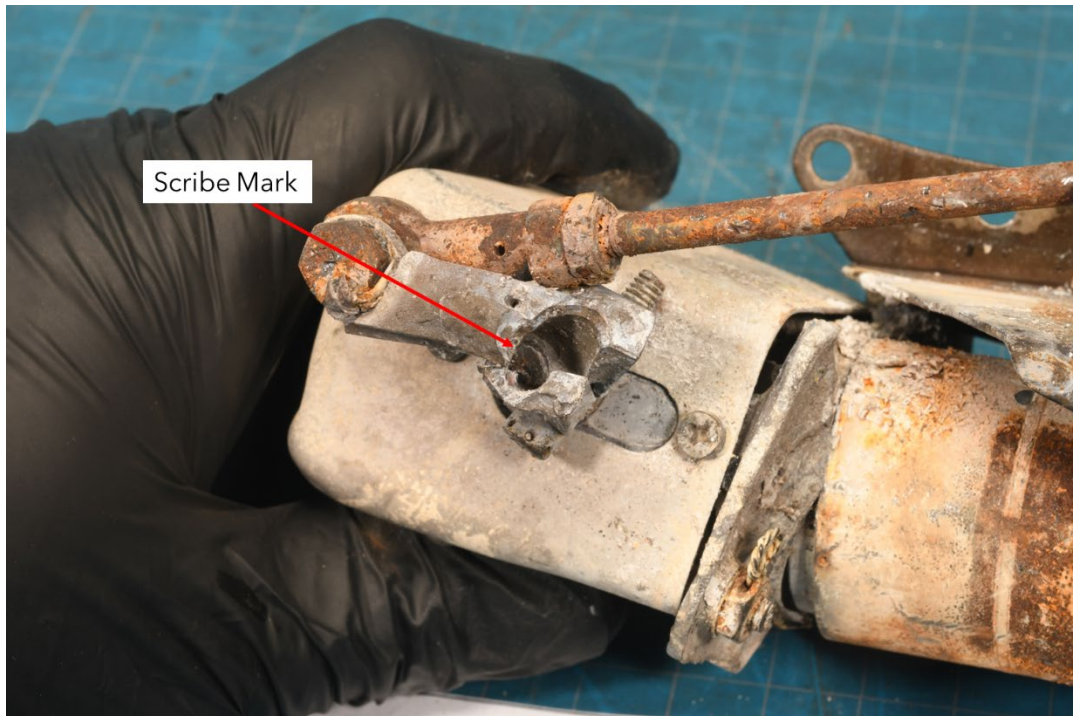
<sup>4</sup> The fuel shutoff valve indicator is aligned with the 12 o'clock position in auto mode or the 3 o'clock position when the condition lever is retarded to the emergency shutoff position in the cockpit. According to Honeywell, the fuel shutoff valve is in the closed position at either the 3 or 9 o'clock positions.

Photo 11- Fuel Shutoff Valve, Input Shaft Scribe

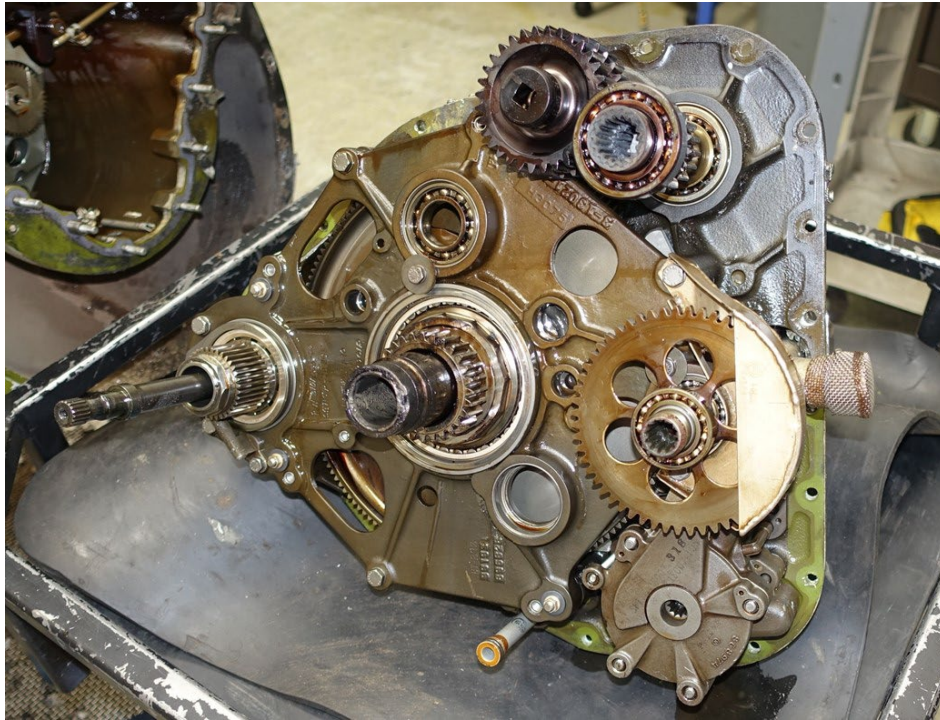
The AGB case and inlet were intact but exhibited discoloration and sooting. All seven forward propeller shaft bearing mount bolts were not present<sup>5</sup>. The nose cone could not be manually separated from the gearbox due to propeller shaft interference. The nose cone, diaphragm, and the propeller shaft were removed as an assembly (**Photo 13**) and the propeller shaft was pushed out using a custom fabricated pusher bar tool. The forward and aft propeller bearings were not exposed but rotated smoothly. The propeller shaft had a 360 degree circumferential rub at the forward radius, immediately aft of the forward retaining nut. In the same location as the circumferential rub, there was raised metal consistent with axial impact. The propeller shaft also had localized circumferential scoring ½ inch and 1¾ inches aft of the retaining nut (**Photo 14**). The ring gear, sun gear, bull gear, and planet gears were intact and rotated. Impact/contact marks were observed on the AGB case feather valve bore and the torque sensor housing with coincident impact marks on the aft sun gear retaining nut (**Photo 15**). According to Honeywell, impact/contact in these locations are

Photo 13- Diaphragm, Propeller Shaft, Nose Cone Assembly

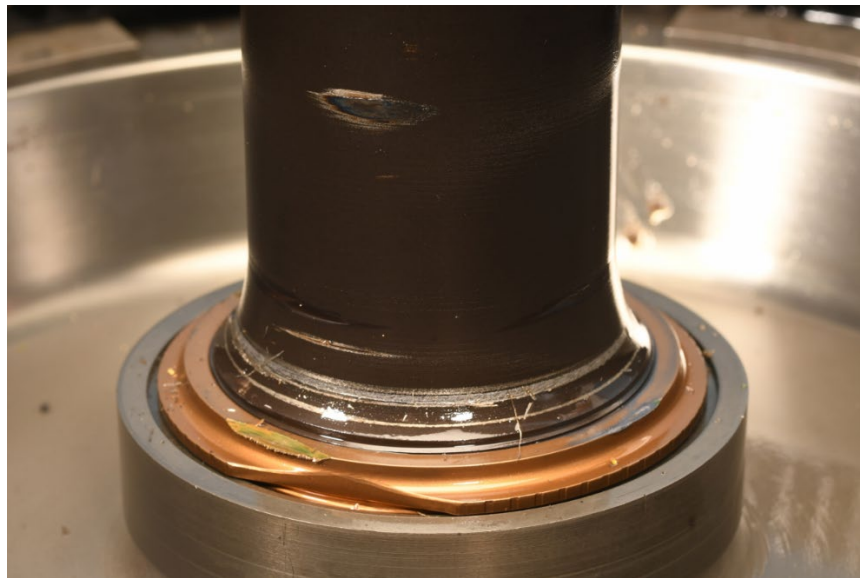
Photo 14- Propeller Shaft Circumferential Rub/Scoring

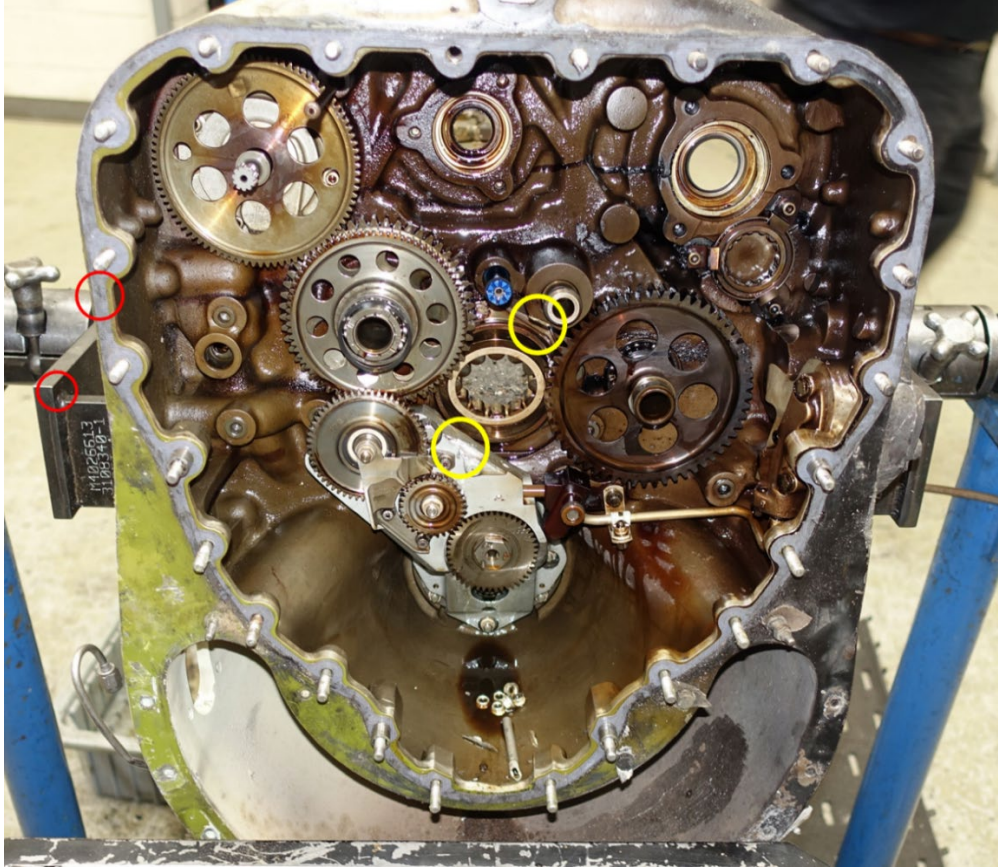
common during nose down accident events on TPE331 engines. The torque sensor assembly was intact, and the gears rotated smoothly.

Photo 15- Accessory Gearbox, Feather Valve Bore, and Torque Sensor Impacts/Contacts

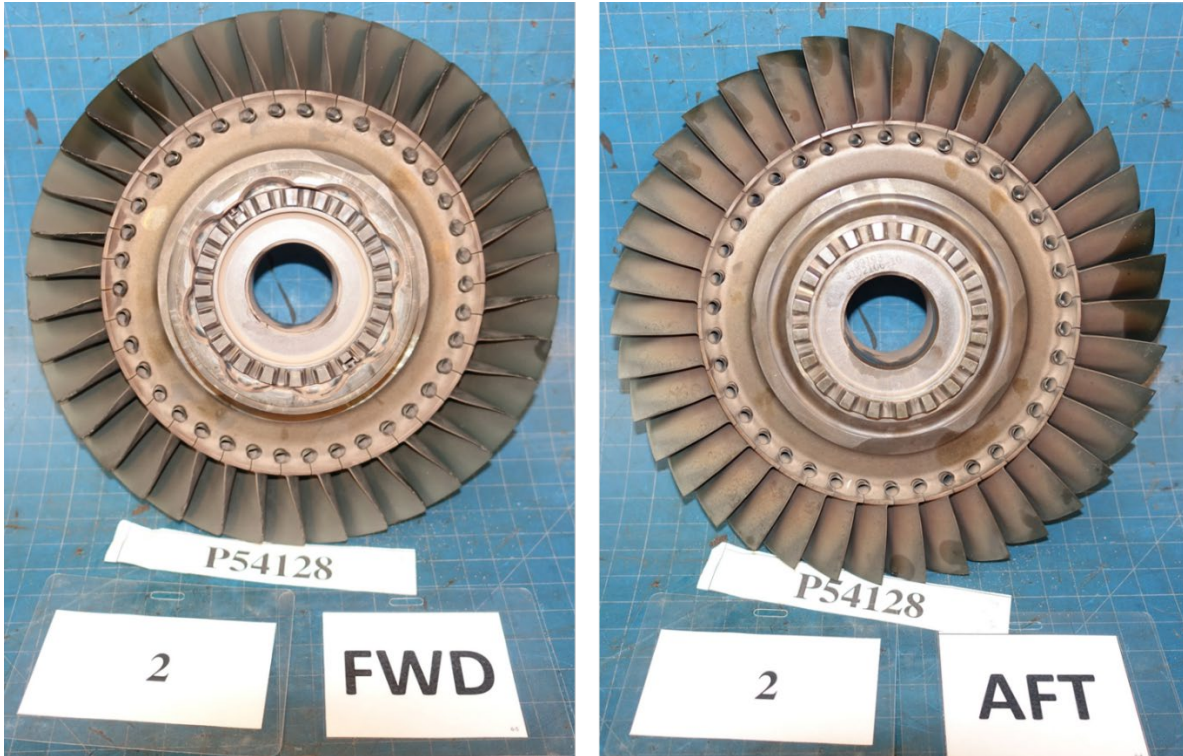
The 2<sup>nd</sup> stage turbine stator exhibited thermal damage and vane material was missing from the 6 to 12 o'clock positions. The thermal damage was most severe from the 8 to 10 o'clock positions (**Photo 19**). All intact vanes had suction side trailing edge thermal damage and the suction side vane surfaces appeared wrinkled. Light 360 degree rotational scoring was visible on the 2<sup>nd</sup> stage turbine shroud. The 2<sup>nd</sup> stage turbine rotor blades were all intact but had light leading edge impact damage (**Photo 20**). The trailing edge along the outer third of the blade span of all 2<sup>nd</sup> stage turbine blades were rolled over opposite the direction of rotation. Tip rub was visible 360 degrees around the rotor.

Photo 20- 2<sup>nd</sup> Stage Turbine Rotor, (L) Leading Edge, (R) Trailing Edge

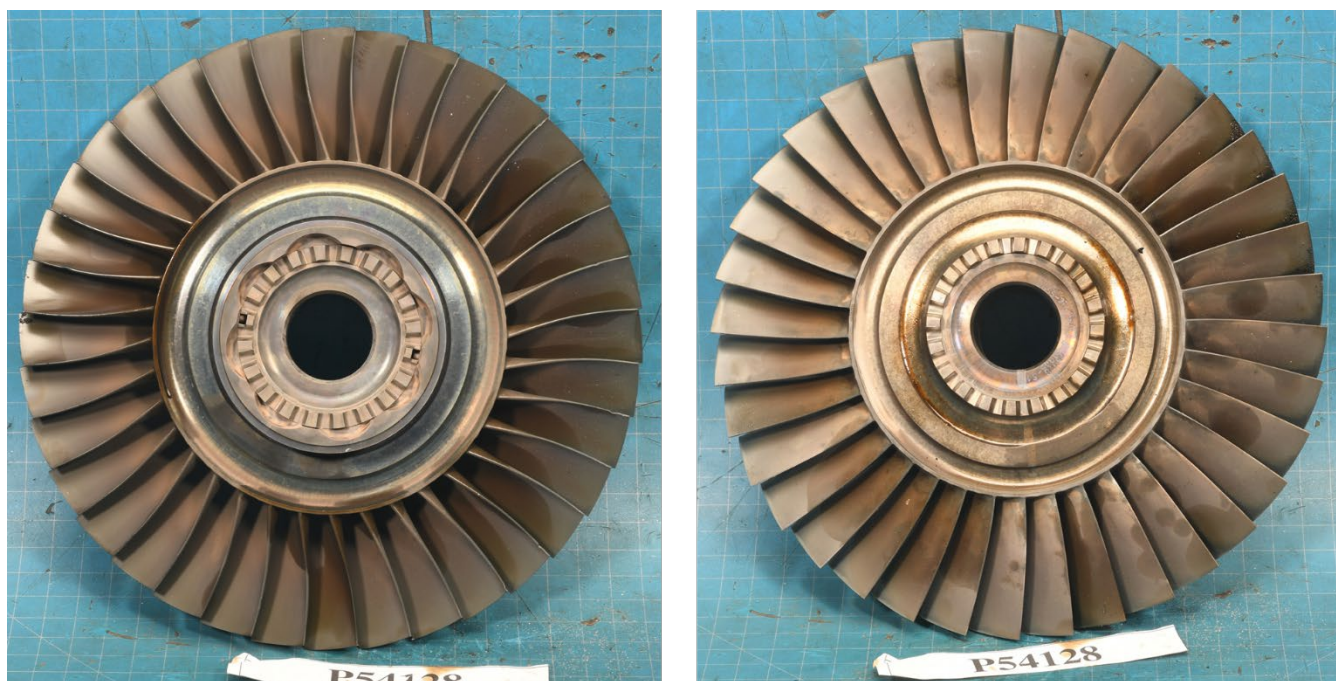
The 3<sup>rd</sup> stage turbine stator had four vanes with chordwise cracks at the midspan from the 9 to 10 o'clock positions (**Photo 21**). One additional vane had a small incipient crack on the leading edge at the 11 o'clock position. Trailing edge deformation was noted on three consecutive vanes at the 11 o'clock position. Light rotational scoring was visible on the 3<sup>rd</sup> stage rotor shroud at the 6 o'clock position. All the 3<sup>rd</sup> stage turbine rotor blades were intact (**Photo 22**) and exhibited tip rub and small leading edge nicks (**Photo 23**). The 3<sup>rd</sup> stage turbine shroud exhibited circumferential scoring consistent with contact from the 3<sup>rd</sup> stage blade tips (**Photo 23**).

Photo 22- 3<sup>rd</sup> Stage Turbine Rotor, (L) Leading Edge, (R) Trailing Edge

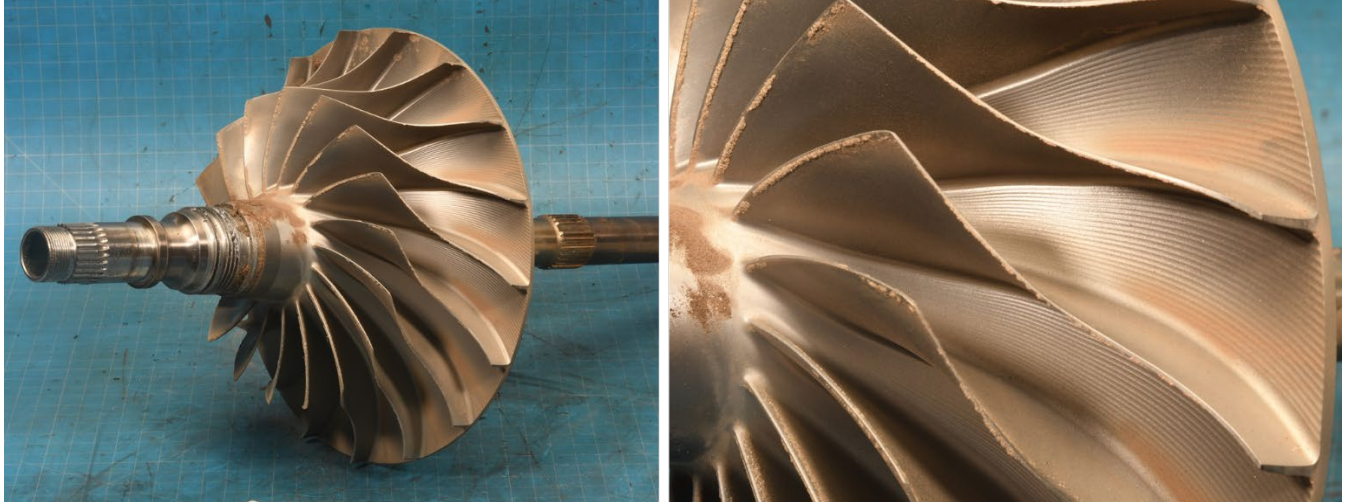
The 1<sup>st</sup> stage compressor impeller was intact. All impeller blades had light tip rub along the length of the blade (inducer to exducer) (**Photo 25**). There was light 360 degree rotational scoring on the hub aft of the forward curvic coupling. The 1<sup>st</sup> stage impeller shroud<sup>6</sup> had light 360 degree rotational scoring from the inducer to the exducer, more visible at the exducer (**Photo 26**). The 1<sup>st</sup> stage impeller/shroud and the 1<sup>st</sup> stage diffuser vanes had fine sand accumulation on all surfaces in the flow path.

Photo 25- (L) 1<sup>st</sup> Stage Compressor Impeller, (R) Impeller Blade Tips

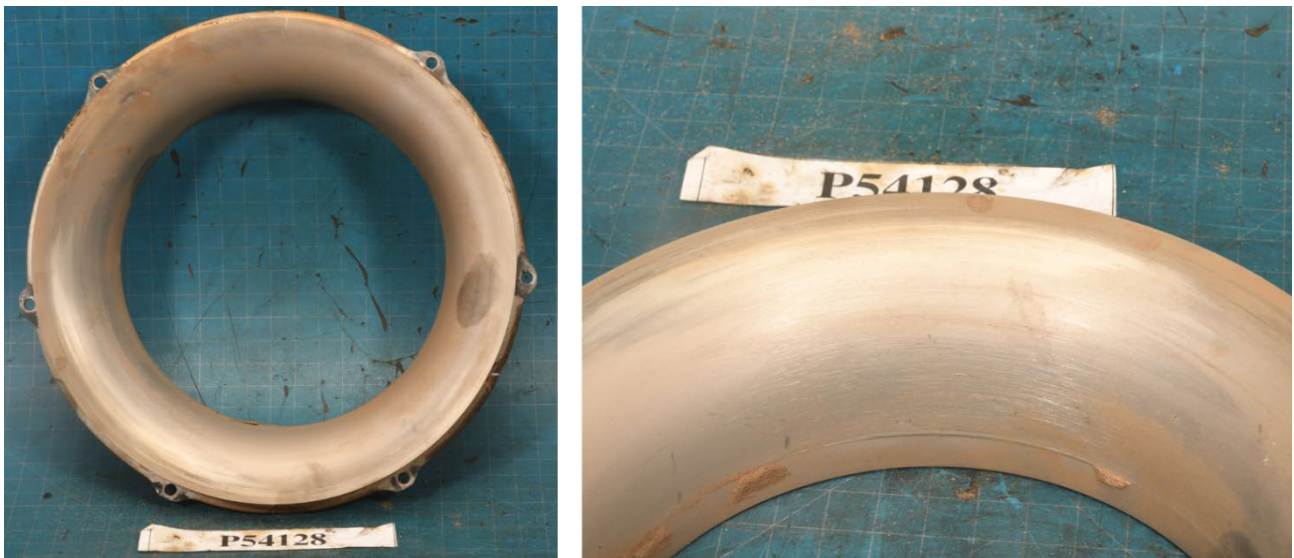
Photo 26- 1<sup>st</sup> Stage Compressor Shroud

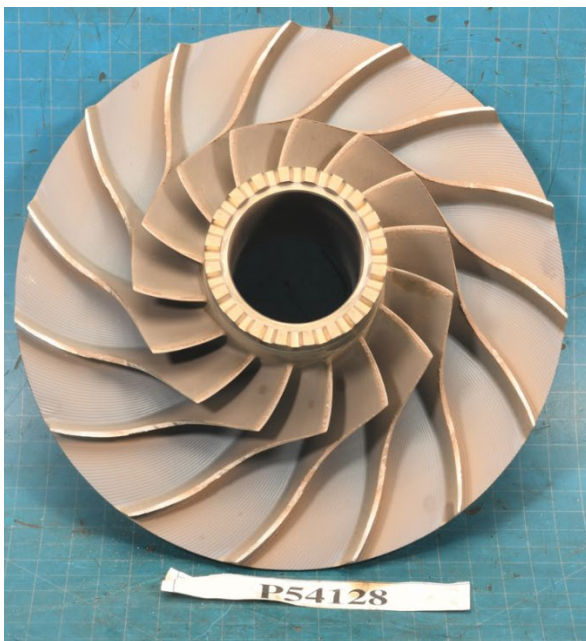
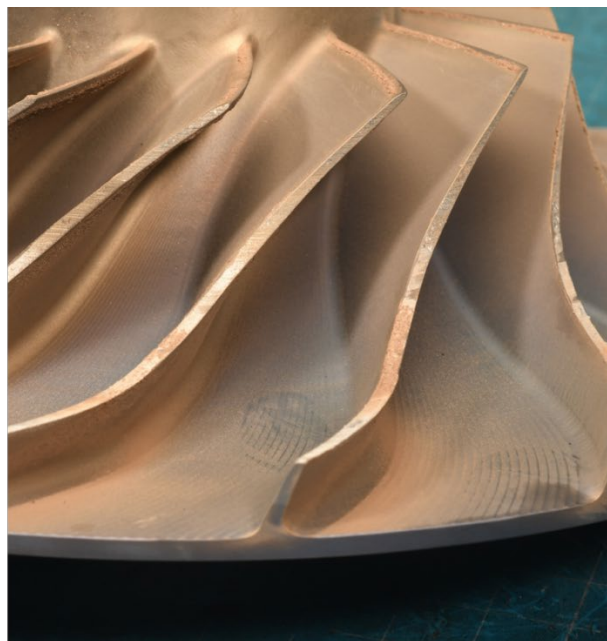
The 2<sup>nd</sup> stage compressor impeller blades were all complete (Photo 27). The impeller blades tips had tip rub from the inducer to the exducer. The impeller had 360 rotational scoring on the hub aft of the forward curvic. The main shaft was intact and did not appear bent/deformed. There was light 360 degree rotational scoring on the hub aft of the curvic coupling (Photo 28). The 2<sup>nd</sup> stage impeller shroud had light 360 degree rotational scoring from the inducer to the knee (Photo 29). The 2<sup>nd</sup> stage shroud also exhibited light static impact marks from the 2 to 7 o'clock positions.

Photo 27- 2<sup>nd</sup> Stage Compressor Impeller

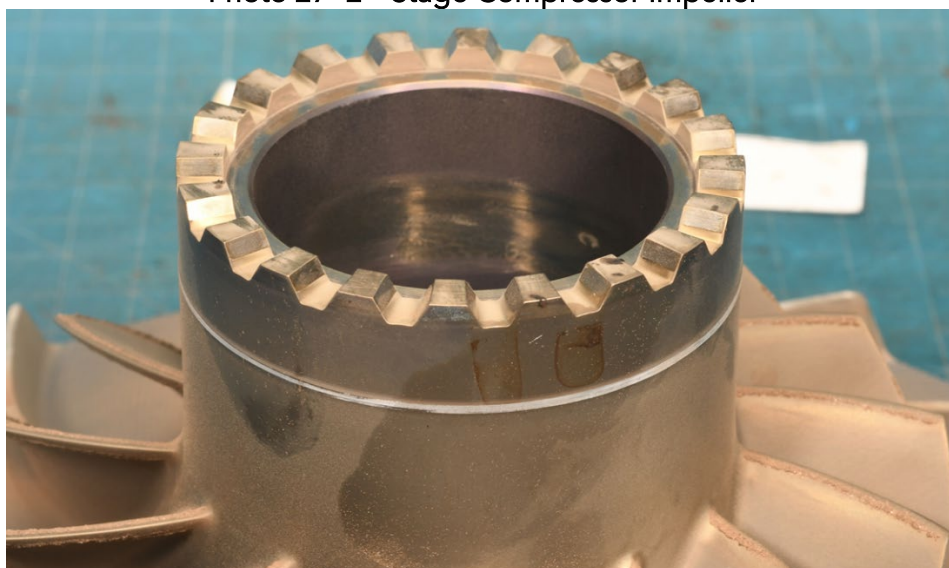
Photo 28- 2nd Stage Compressor Impeller Hub Curvic Scoring

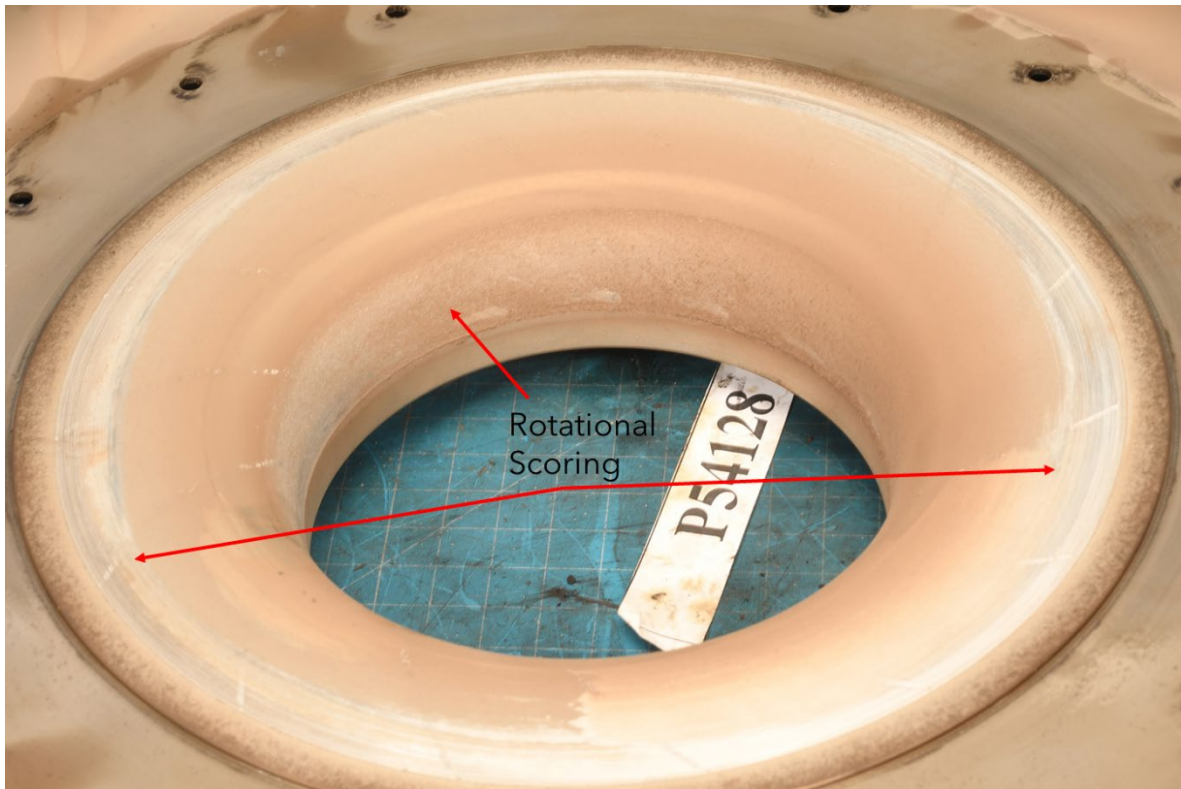
Photo 29- 2<sup>nd</sup> Stage Compressor Shroud

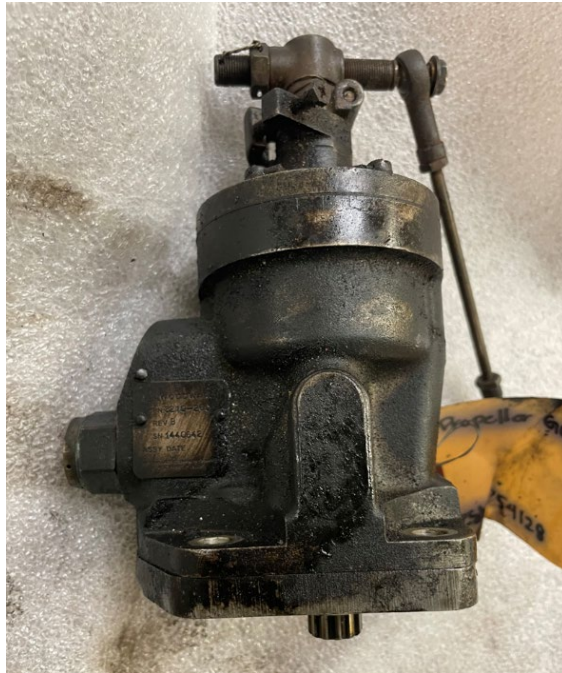
Propeller governor, serial number, 1440642, was shipped to Woodard in Loves Park, Illinois for a group examination with the same group members in attendance and conducted the same time as the FCU exam. The propeller governor external surfaces were all discolored and covered with soot and debris (**Photo 31**). The governor was run on the test bench in the as received condition. During initial startup, there was significant leakage from the governor baseplate. The baseplate packing was replaced, but leakage was again observed from the governor housing and baseplate. Multiple test points were out of limits during the as received test run. The bypass valve was replaced with an engineering spare relief valve and the test procedure was run again. The test points were within the expected range of similar service run units according to Woodward.

The propeller governor was disassembled. Internal components exhibited signs of thermal exposure consistent with post-crash fire. The governor relief valve spring had a free length of 1.560 inches instead of a new spring unit length of approximately 1.760 inches. In the as-installed condition, the spring is compressed to approximately 1.500 inches. The shorter spring length on the as received unit is consistent with the spring taking a set at the working height due to post crash fire exposure. There were no other internal anomalies identified that would have precluded normal operation. The Woodward report and test run sheet are available in the investigation docket as "Attachment 2- Woodward Propeller Governor, Serial Number, 1440642, Investigation Report and Test Run Sheet."

Photo 31- Propeller Governor, as Received at Woodward

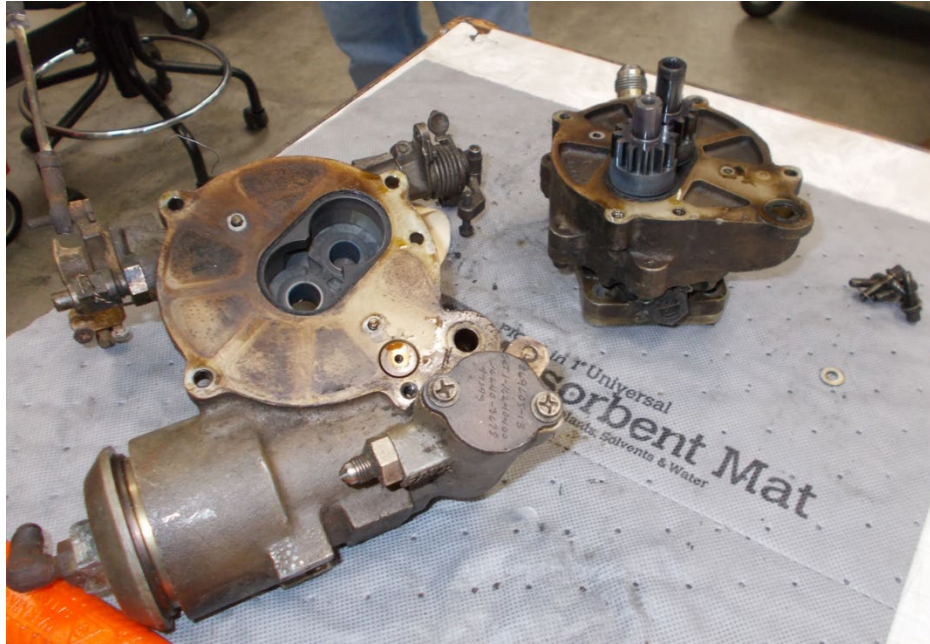
The fuel pump was examined at Honeywell in Phoenix, Arizona on November 10, 2022, under oversight by a FAA representative. The fuel pump drive spline had heavy resistance when it was rotated by hand. The fuel pump could not be bench tested due to thermal damage, so it was fully disassembled and inspected. There were indications of thermal damage throughout fuel pump internal components including discoloration and consumed/melted o-ring packings (**Photo 33**). The fuel pump relief valve was functionally tested after it was removed and opened at 1000 psi<sup>8</sup>. There were no indications of pre-impact failure or other anomalies that would have precluded normal operation.

Photo 33- Fuel Pump, Partially Disassembled (Photo Courtesy of Honeywell)

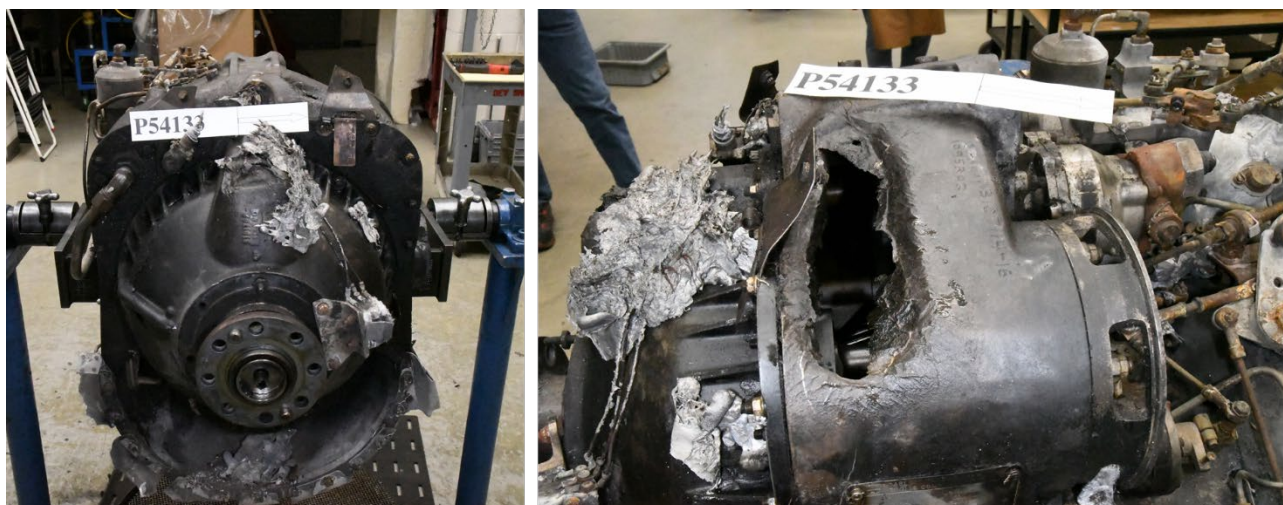
Photo 41- (L) Nose Cone, Inlet, (R) AGB Case Hole

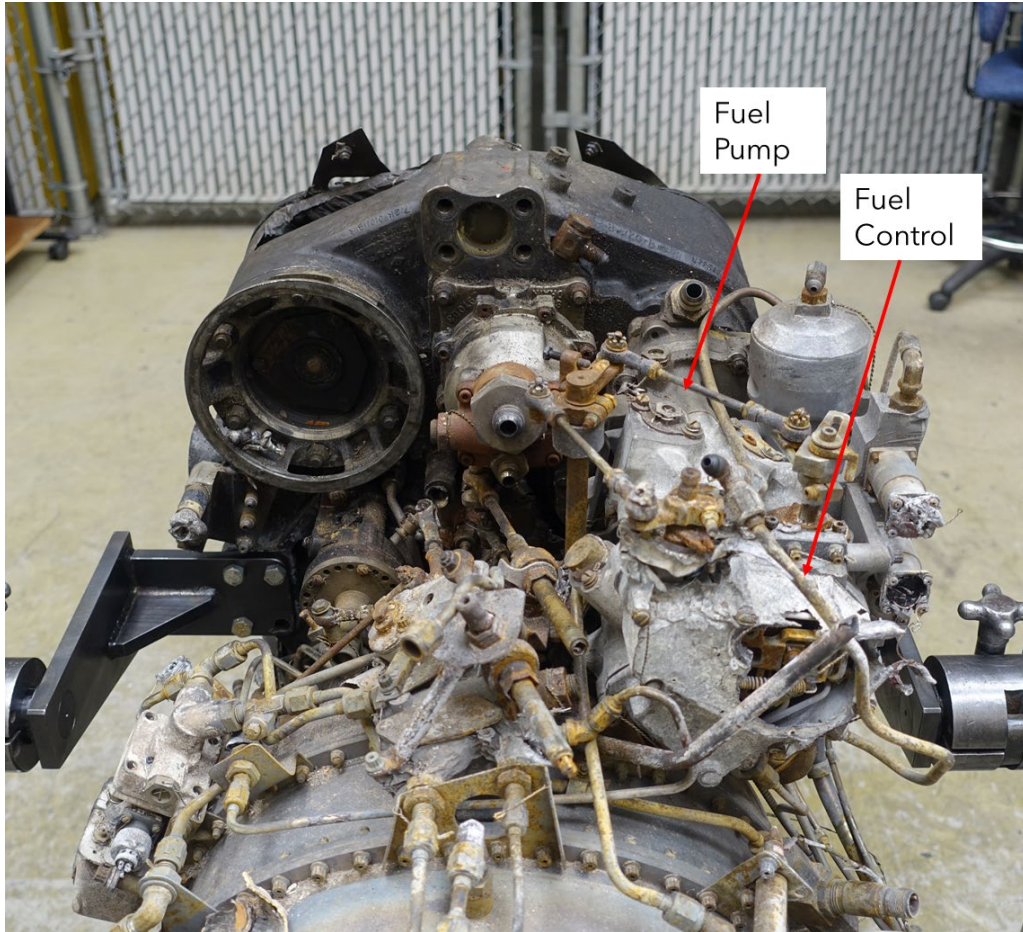
The fuel pump and FCU remained secured to the AGB mount and both components were thermally damaged and covered in soot. A portion of the aft side the FCU cover was thermally consumed (**Photo 42**). The FCU power lever linkage indicator dial was aligned with the 60 degree mark. All three PPC attachment mounts were broken and the PPC was pushed aft, away from the AGB. The PPC indicator dial was at the 24 degree mark (**Photo 43**). The aft propeller shaft thrust bearing was pushed out of the aft side of the gearbox. The propeller feather valve actuator end was pulled out. The propeller governor was intact with dark discoloration/sooting. After the governor was removed the mating face of the governor was discolored and the gasket was thermally damaged. The propeller governor check valve orifice was obstructed with dark carbon like debris. The FSOV was secured to the engine but exhibited thermal damage and case bulging. The input shaft scribe was pointed toward the 3 o'clock position (manually closed) (**Photo 44**). A low pressure air check was performed air did not pass through the valve, indicating it was in the closed position.

Photo 42- Fuel Pump and Fuel Control Unit

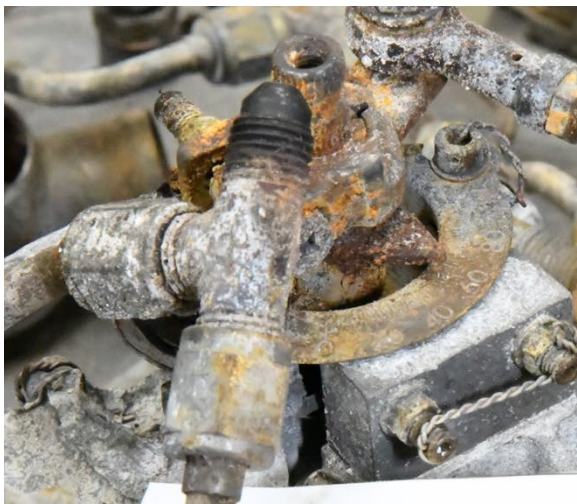
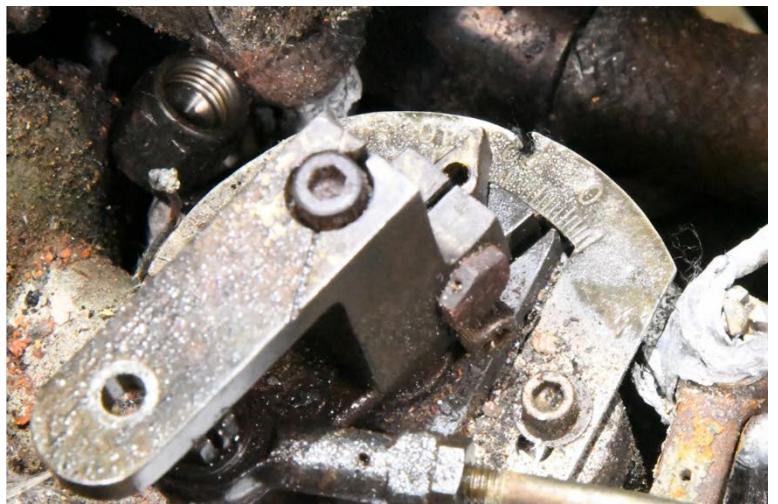
Photo 43- (L) Fuel Control Unit Power Lever Linkage Dial Indicator, (R) Propeller Pitch Control Dial Indicator.

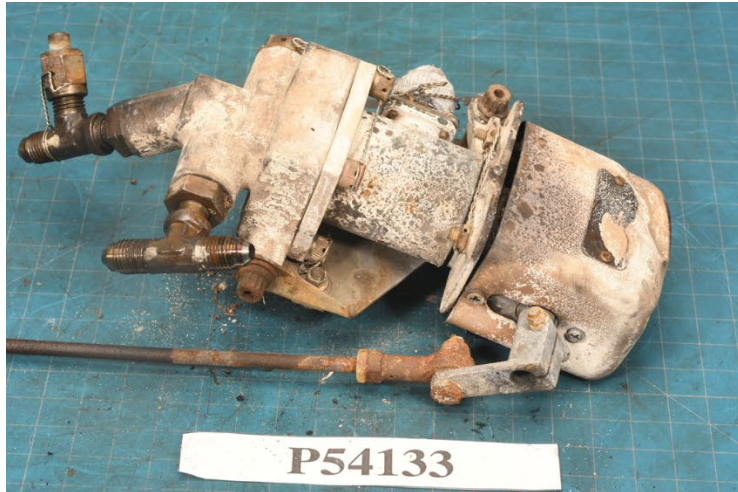
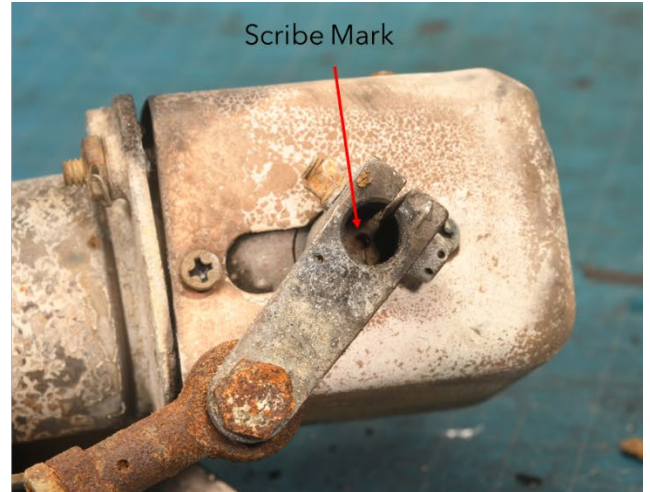
Photo 44- (L) Fuel Shutoff Valve, (R) Input Shaft Scribe

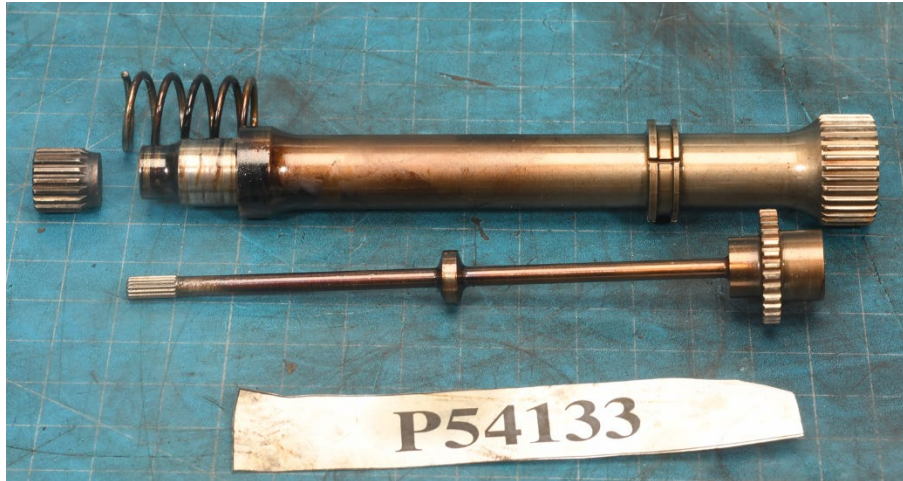
The high speed pinion coupling shaft aft spline was broken and remained in the torque shaft when the shaft was removed. The negative torque sensing (NTS) quill shaft was intact and undamaged (**Photo 47**). The diaphragm was removed, and all diaphragm and AGB components were darkly discolored with no residual oil (**Photo 48**). The sun gear, bull gear, and associated accessory gears were intact, properly mated, and could be rotated by hand (**Photo 49**). Impact marks were observed on the AGB case feather valve bore and the torque sensor housing with coincident impact marks on the aft sun gear retaining nut. The torque sensor gears rotated and did not exhibit indications of pre-impact damage.

Photo 47- High Speed Pinion Power Coupling Shaft and NTS Quill Shaft

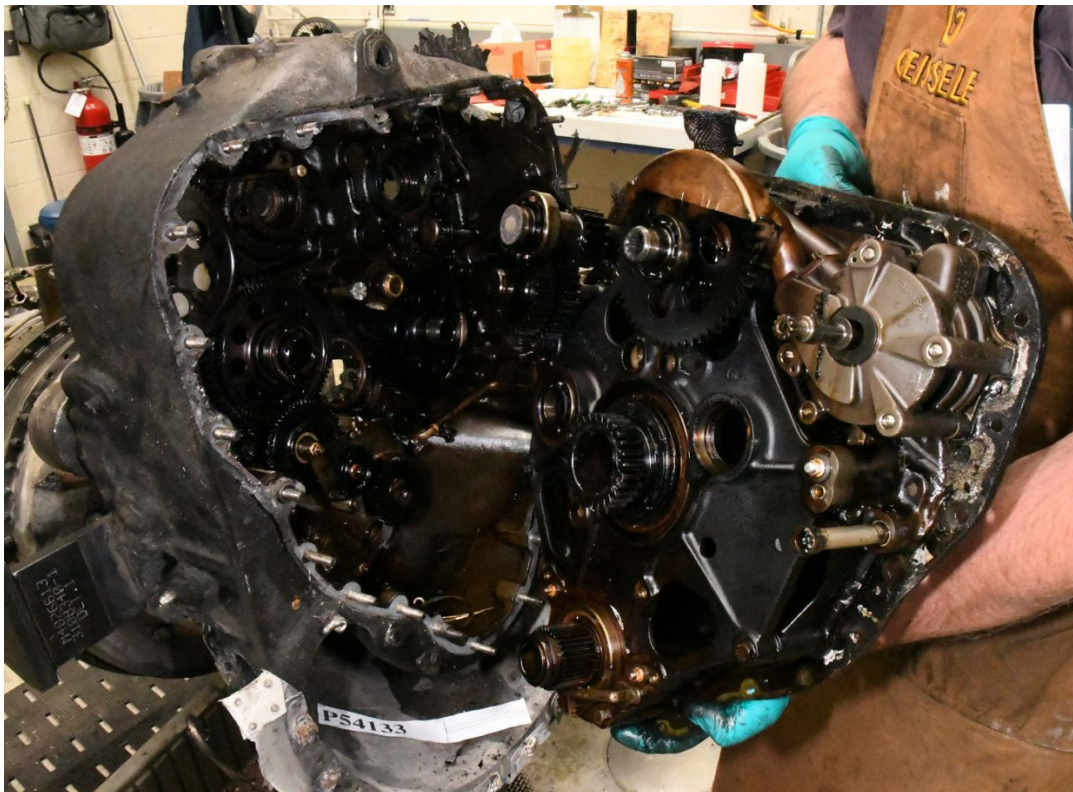
Photo 48- Diaphragm Assembly

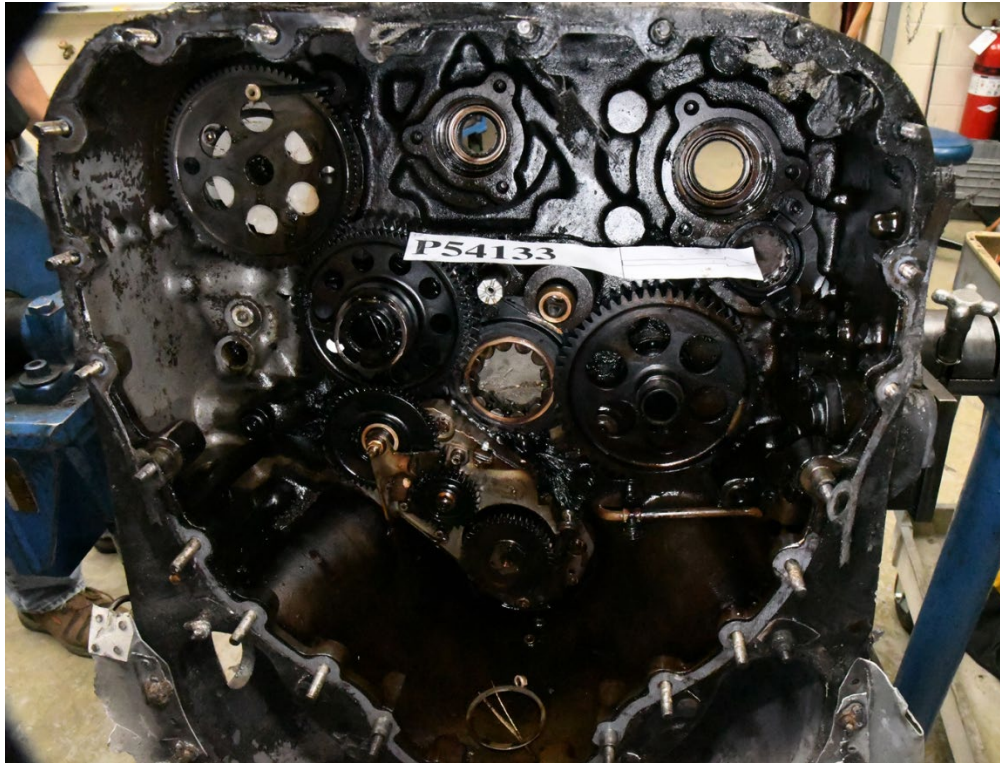
Photo 49- AGB Case

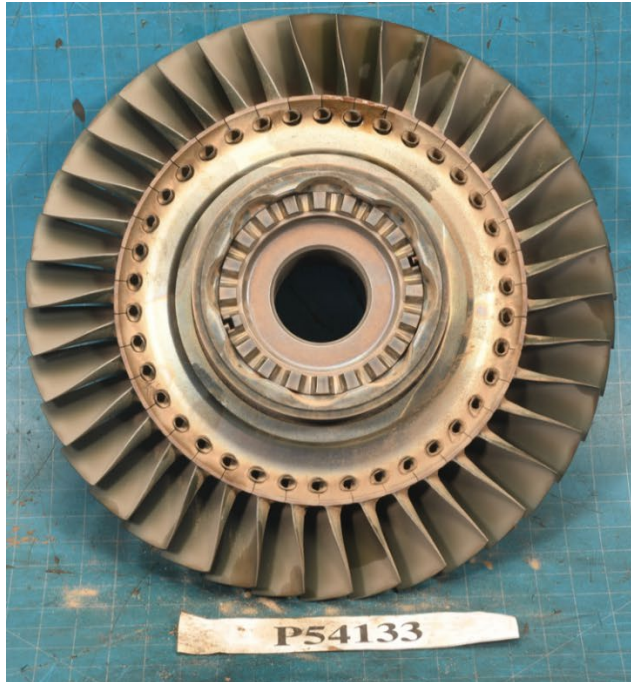
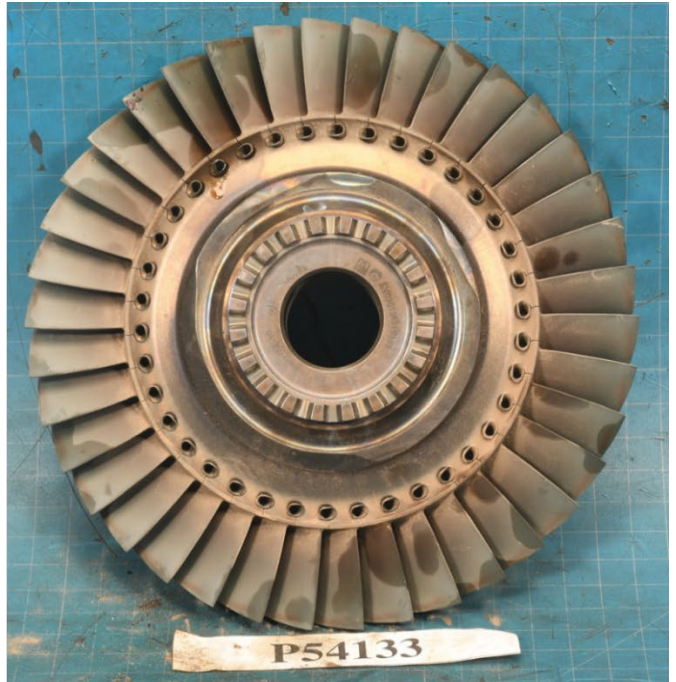
The 2<sup>nd</sup> stage stator vanes were all complete (Photo 53). One vane had small trailing edge cracks at the quarter span and near the inner diameter platform. The 2<sup>nd</sup> stage turbine shroud had light localized scoring at locations coincident with the 2<sup>nd</sup> stage turbine blade mid-chord. The 2<sup>nd</sup> stage turbine rotor blades were all intact and complete (Photo 54). The blades tips exhibited light tip rub from the mid-chord to the trailing edge 360 degrees around the rotor.

Photo 54- 2<sup>nd</sup> Stage Turbine Rotor, (L) Leading Edge, (R) Trailing Edge

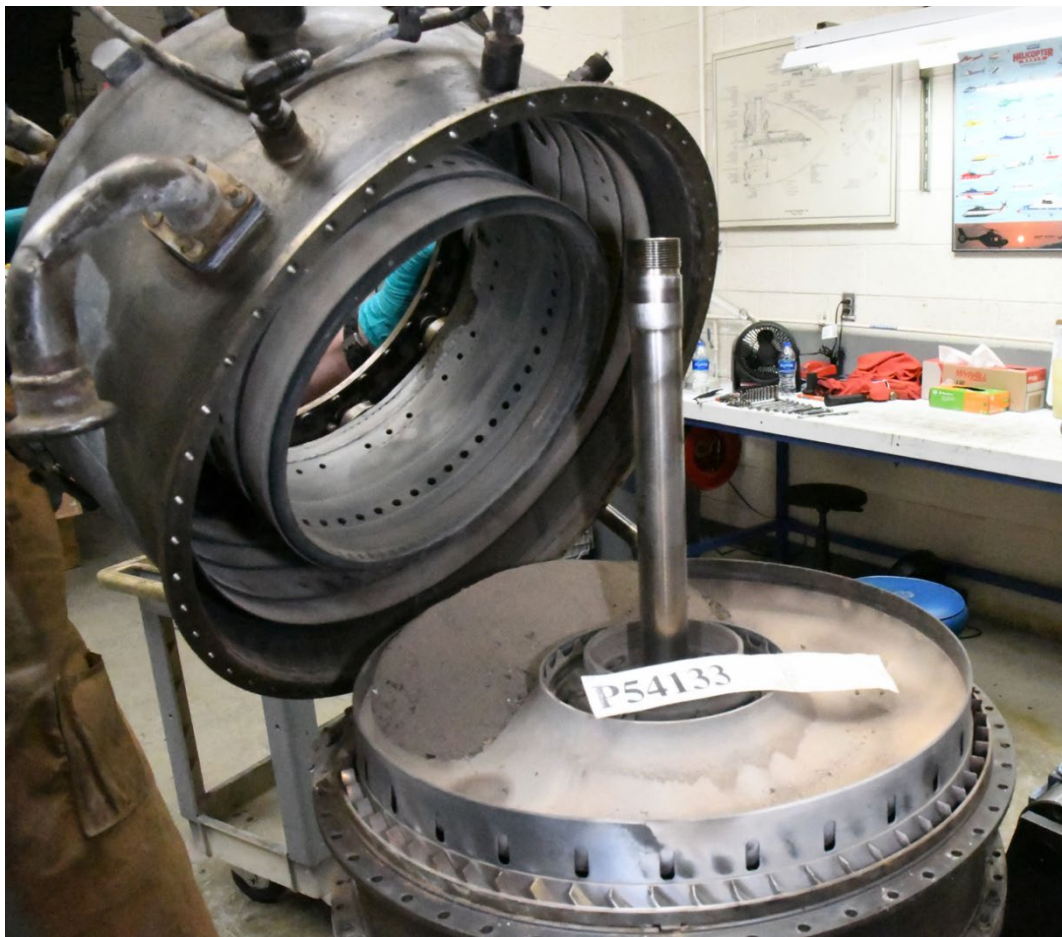
The combustion liner was intact and had no indications of fuel nozzle streaking (**Photo 57**). All the fuel nozzles were properly seated. The thermal barrier coating was eroded on the liner wall skirt adjacent to the fuel nozzle at the 2 o'clock position. The primary and secondary fuel manifold was thermally damaged, but all nozzle connections remained intact. The outer transition liner had localized thermal barrier coating missing at three locations. Sand was collected in the combustor, most notably in the outer transition liner (**Photo 58**). There was no metal spray visible on the combustion liner walls.

Photo 58- Outer Transition Liner

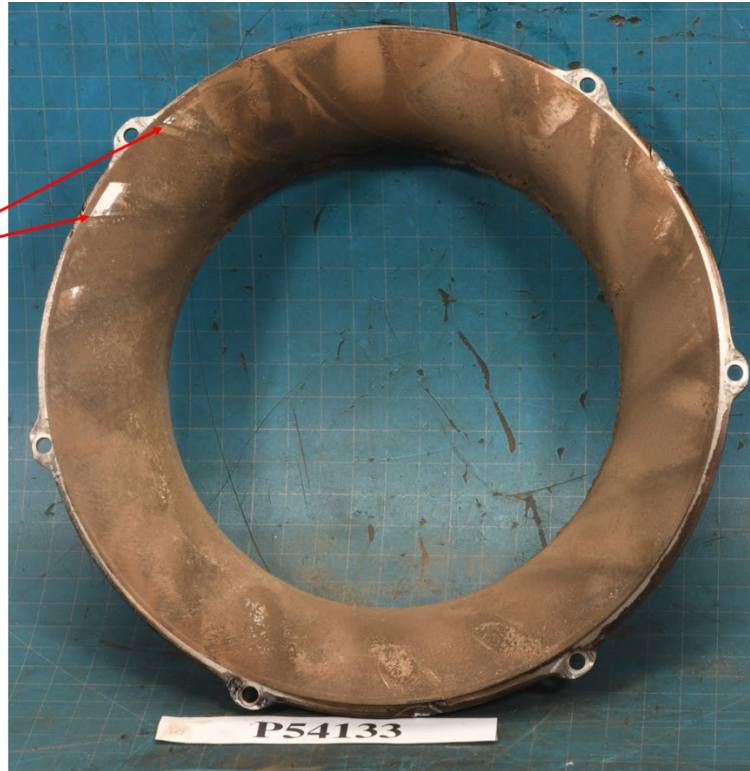
The 1<sup>st</sup> stage compressor impeller was intact but exhibited thermal discoloration. One impeller blade tip was bent opposite the direction of rotation (**Photo 59**). There was light 360 degree rotational scoring on the hub forward of the aft curvic coupling. The 1<sup>st</sup> stage impeller shroud had 360-degree rotational scoring at the exducer (**Photo 60**). The 1<sup>st</sup> stage impeller, shroud and the 1<sup>st</sup> stage diffuser vanes were coated in a layer of fine sand.

Photo 60- 1<sup>st</sup> Stage Impeller Shroud, Rotational Scoring
