# National Transportation Safety Board

ERA22FA086

## POWERPLANTS

Group Chair's Factual Report

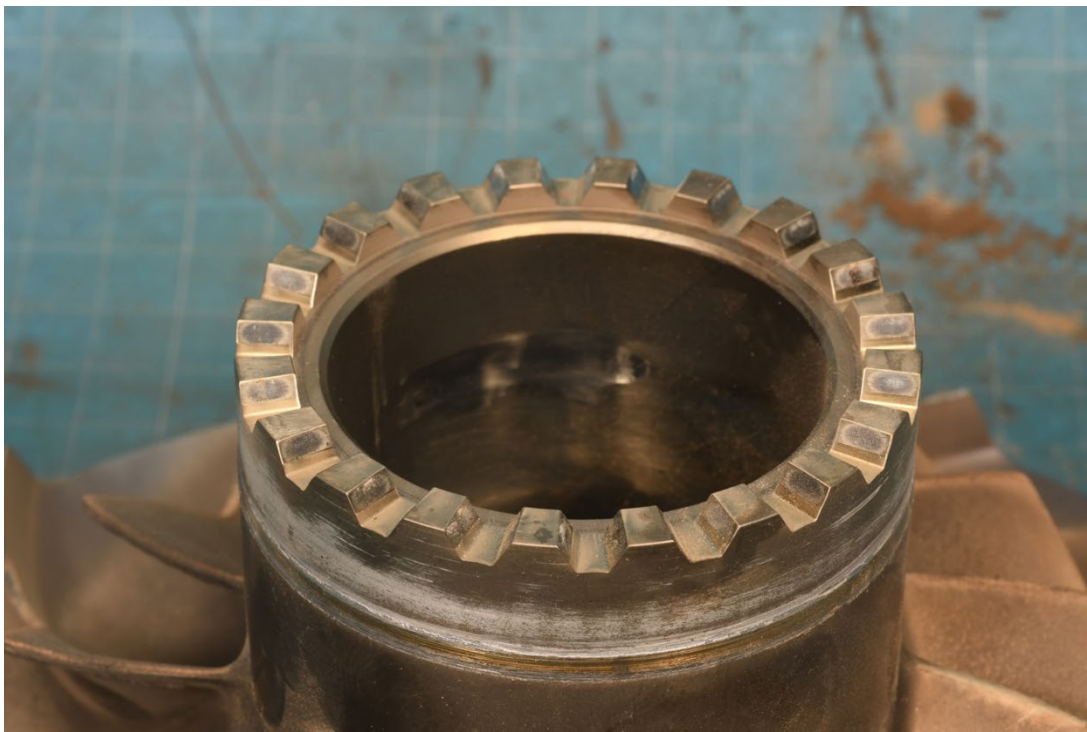
The 2<sup>nd</sup> stage compressor impeller blades were all complete (**Photo 61**). The impeller blades tips had tip rub from the inducer to the knee and at the exducer. The impeller had 360 degree rotational scoring on the hub aft of the forward curvic (**Photo 62**). The main shaft was intact and did not appear bent/deformed. The 2<sup>nd</sup> stage impeller shroud had 360 degree rotational scoring at the exducer and light rotational scoring from the inducer to the knee (**Photo 63**).

Photo 62- 2<sup>nd</sup> Stage Compressor Impeller Hub Rotational Scoring

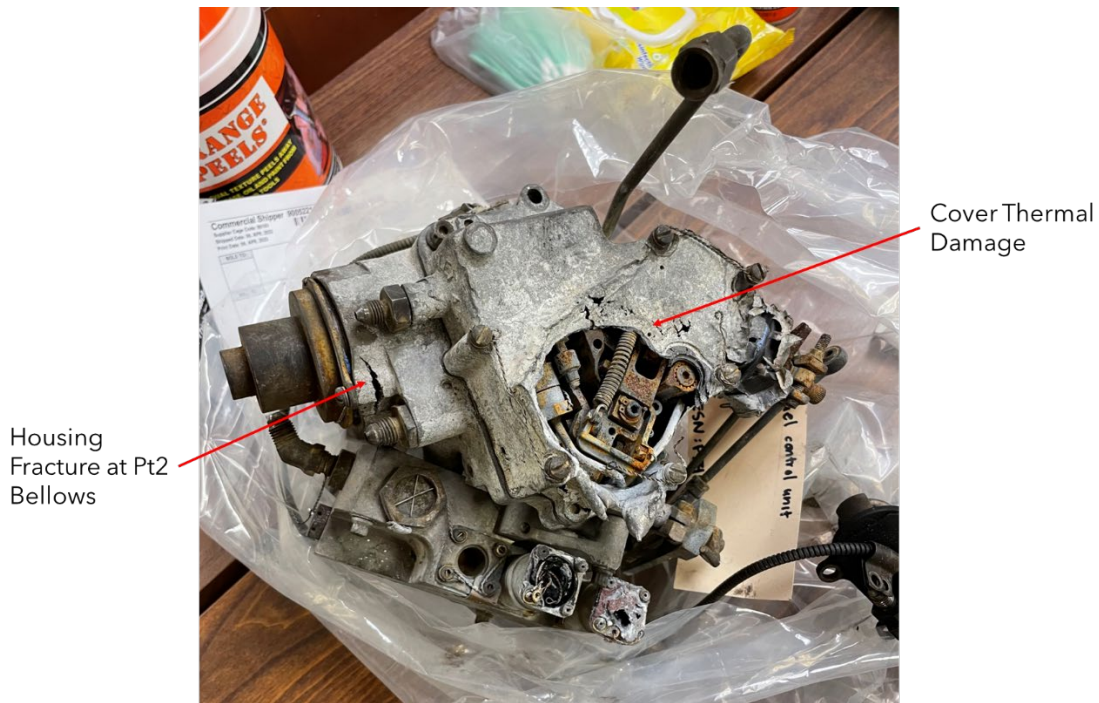
All external surfaces were discolored and covered in soot. A section of the FCU cover was melted and missing, exposing the internal mechanical linkages. The FCU housing was fractured next to the Pt2 (inlet total pressure) bellows assembly (**Photo 64**). The FCU driveshaft could not be rotated by hand but turned with resistance when a mating drive spline tool was used. The FCU could not be bench tested due to thermal and mechanical damage. The FCU was fully disassembled, and internal components all exhibited thermal damage but there was no evidence of pre-impact failure. The Woodward shop report is available in the investigation docket as "Attachment 4- Woodward Fuel Control Unit, Serial Number 905139, Investigation Report."

Photo 64- FCU, as Received at Woodward
