ERA22FA086

Group Chair's Factual Report - Attachment # 3

Honeywell Materials Laboratory Report, Engine Serial Number, P54128

Conduct investigation of the separated turbine blade, Blade 1, from the 1<sup>st</sup> stage rotor assembly P/N 3107080-1, S/N 3-03501-1120.

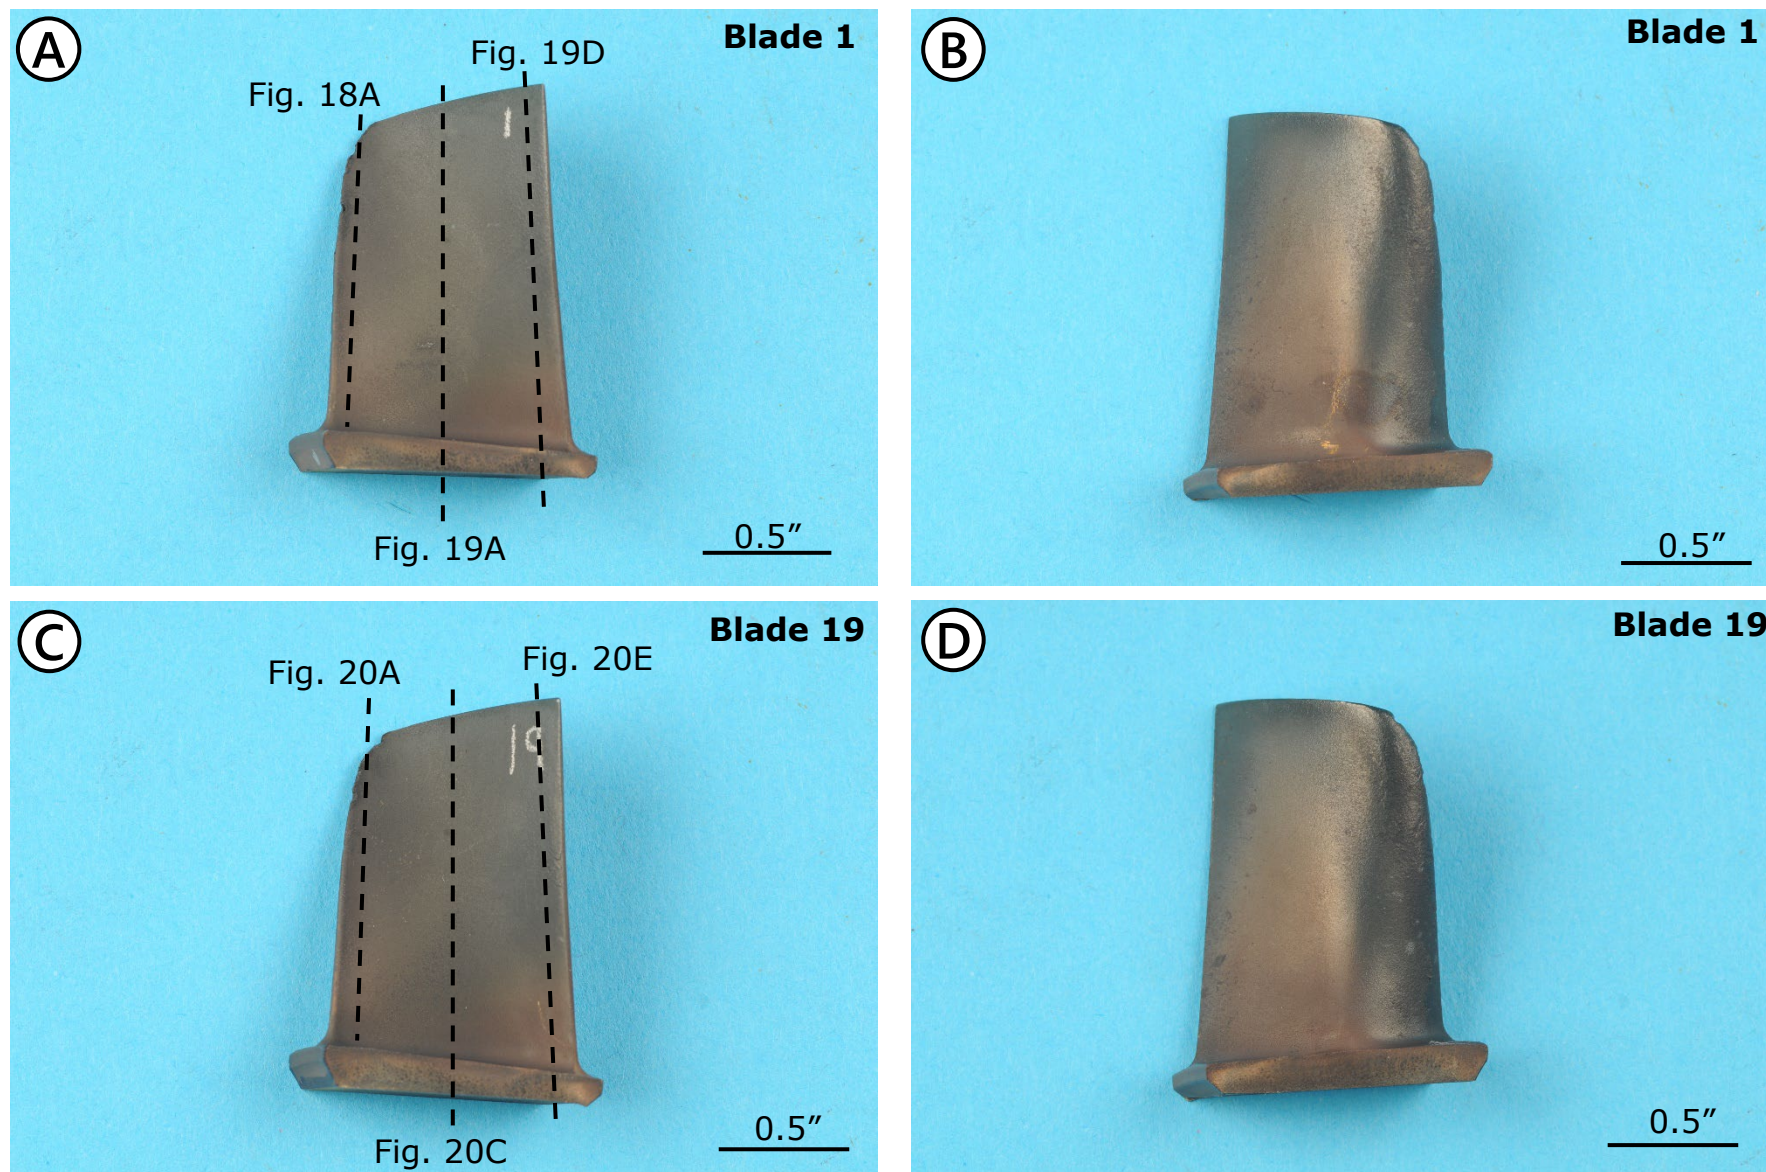
**Figure 16.**

Close-up images of the (A-B) forward and (C-D) aft sides of the 2<sup>nd</sup> stage turbine rotor. No blade separations were observed. Damage was observed on the leading edges of the blades near the tips (yellow arrows in (A-B)).
