## Robinson Helicopter Company Accident Report

| AIRCRAFT MODEL: | <u>R44 Raven II</u> |
| REGISTRATION: | <u>N544SC</u> |
| NTSB IDENTIFICATION: | <u>ERA22FA096</u> |

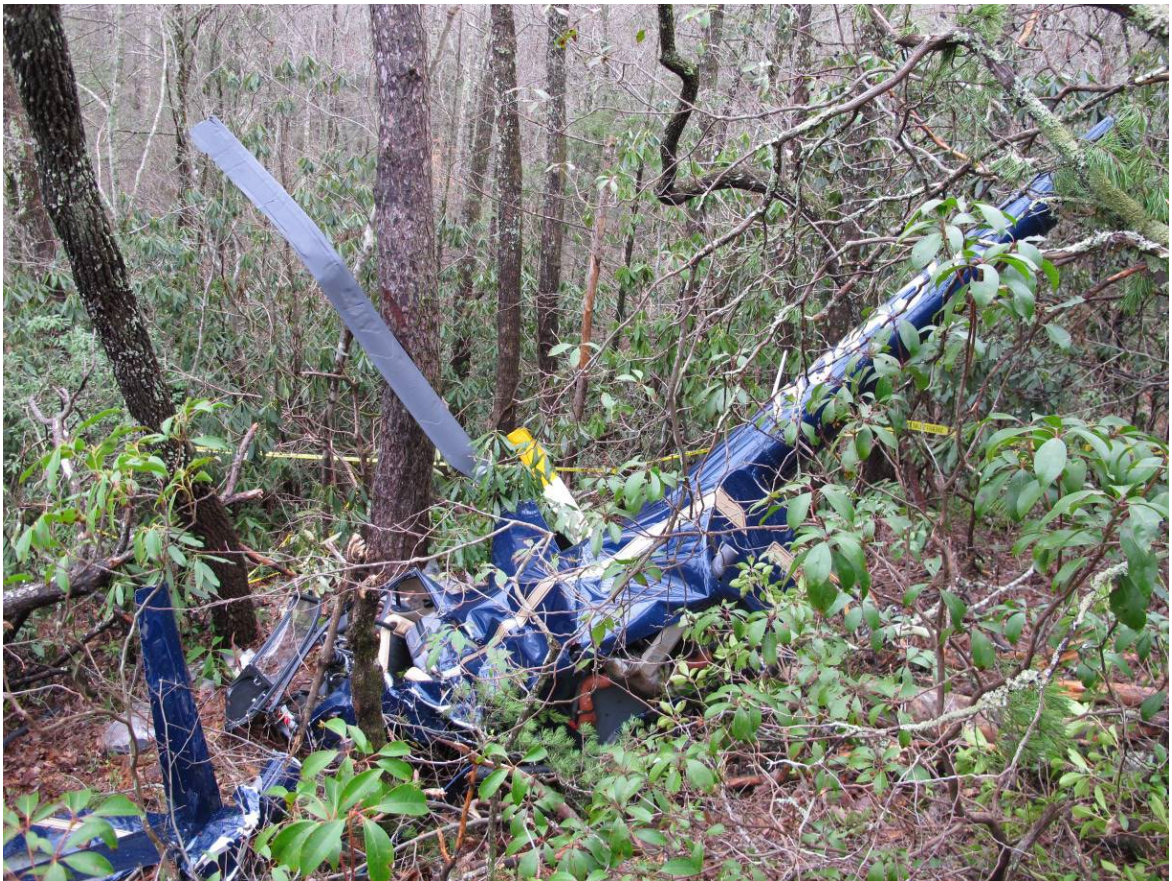
Accident location looking west.

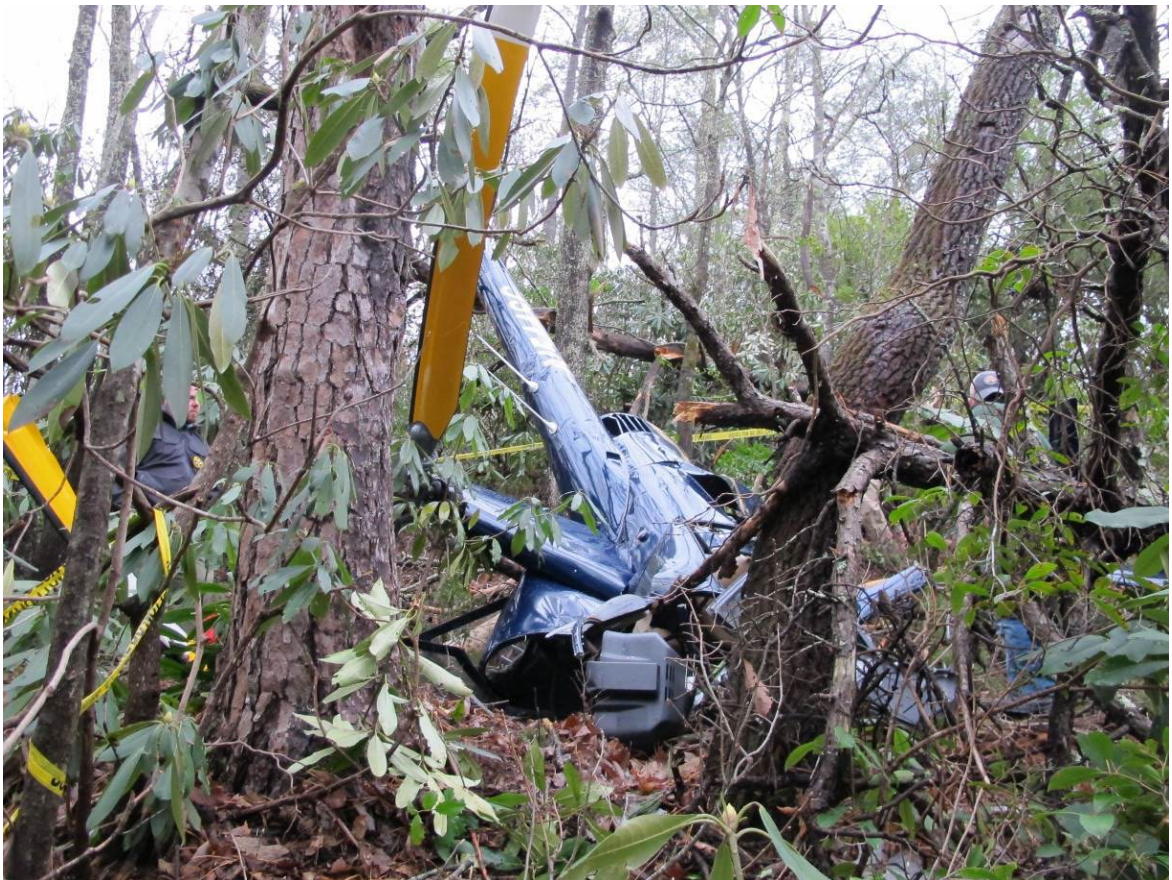
Accident location looking north.

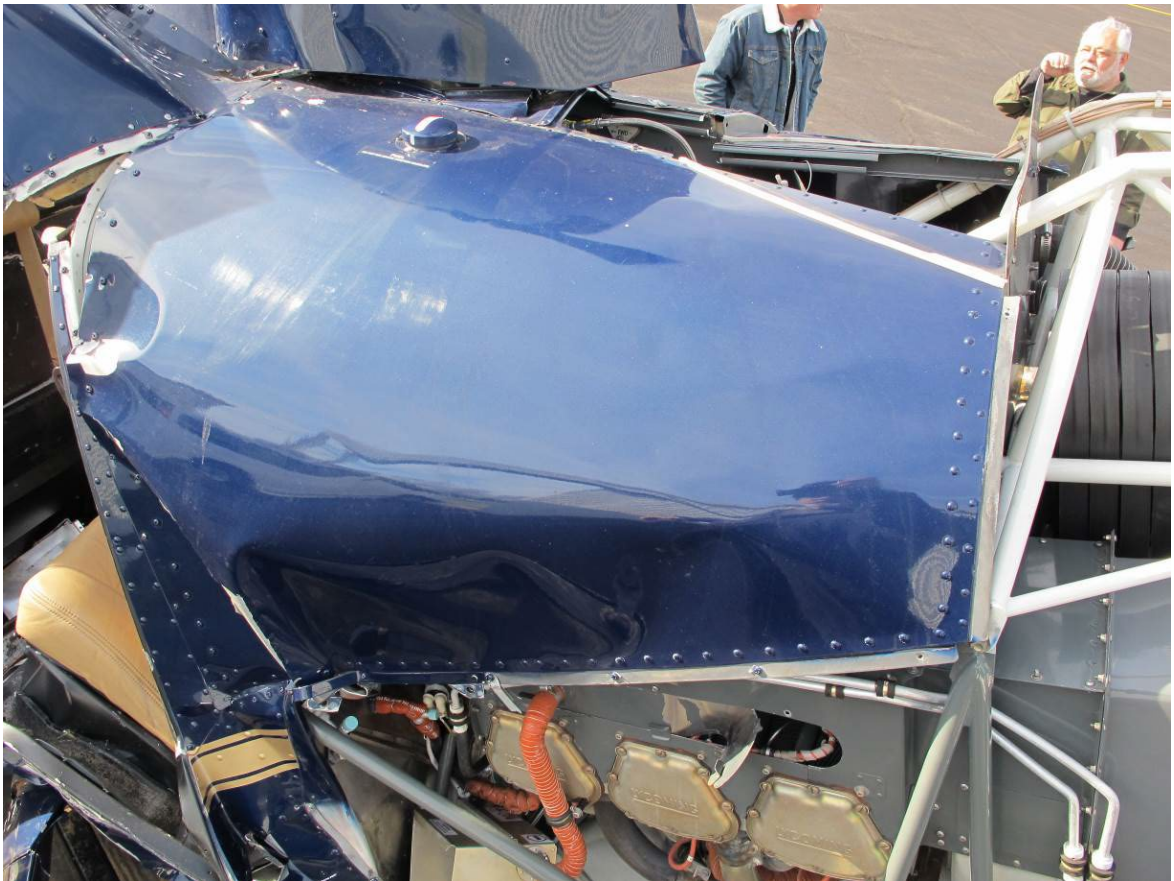
The main fuel tank sustained impact damage to the forward end of the outer shell, but the bladder was not compromised. The filler cap remained secure on the filler neck. The main fuel tank appeared to be half full of 100LL aviation fuel, blue in color with proper aroma. No water was present in the sample taken.

Main fuel tank.

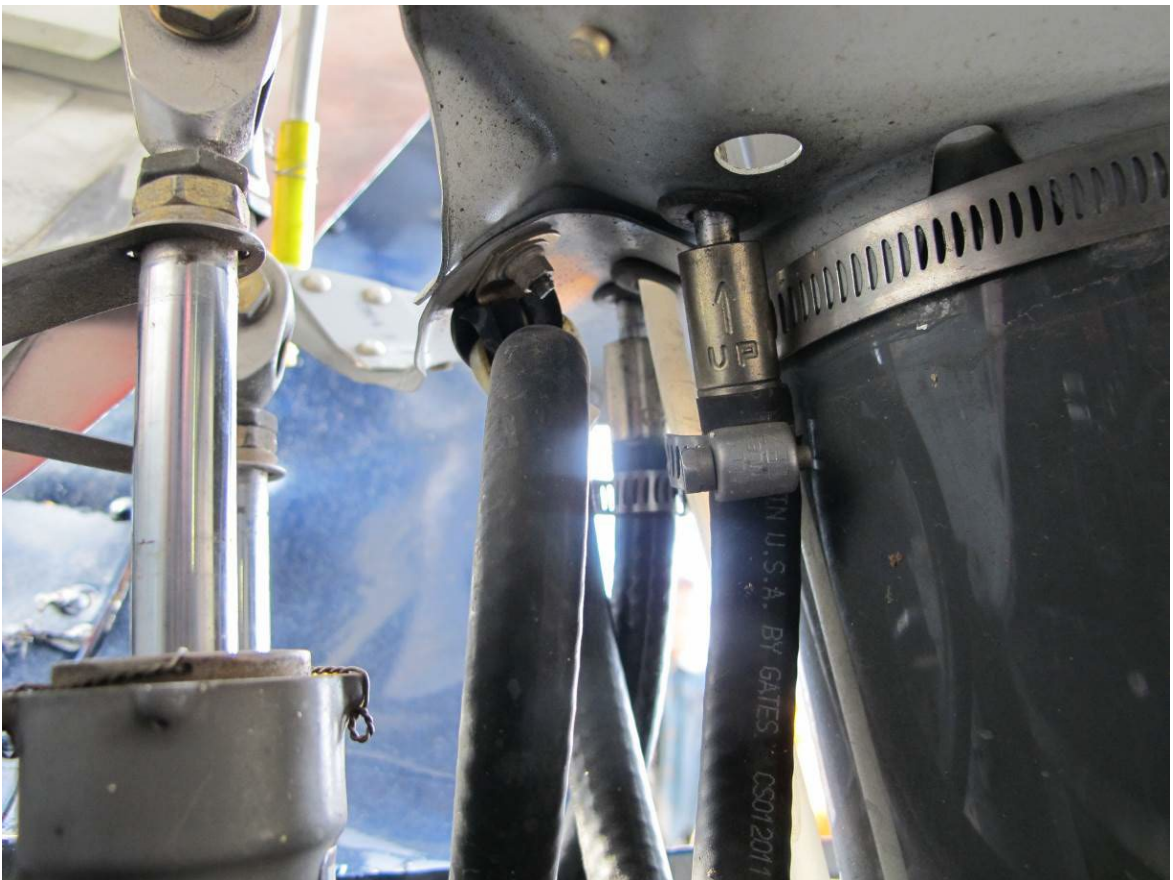
The fuel tank vent tubes were separated from the rollover valves. The tubes and hoses were clear when blown through. The rollover valves operated properly.

Fuel vent system rollover valves.

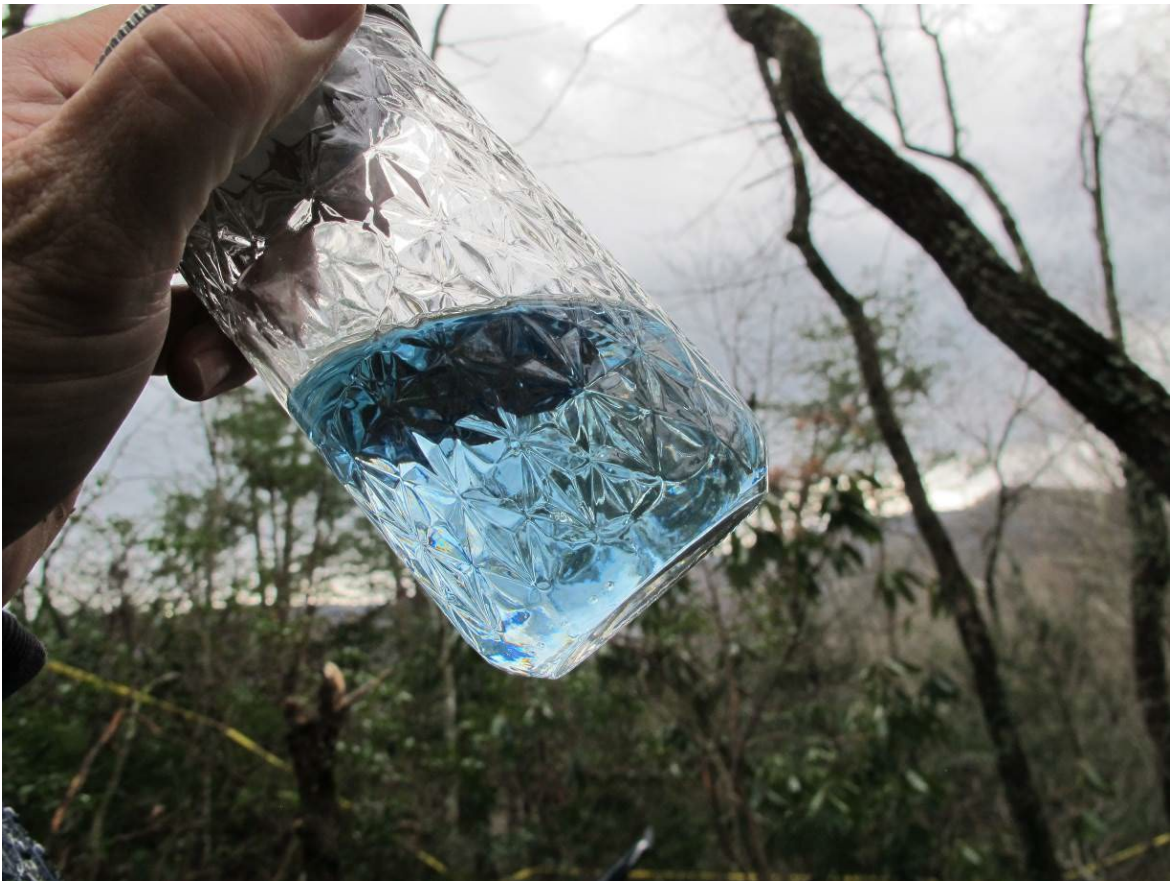
Fuel sample from main fuel tank.

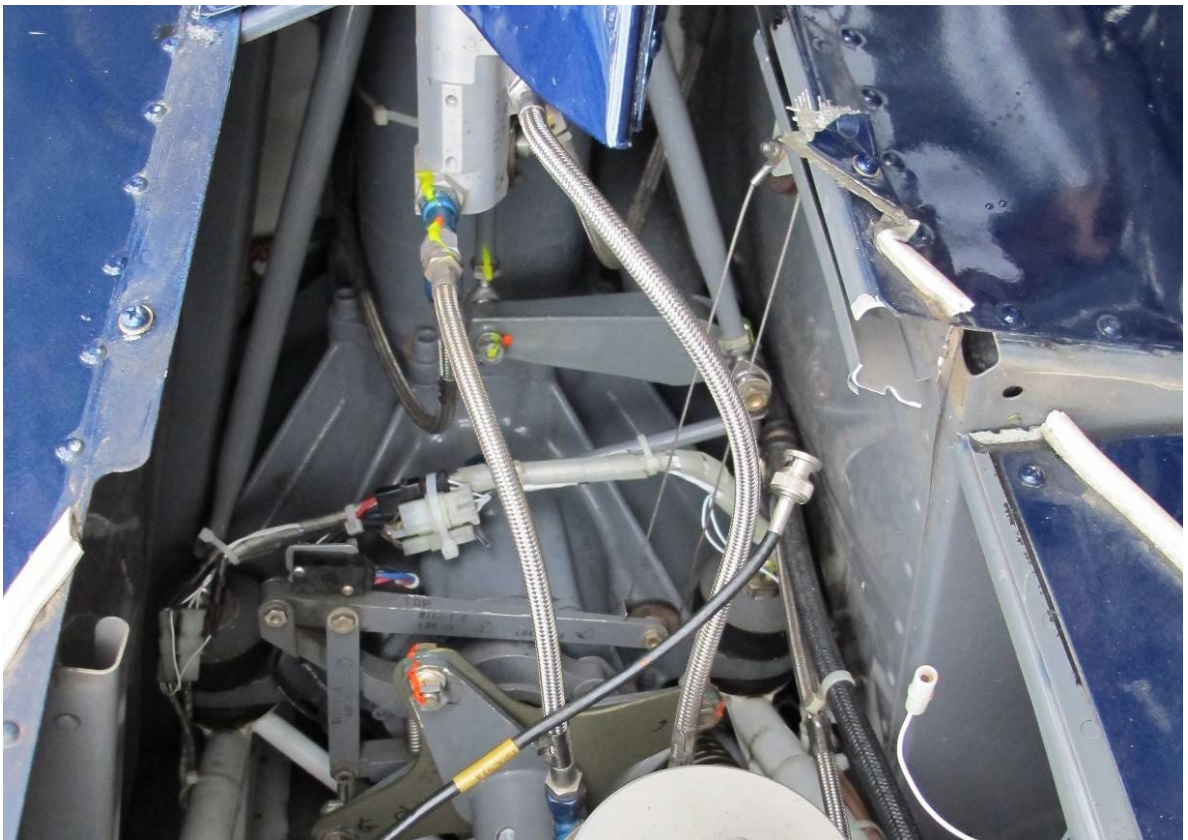
Forward flex coupling.

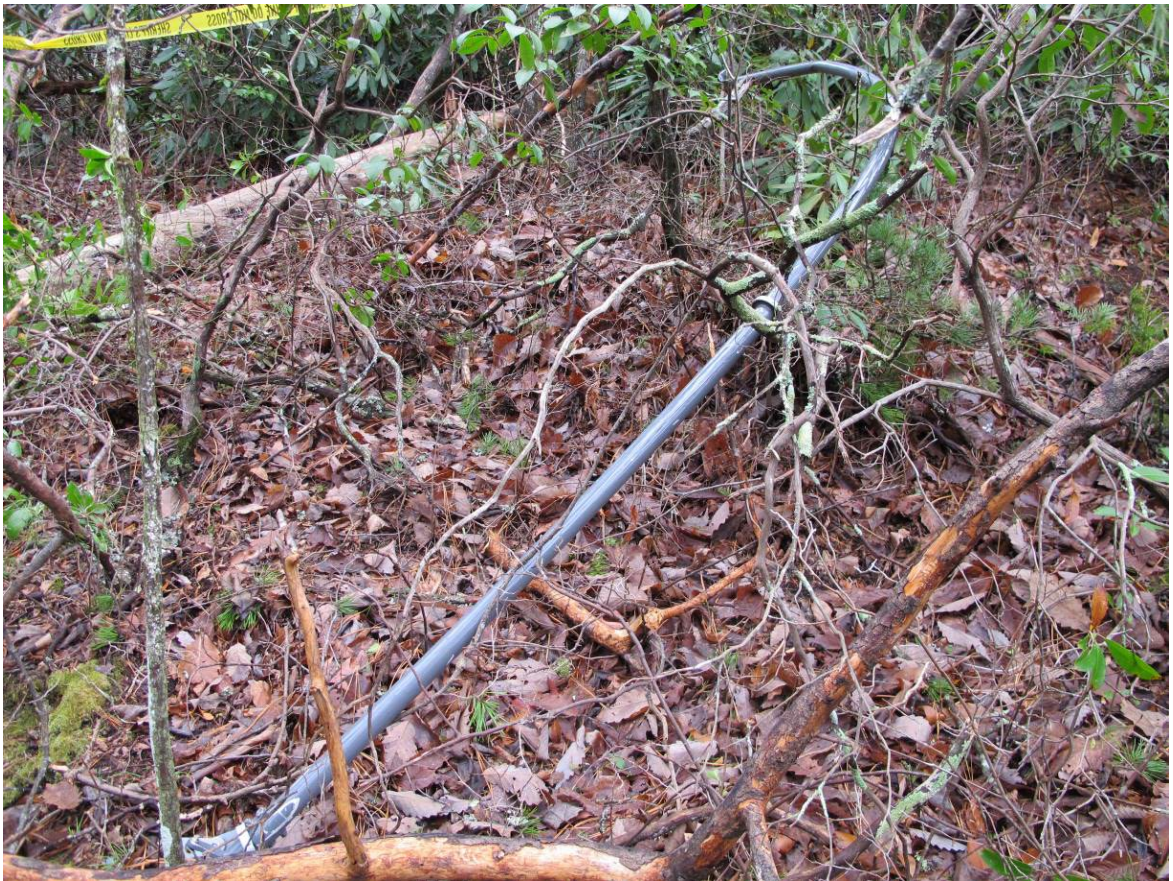
Above and below: Disconnect in intermediate flex coupling.

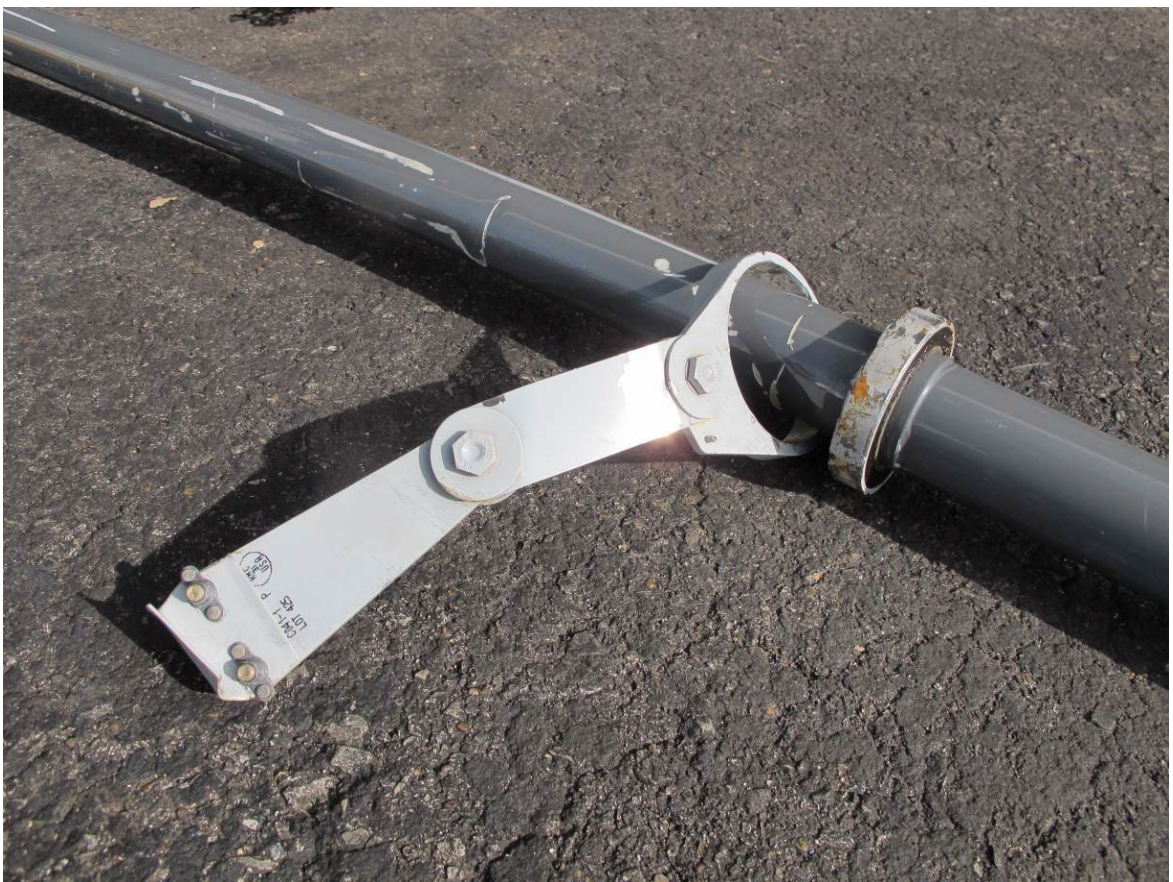
Forward section of tail rotor driveshaft.

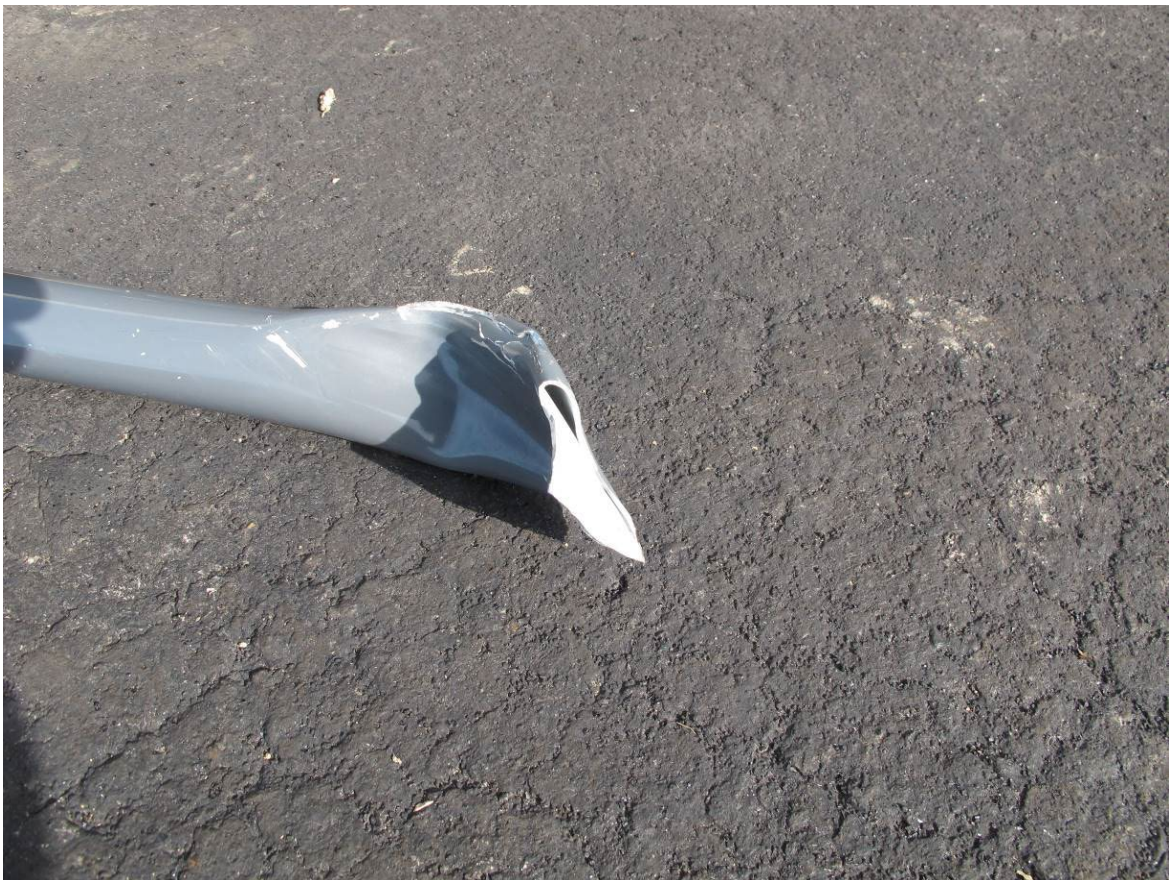
Aft section of tail rotor driveshaft.

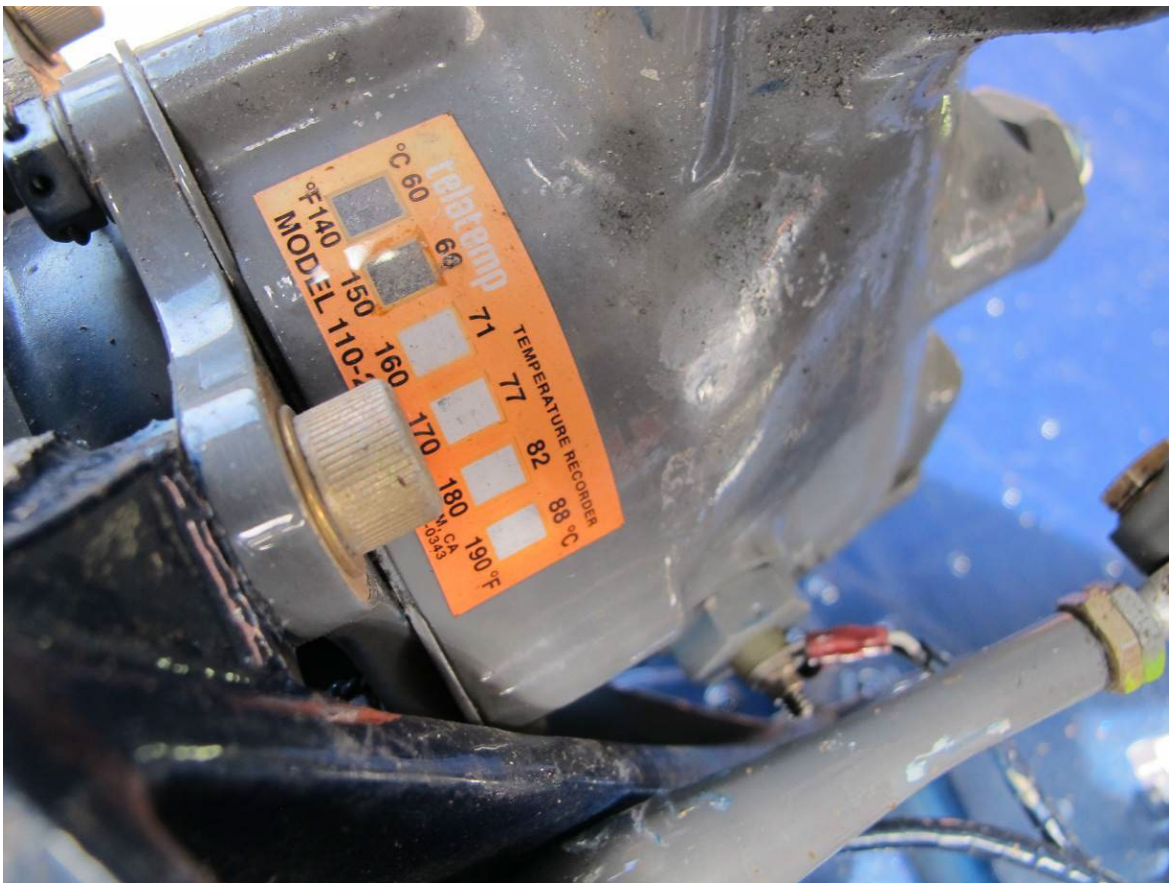
The tail rotor gearbox mounting flanges bolts were secure, but one of the flanges was disconnected and one was bent coinciding with damage to the bulkhead casting. The surface of the disconnects were angular, jagged, and flat gray in color. The input yoke rotated smoothly by hand more than 360° of the tail rotor with no anomalies confirming continuity throughout the gearbox. Oil, blue in color, was visible in the sight gauge. The chip detector was clear of any debris. The output shaft remained straight.

Tail rotor gearbox.

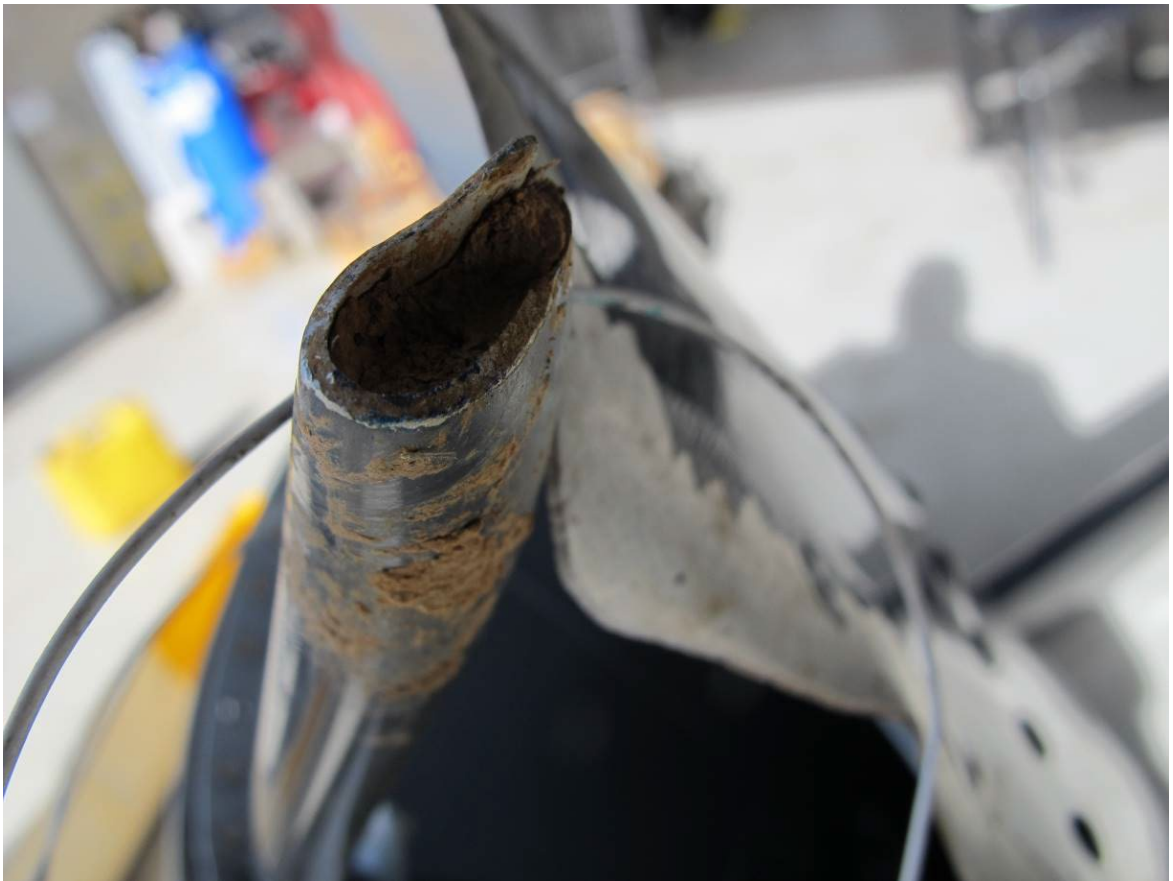
Disconnect TC in aft section of C121-17 push pull tube.

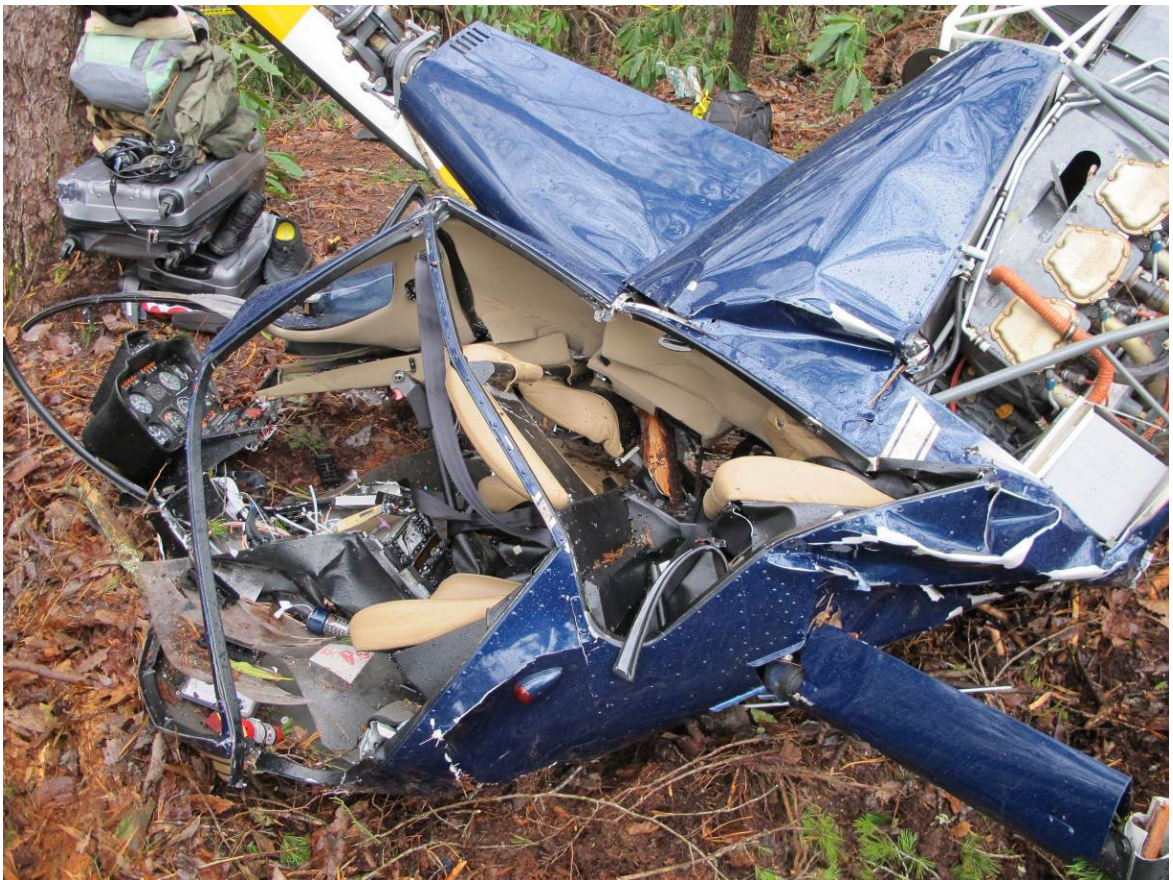
The fuselage and cowlings sustained impact damage with the belly and chin being deformed upward and aft. The door frames were distorted. Three doors remained attached to the cabin, the aft left door was separated. The windshields were shattered.

Left side door frame and cabin structure.

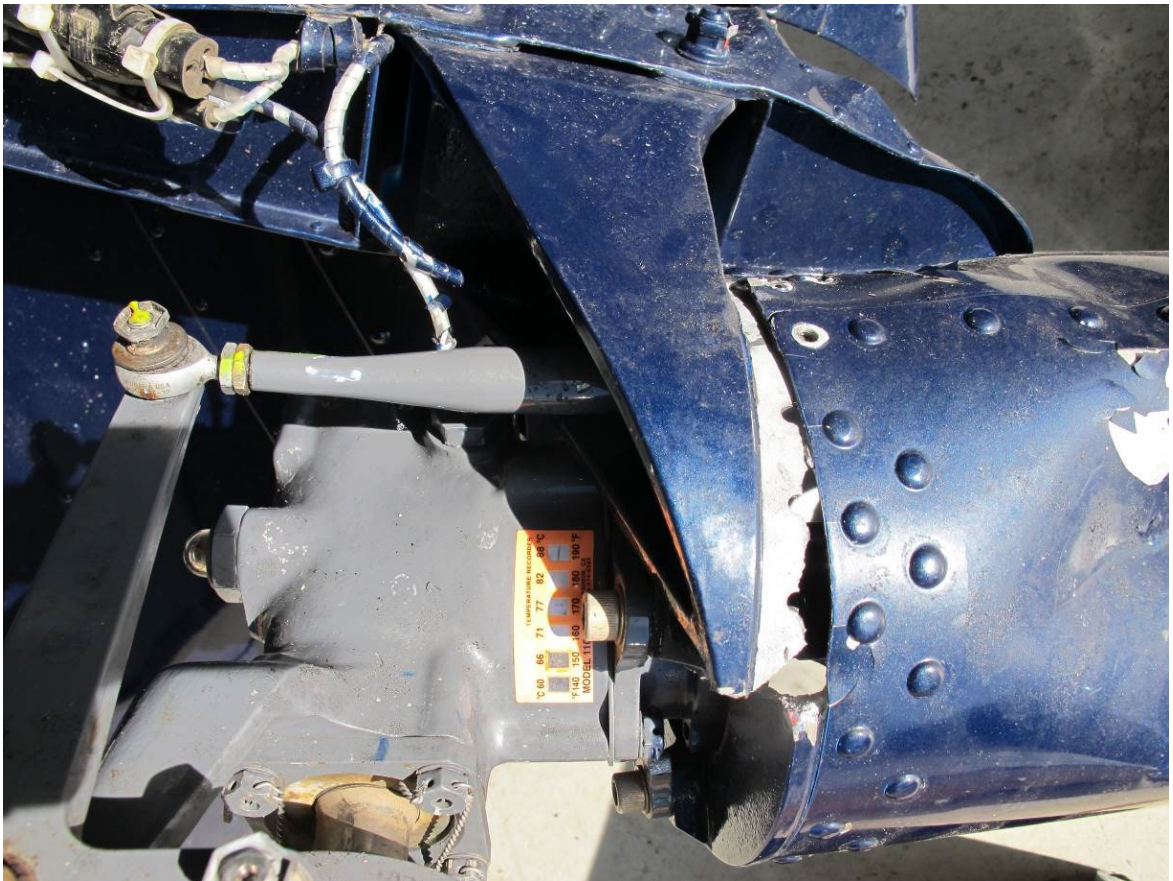
Separation between tailcone bay 7 and aft bulkhead casting.
