# National Transportation Safety Board

ERA22FA096

## **WRECKAGE EXAMINATION SUMMARY**

Location: Cosby, Tennessee  
Date: December 29, 2021  
Time: 1425 EST  
1925 UTC  
Helicopter: N544SC, Robinson Helicopter Company R-44 II

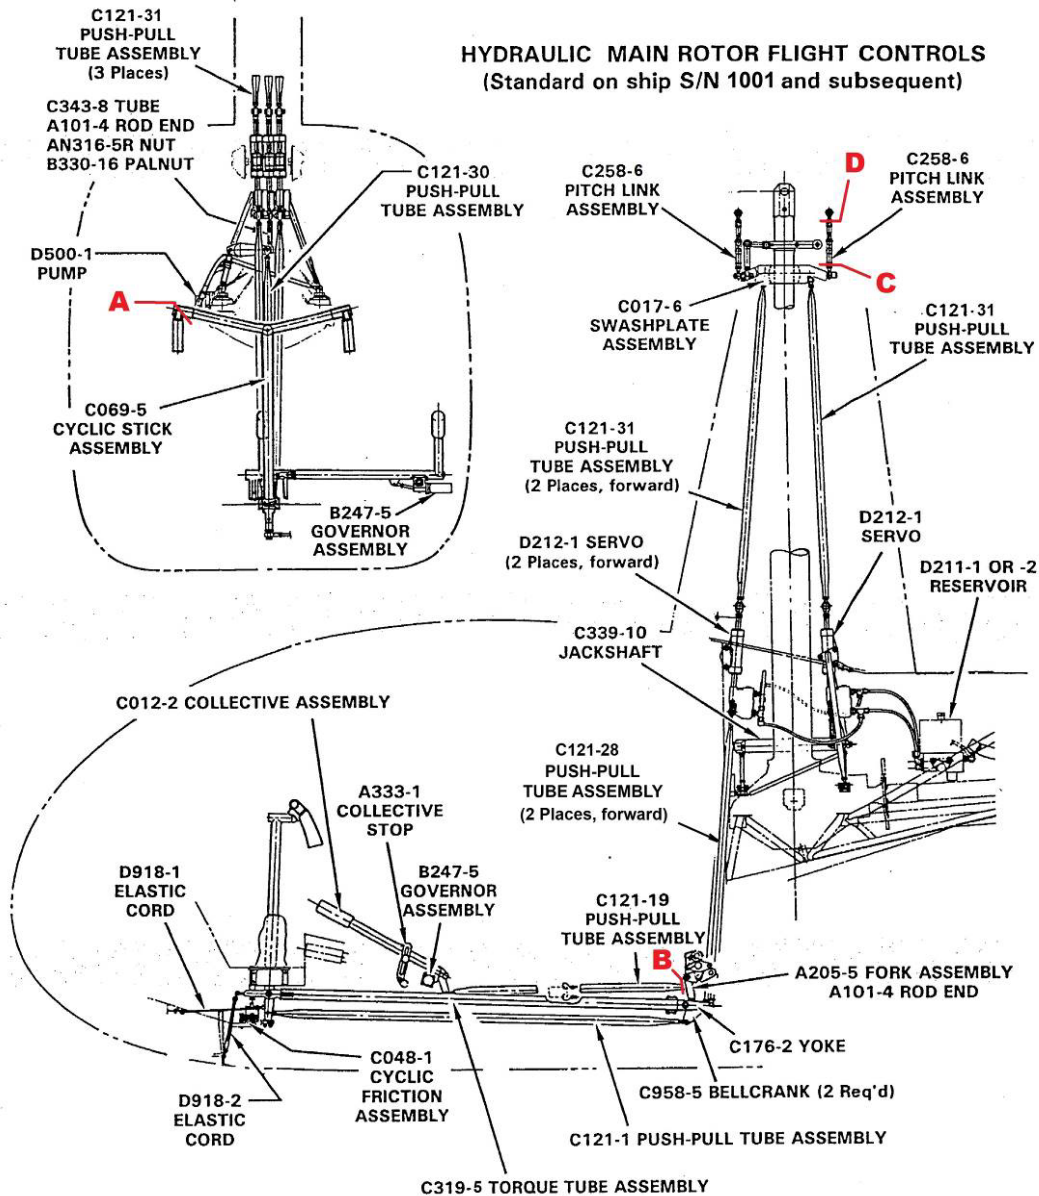
# TAIL ROTOR CONTROL SYSTEM

The flight control system had discontinuities at the locations indicated on the diagrams on pages 10 and 11. The disconnects are shown individually in the photographs that follow. No evidence of pre-impact failures of the flight control system was found. The center section of pitch link between disconnects C and D was not recovered.
