# NATIONAL TRANSPORTATION SAFETY BOARD

## Onboard Image Recorder

### Specialist's Factual Report By Sean Payne

Location: Crosby, TN  
Date: December 29, 2021  
Helicopter: Robinson R-44 II, N544SC  
Operator: Private  
NTSB Number: ERA22FA096

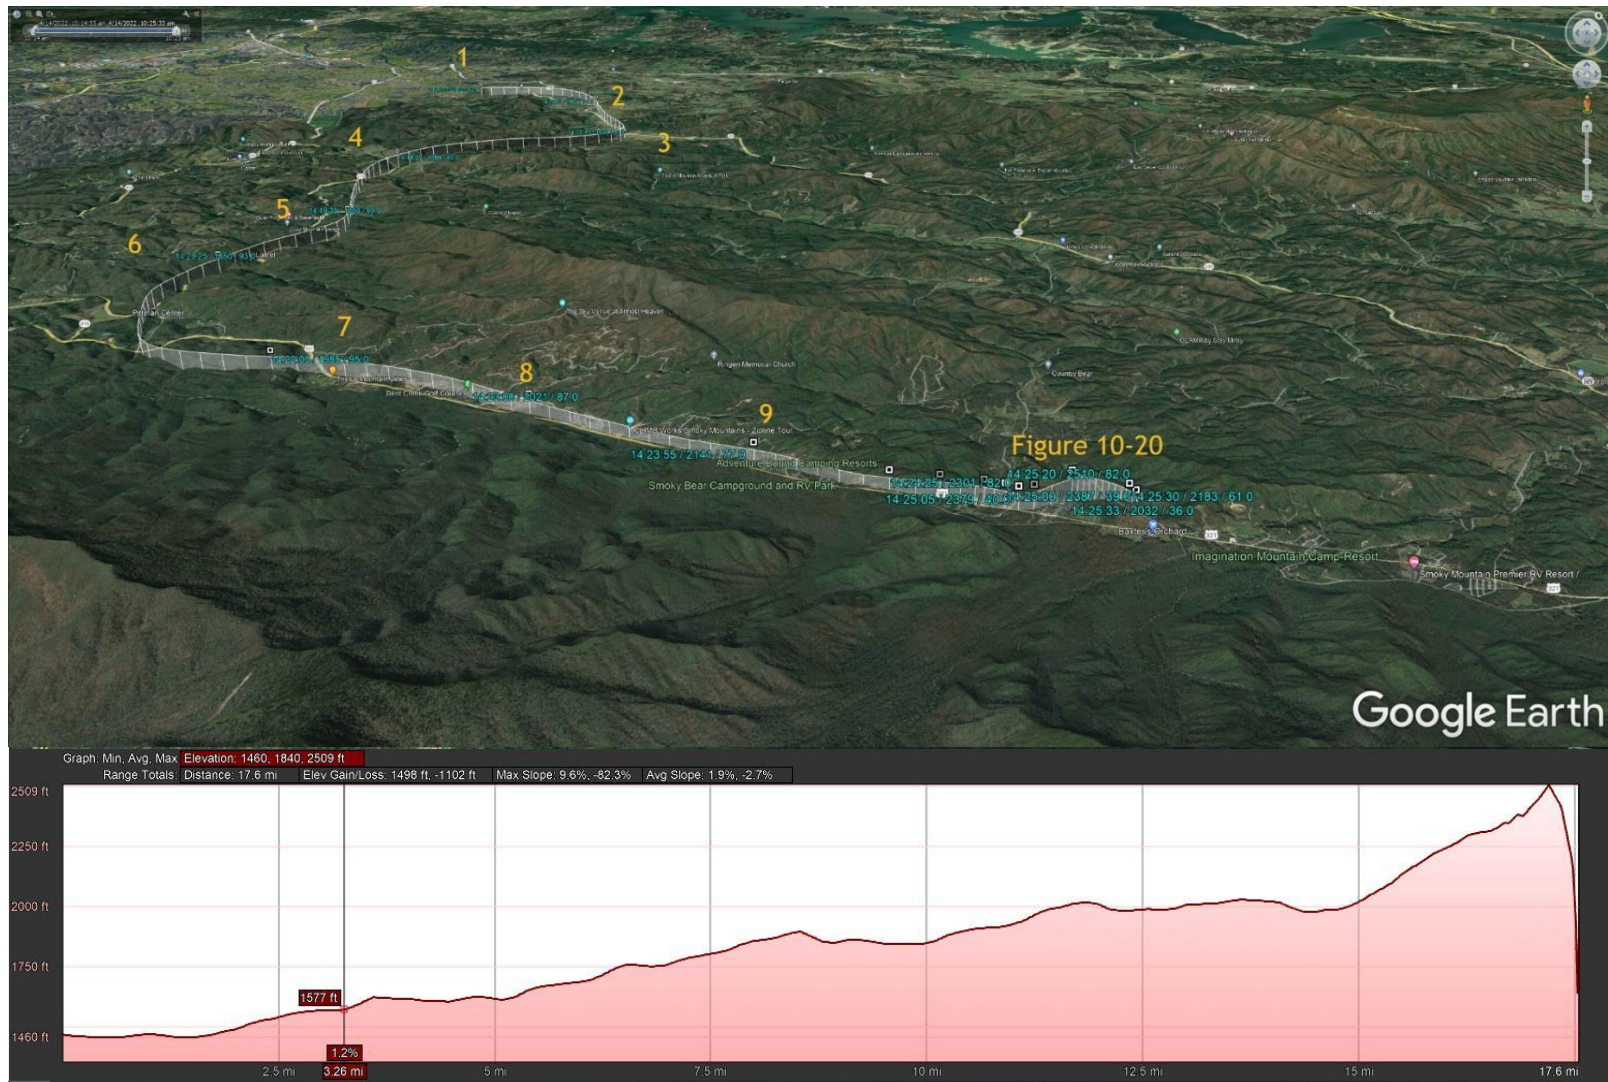
Figure 21 is a KML constructed of the helicopter’s flightpath from the available GoPro data. The KML presenting the flightpath is overlaid on Google Earth. Note the weather depiction on Google Earth does not depict the weather and lighting

conditions at the time of the accident. Under the depiction of the helicopter's groundtrack data, is the helicopter's elevation data as presented in Google Earth. The data used to generate the figure is attached as attachment 1 to this report.

**Figure 21.** The helicopter's groundtrack created from the GoPro's metadata. Figure numbers associated with this report have been added for reference. The helicopter's altitude history is also presented as represented in Google Earth. The altitude is presented in feet MSL.

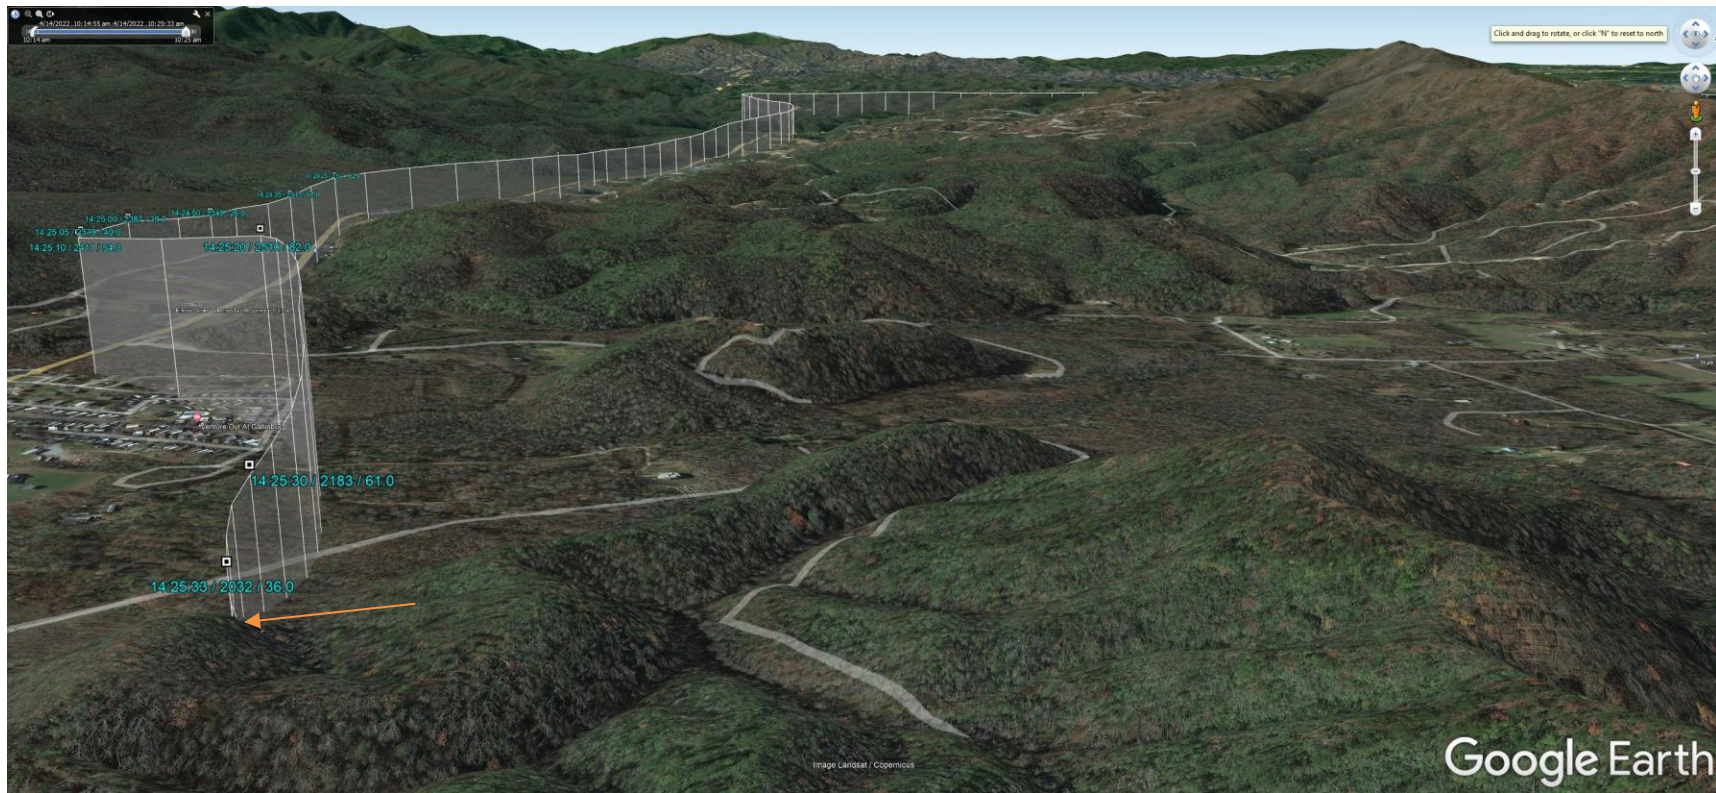
Figure 22 is a Google Earth presentation of the final recoded tracklog points from the GoPro metadata. An arrow has been added to show the vicinity of the wreckage.

**Figure 22.** The helicopter's groundtrack created from the GoPro's metadata. This figure shows the last recorded points leading up to the impact with terrain. An arrow has been added to show the vicinity of the wreckage.

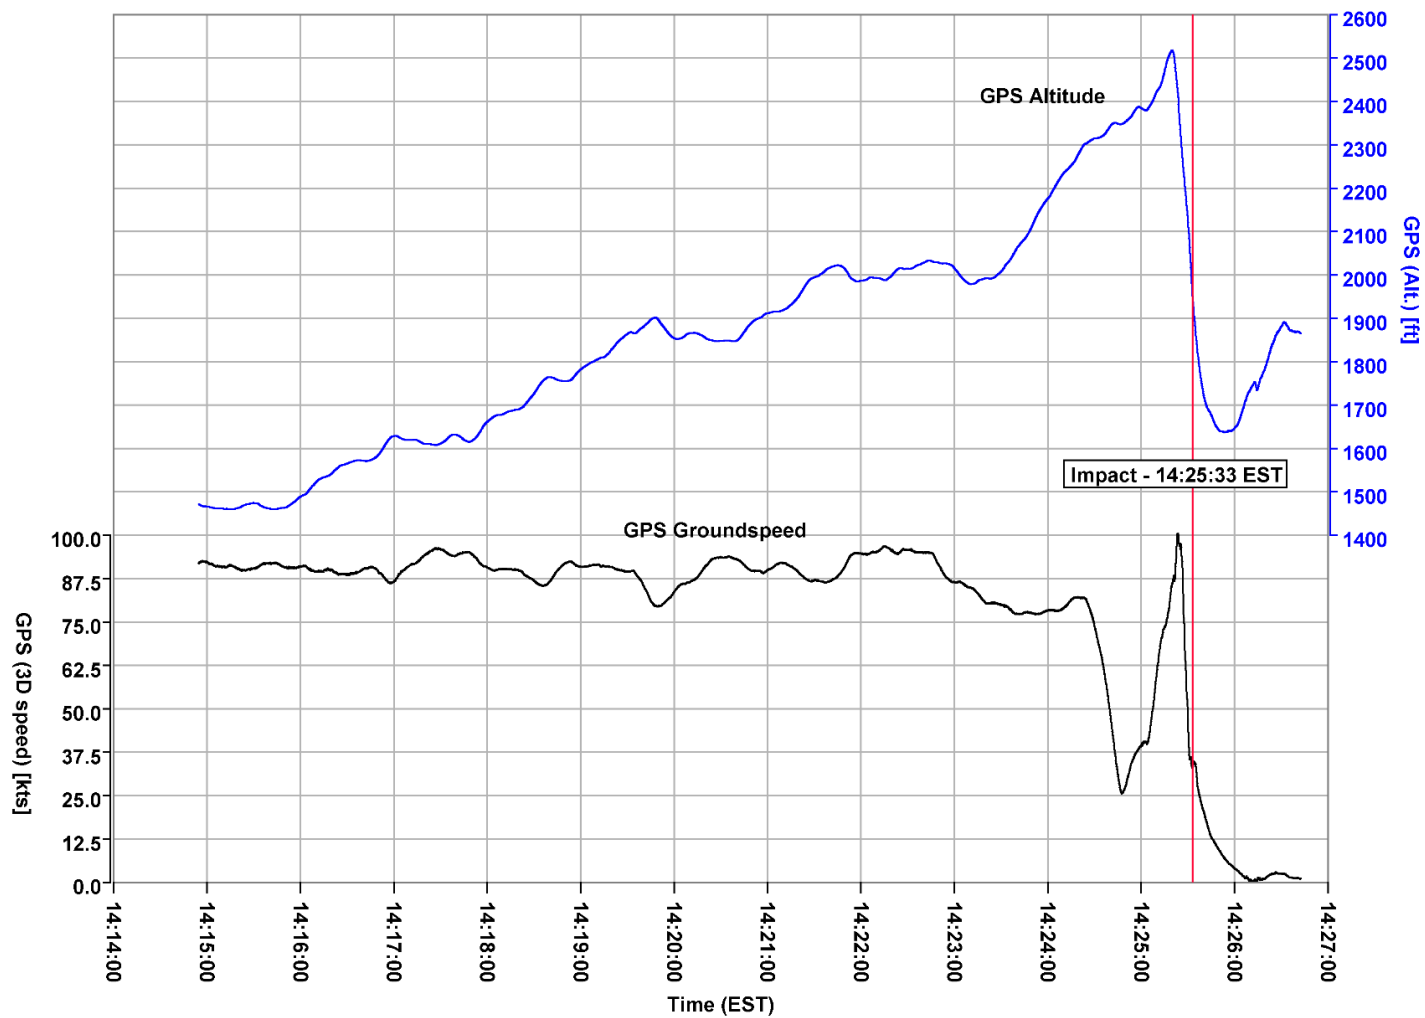
Figure 23 is a plot of the helicopter's altitude, groundspeed and groundtrack. The data is from the GoPro. The time interval has been set to illustrate the entire accident recording. The red line indicates the time at which the helicopter impacted terrain, the GoPro continued to operate and collect metadata although the helicopter had crashed.

**Figure 23.** A plot of GoPro metadata providing GPS altitude and GPS derived groundspeed. Red line indicates the time at which the helicopter impacted terrain.
