# NATIONAL TRANSPORTATION SAFETY BOARD

## MATERIALS LABORATORY FACTUAL REPORT

Report No. 22-063

Place : Danville, VA  
Date : 2/1/2022  
Vehicle : Cessna 310R, N622QT  
NTSB No. : ERA22FA114  
Investigator : Lynn Spencer

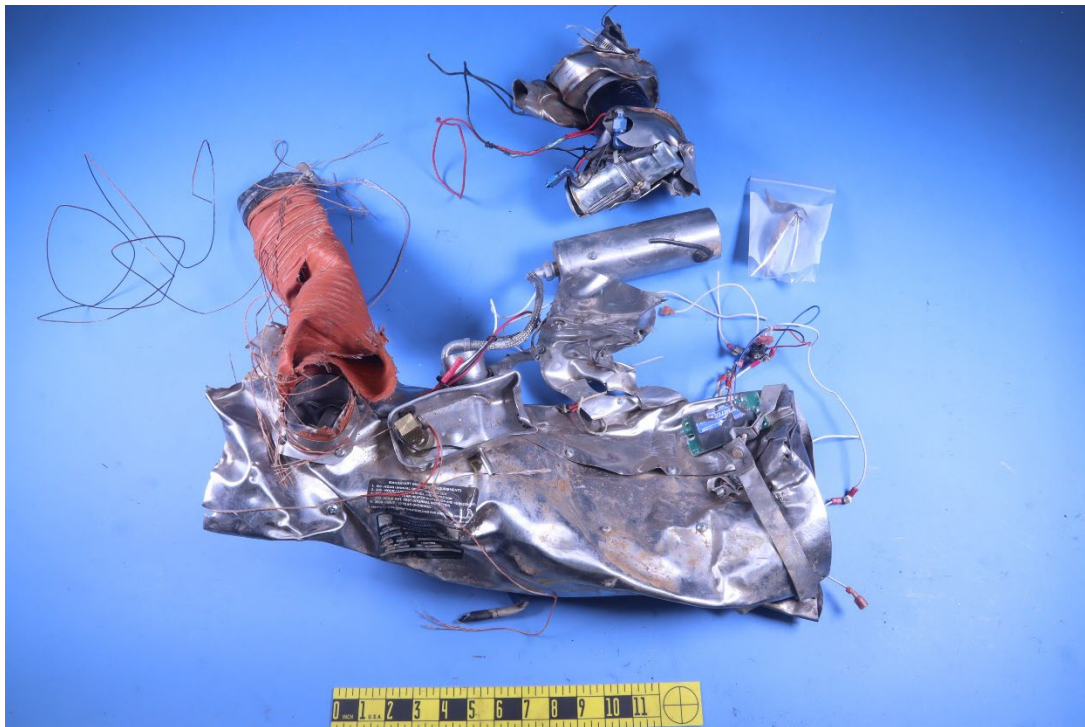
Hartzell combustion heater assembly (Figure 1).

The aircraft heater assembly was a Hartzell model CD45K (P/N:CD14073-1). The heater assembly had sustained impact damage from the crash and exhibited deformation of the outer casing, heat exchanger and combustor chamber sections as well as separation of some of the external accessories. The combustion air blower and fuel pump accessories had separated from the heater assembly. The ignition coil had separated from the heater assembly and was only attached by the ignition cable. The heater assembly did not exhibit any external fire or thermal damage. The remaining external accessories, hoses and wires were removed for the disassembly process.

Figure 1: Parts as received.

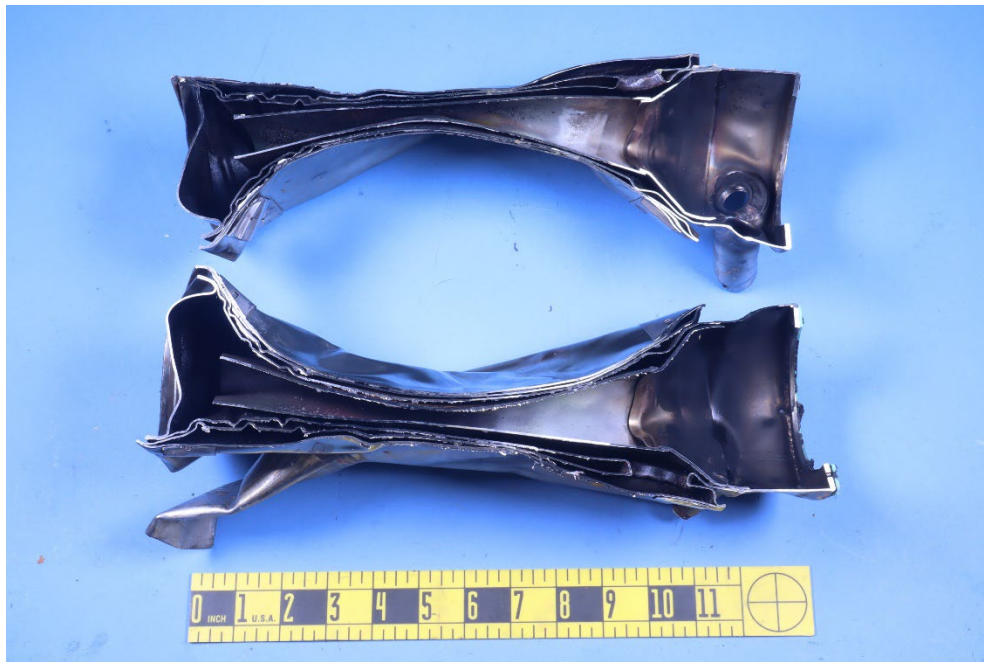
the combustor portion of the heater. The heat exchanger and combustor assembly was sectioned to facilitate examination of the interior surfaces and crossover ports between the interior hot section and the outer hot section. First a longitudinal section was made splitting the heat exchanger and combustor assembly in half (Figure 5). Additional, perpendicular sections were made at the ends of both halves of the heat exchanger and combustor assembly to allow the individual layers of the assembly to be examined (Figures 6, 7). Examination of the layers of the heat exchanger did not reveal any defects or failure of the materials that would allow combustion products to intermix with the ventilation air. The weld seam of the end cap of the interior hot section was intact with no evidence of any cracking (Figure 8). The weld seam of the outer hot section layers was intact with no evidence of any cracking (Figure 9).

Figure 5: Heat exchanger and combustor assembly sectioned.

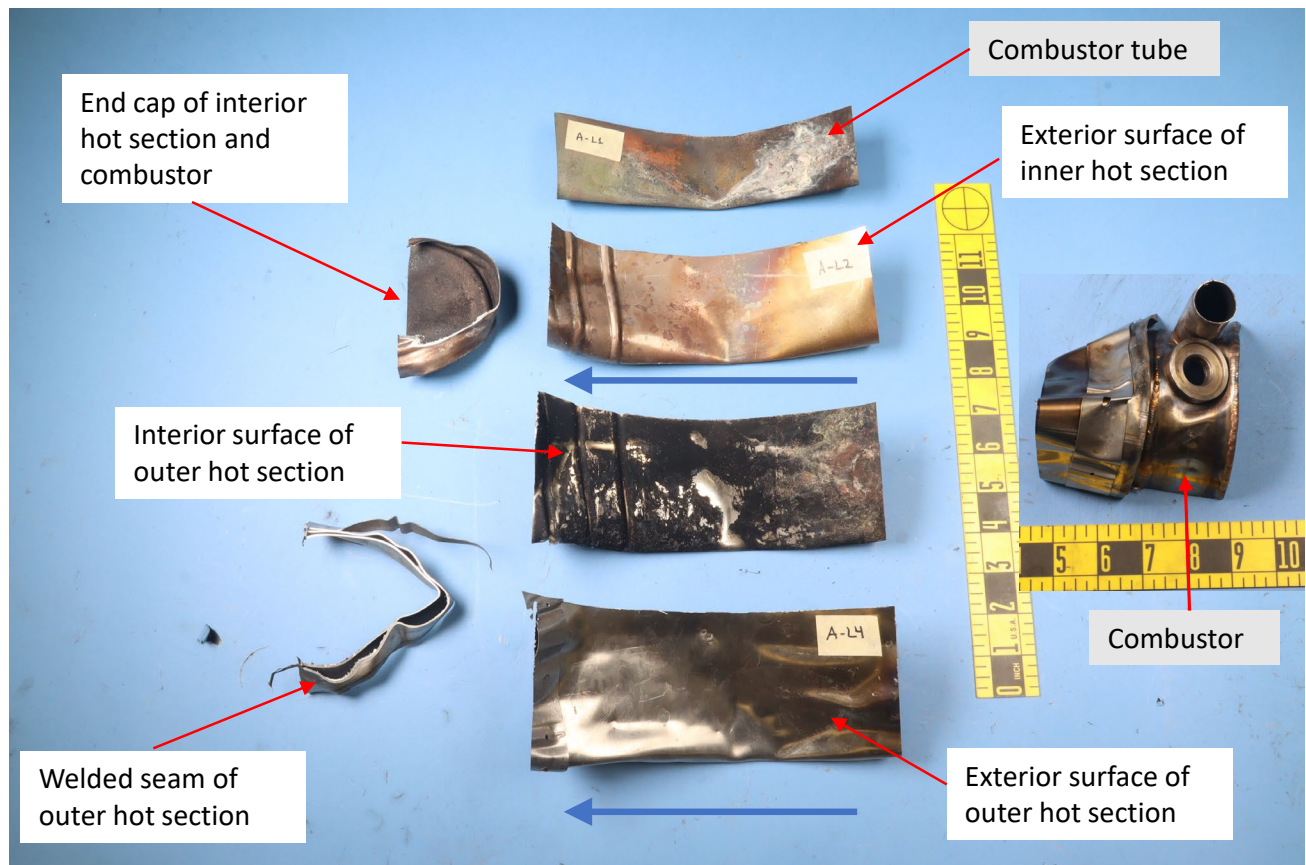
Figure 6: Disassembly of heat exchanger and combustor assembly layers. Blue arrows indicate ventilation air paths.

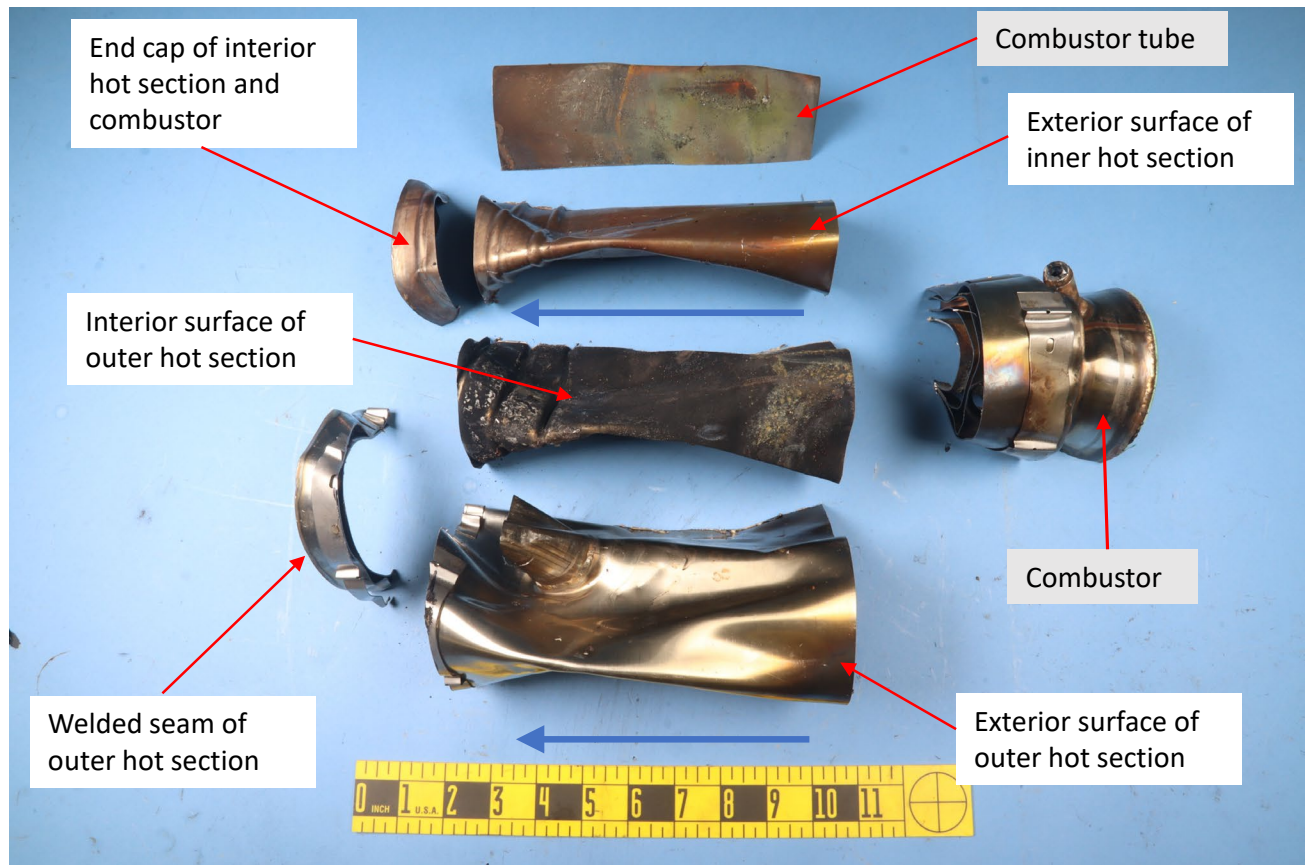
Figure 7: Disassembly of heat exchanger and combustor assembly layers. Blue arrows indicate ventilation air paths.
