# National Transportation Safety Board

ERA22FA114

## **AIRPLANE PERFORMANCE STUDY**

Location: Danville, Virginia  
Date: February 1, 2022  
Time: 1006 EST  
1506 GMT  
Airplane: Cessna 310R, N622QT

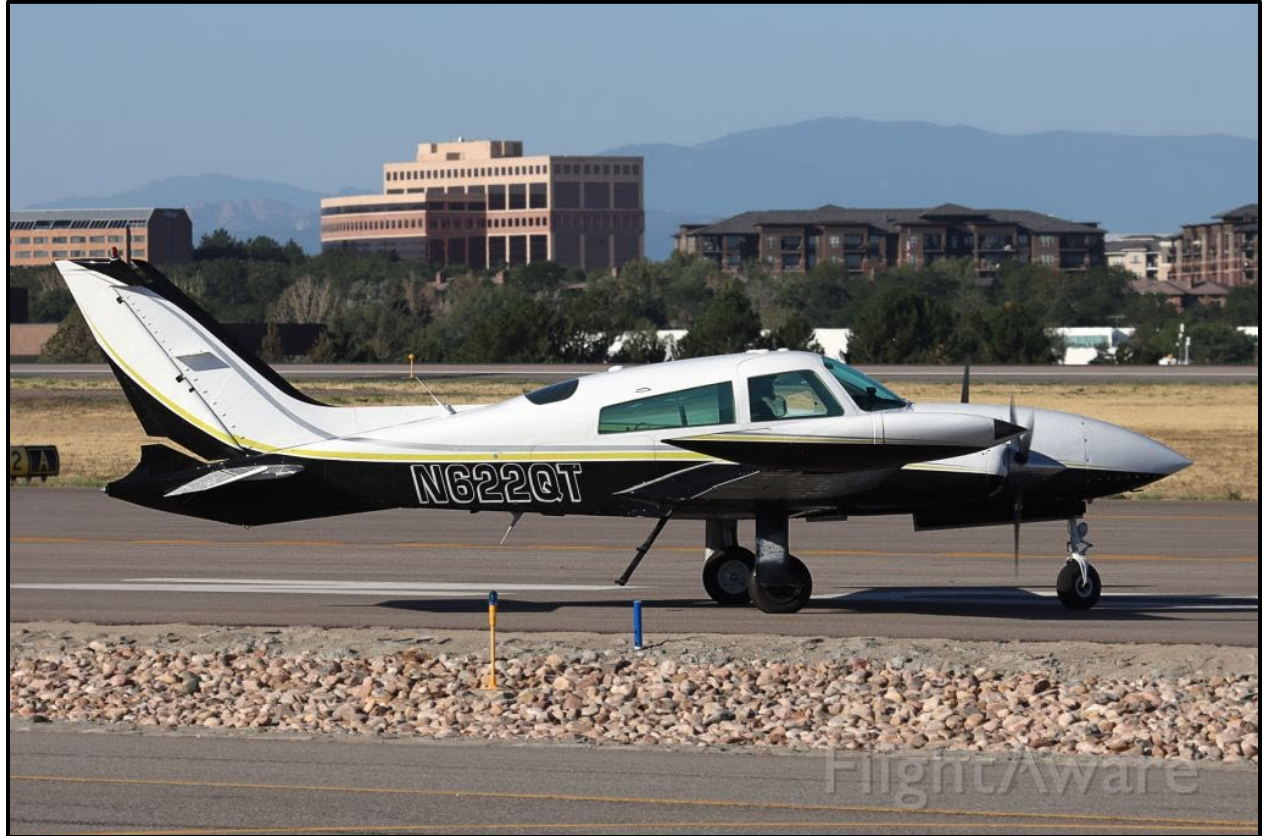
A picture of the accident airplane, a Cessna 310R, is shown in Figure 1. The airplane was manufactured by Cessna in 1976 and is registered to Sol Aerial Surveys, LLC.

**Figure 1: Accident Airplane, N622QT, a Cessna 310R,  
Manufactured by Cessna in 1976**
