## MEMORANDUM OF RECORD

Exhaust CO Exposure Research

NTSB Accident Number: ERA22FA114

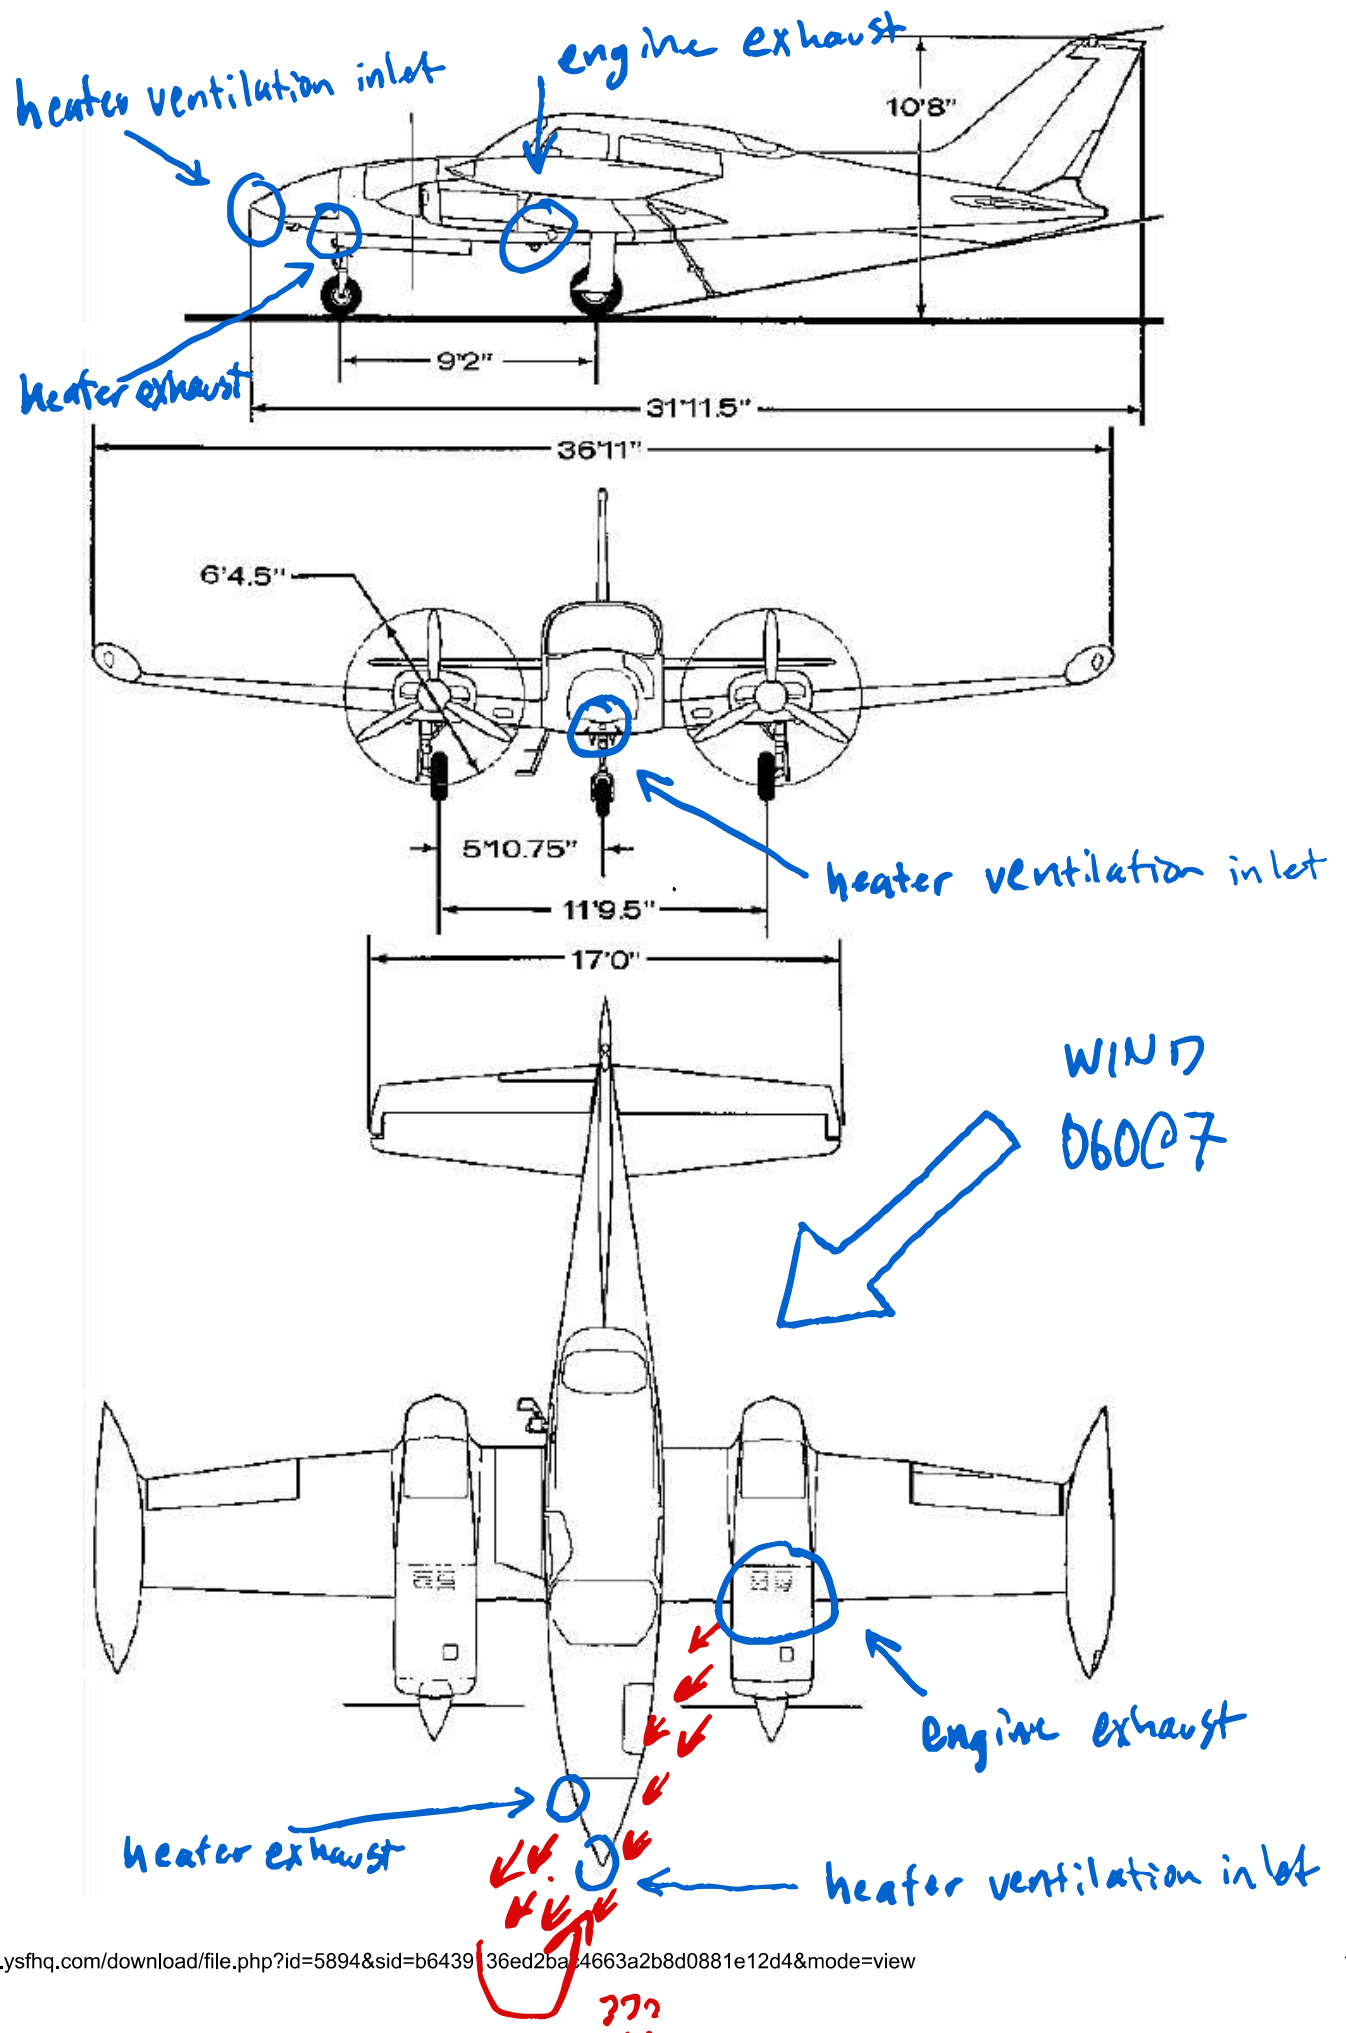
My startup and taxi time was "average". I taxied to runway 18 with the door cracked open and window open due to the heat that day. The heater was left off, including the fan. Neither were turned on. During the taxi, the electronic CO detector read "0" PPM the whole time. As I approached the run up area, I closed the door and window. Once I got to the run up area I angled, the airplane close to an East- NorthEast orientation to put the breeze off my right quartering tail based on the grass and other indicators. Almost immediately, I noticed the audible alarm on the CO detector going off. I looked over and could see the number on the CO detector rising

through the 50-60PPM range. I immediately grabbed my phone to take a video. As you'll see in the video, it quickly rose above 100 PPM within the 17 second video. At the time, I was unsure what level would be harmful to myself. For that reason, I shut the video off so I could focus on clearing the cabin air. The number eventually climbed up to around 150-160 before finally coming back down. There were very minor exhaust odors present during the high readings.

NOTE: If the heater had been turned on the day of the accident, when outside temperatures were 33° F, the heater would have drawn in air at the ventilation inlet on the front of the nose (fan driven to draw in air). With the heater running and exhaust passing over the inlet, the exhaust would have been drawn into the cabin for 8-10 minutes.
