# National Transportation Safety Board

ERA22FA354

## **NTSB IIC EXAMINATION**

Location: Cynthiana-Harrison County (018)  
Date: August 3, 2022  
Time: 1932(UTC)  
1532 (EDT)  
Airplane: N88550 1946 J3C

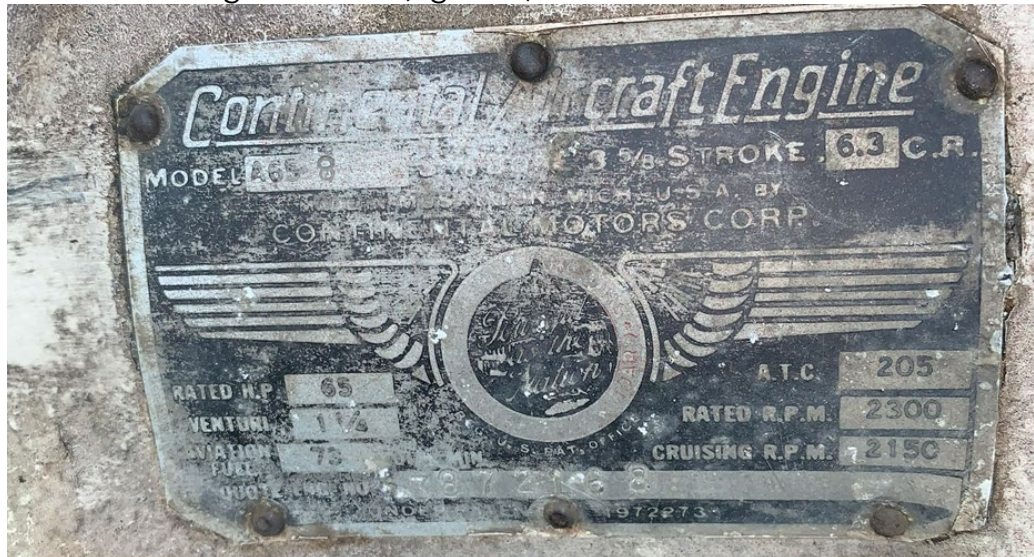
Continental Engine A-65-8 (figure 2)

The powerplant is a four-cylinder, air cooled, direct drive, horizontally opposed, carbureted, naturally aspirated engine with a rating of 65HP. The engine was impact damaged, but all cylinders, spark plugs remained intact. There was no evidence of a post-crash fire.

The carburetor remained attached to the intake which was fractured. The throttle control cable remained attached to the carburetor and mid-travel position. The alternate air box was deformed upward, and the induction air filter was clear of obstruction. The alternate air control cable remained attached to its mounts and was noted in the "primary/filtered" air position.

Impact damage was noted to the engine oil sump and oil was observed within the engine. The oil screen contained non-ferrous debris but was clear of obstruction. The oil appeared dark brown in color and all lubricated components appeared to be well lubricated.
