# National Transportation Safety Board

ERA22FA376

## **WRECKAGE EXAMINATION SUMMARY**

Location: Glendora, Mississippi  
Date: August 19, 2022  
Time: 1005 CDT  
Airplane: N602PB, Air Tractor AT-602

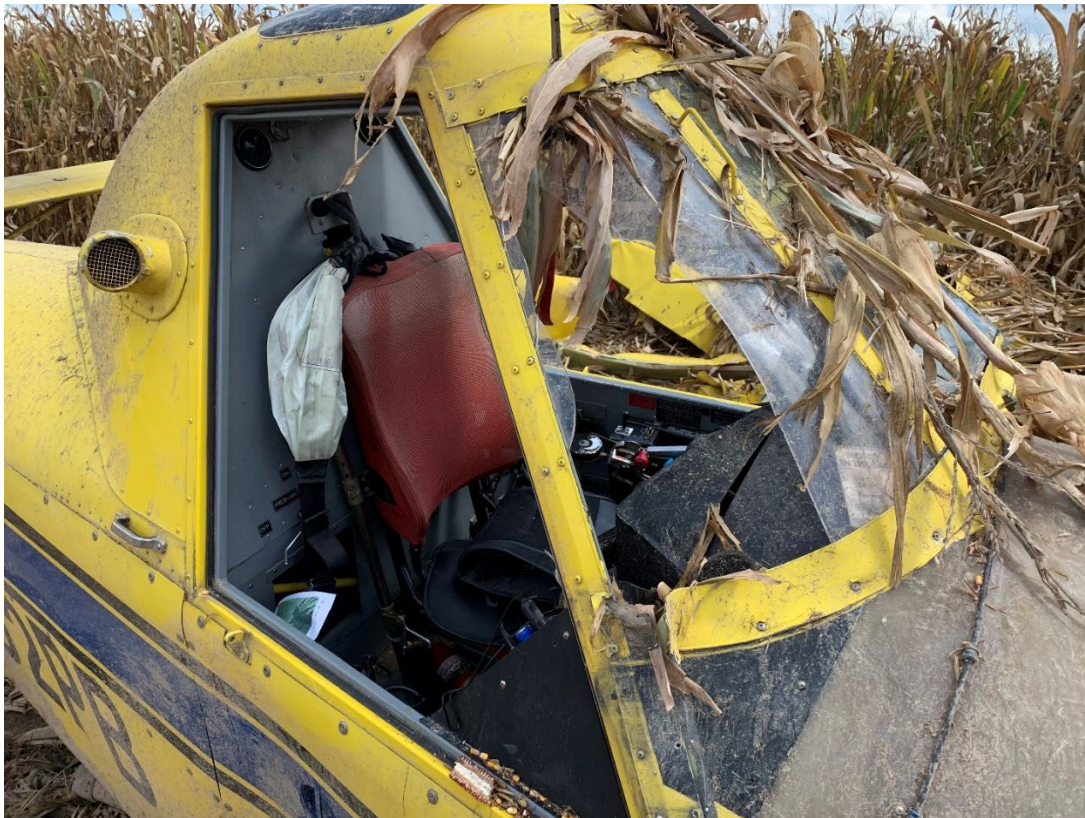
Container - the cabin remained intact and was not crushed.

Restraint - the airplane was equipped with a 5-point harness. The seatbelt remained secure to the seat and the webbing was examined and slight stretching was noted. The shoulder harness was an inflatable restraint. The airbag was deployed on both sides and there were no tears or rips in the airbags. The seat rails exhibited a slight bend forward where they seat attached to the rails. The seat was deformed in a downward direction and sloped forward. First responders unbuckled the pilot and removed him from the left side of the airplane.

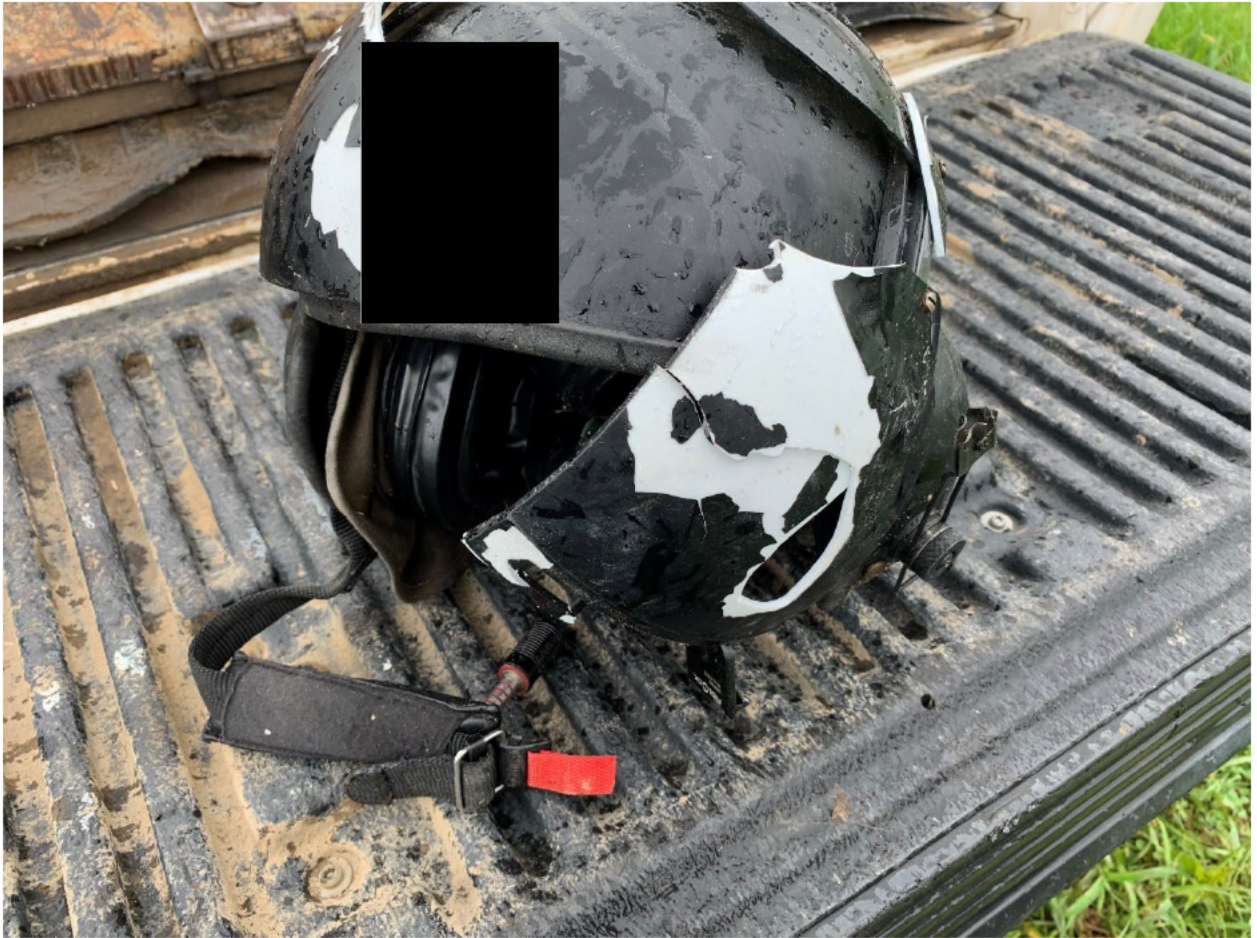
**Figure 10. View of pilot's helmet.**

Helmet - the pilot was wearing a helicopter pilot type helmet that remained on his head. The helmet went with the coroner.

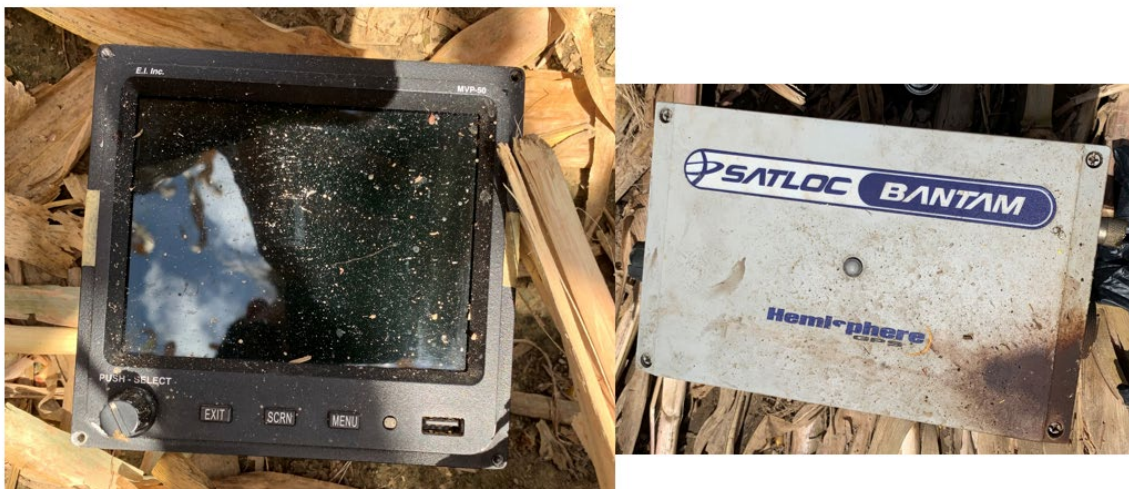
**Figure 12. View of units retained for data download.**

The airplane was equipped with an Electronics International MVP-50T and a SATLOC Bantam system that were retained and sent to the recorders laboratory for data download.

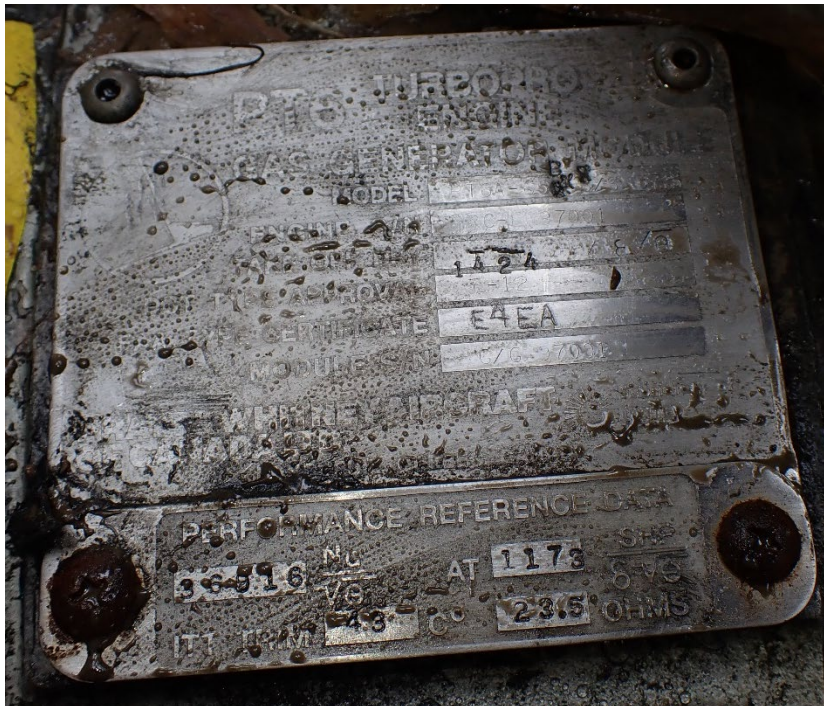
**Figure 13. View of engine data plate.**

Rated power - 1,173 shp

Most recent inspection - Annual inspection - January 2022
