## Allen Mains - Incident Report

### Wingtip damage 996LM at LRO airport

10-18-2021

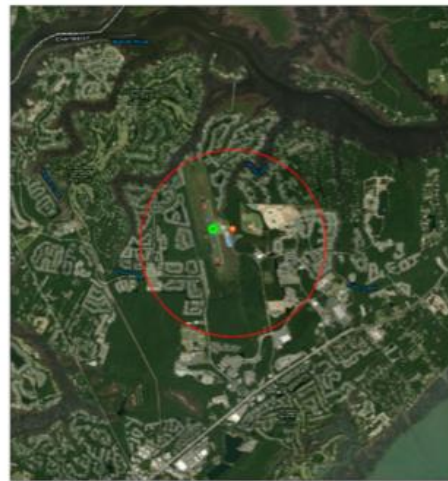
| # | Condition | Remark | ResolvedStatus | CreationDate | Area |
|---|---|---|---|---|---|
| 4 | Hazardous Material Storage | Fuel truck should be parked at least 50' from building or any other structure. | Un-Resolved | 12/11/2020, 11:30 AM | 0 |
