### MATERIALS LABORATORY INVESTIGATION REPORT

TYPE: IO-540-K1A5

NAME: Crankshaft, #5 and #6 conn  
rods, and counterweights

Analyze crankshaft/counterweights/#5 and #6 connecting rods to find potential causes of failure.

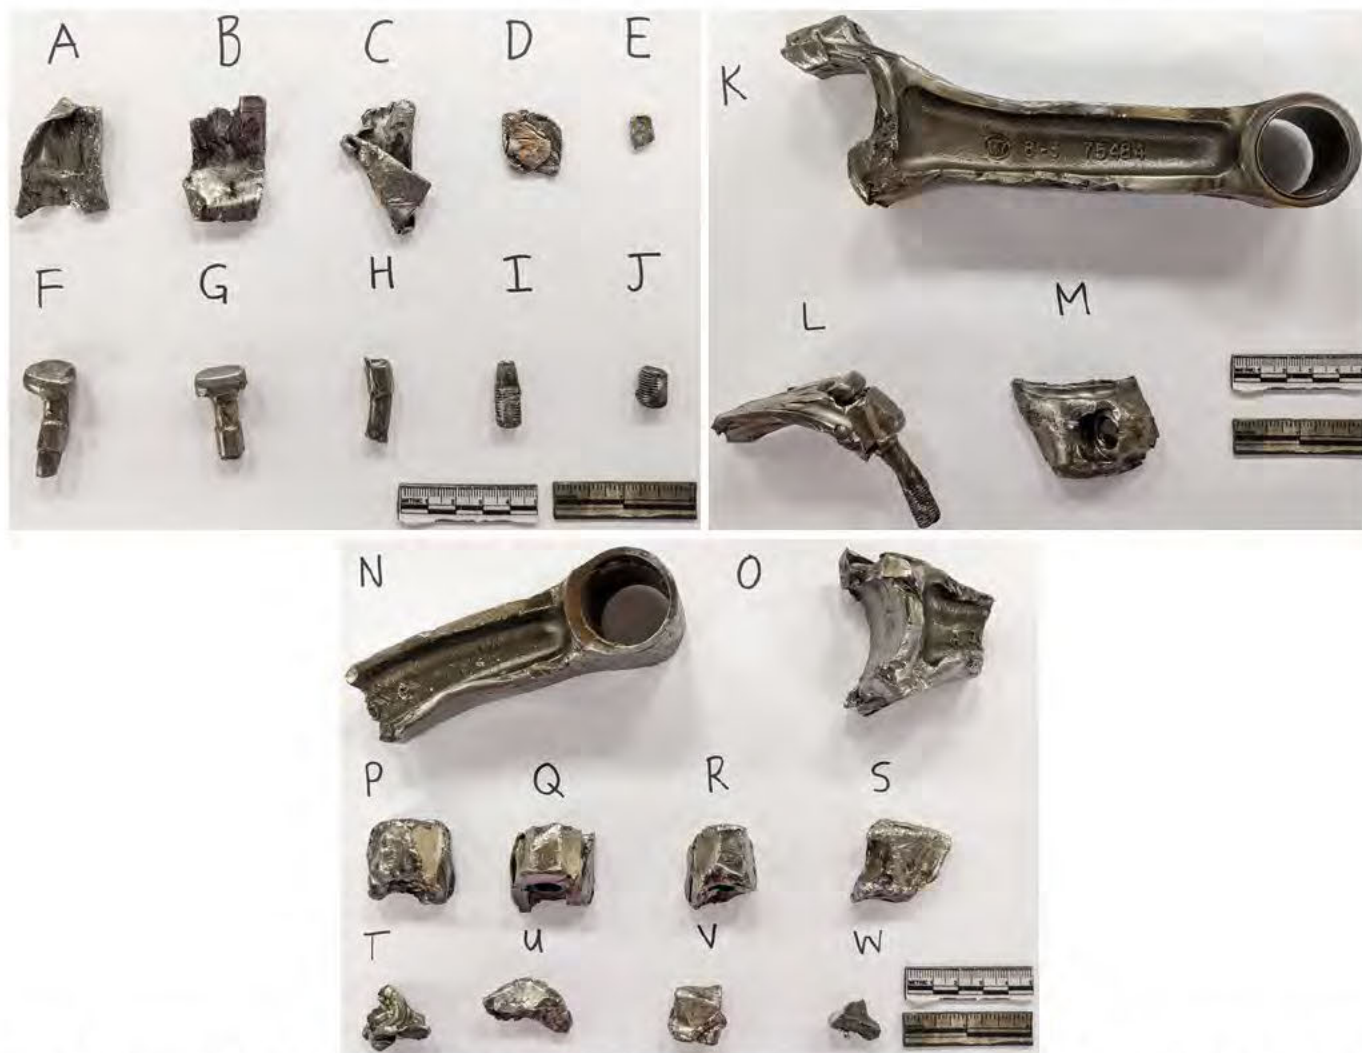
**Figure 7.** Images of all 23 remnant pieces (bearings, connecting rods, connecting rod bolts, and an unidentified part), labeled pre-cleaning.

The observations in Table 2 generally discuss the state of the fracture surface, not the entire piece at large. It should be noted that all pieces were severely damaged. They all showed physical evidence (impact marks, bending, twisting) of being violently tossed around inside the engine once failure occurred (additional details are available in the report in Appendix A). The parts from Table 2 that have the note “Clean and re-evaluate” in their Observation field (that are in rows with green backgrounds) were ultrasonically cleaned in Alconox and then in ethanol, and they are pictured in their clean state in Figure 8.

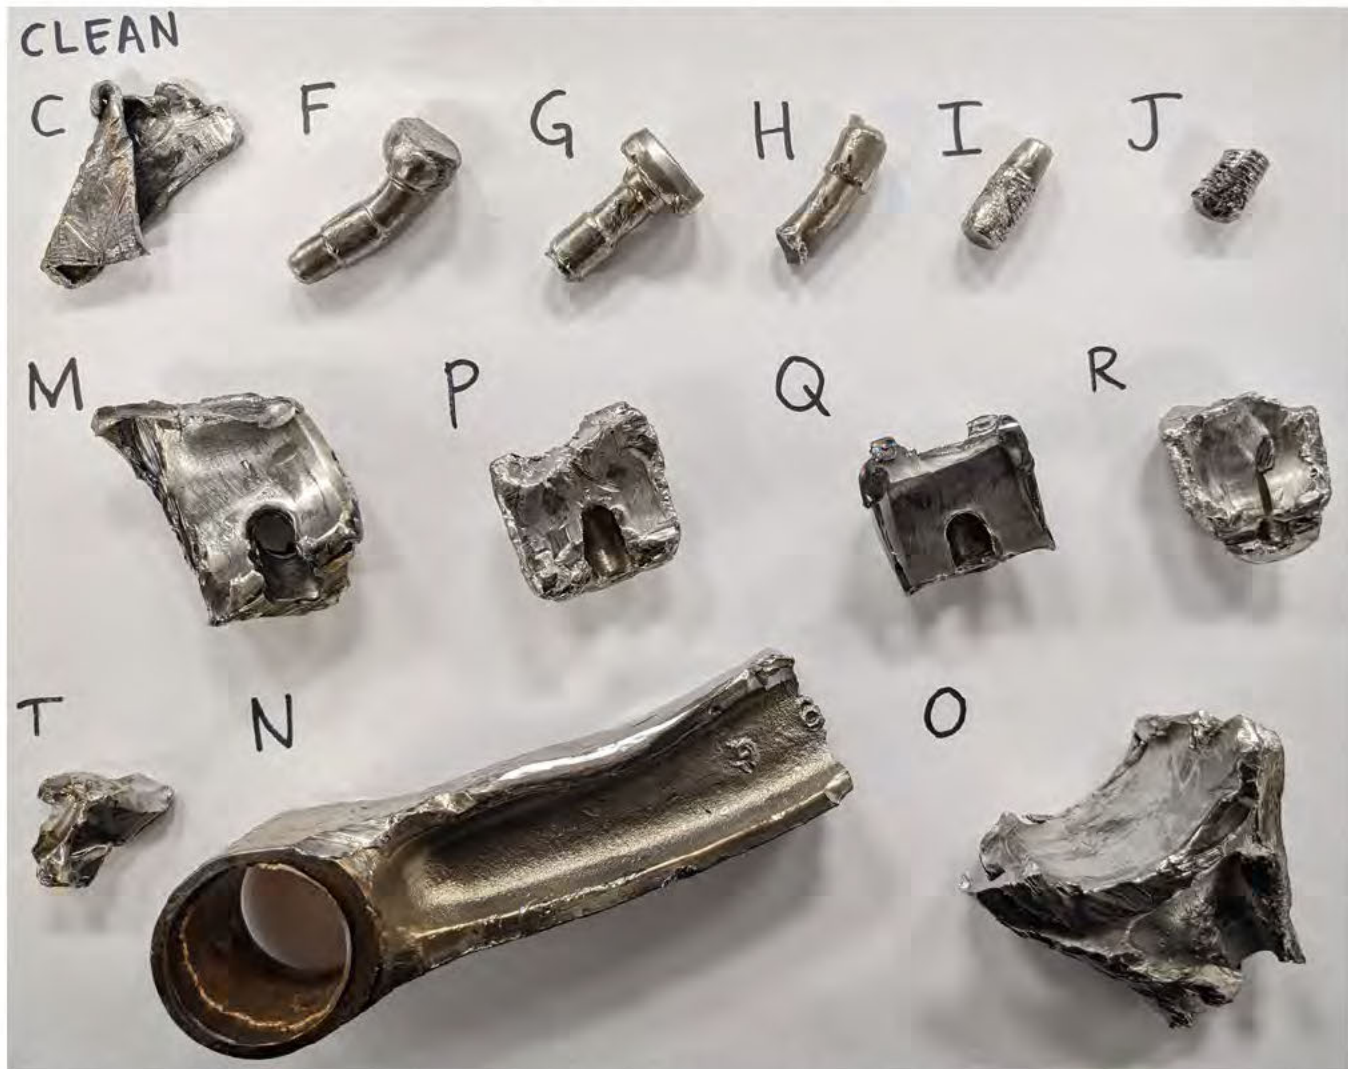
**Figure 8.** Image of all 13 remnant pieces judged to have fracture surfaces with potentially salvageable (at least partially undamaged) fracture surfaces, labeled and cleaned.

Once cleaned, each lettered piece pictured in Figure 8 was visually (with the naked eye and with microscopes) examined further. Observations are summarized in Table 3. Pieces that were deemed to provide useful failure information or show interesting surface characteristics are shown in Figures 9-23.
