# National Transportation Safety Board

## **MATERIALS LABORATORY**

Factual Report 22-104

Location: Sparta, Tennessee  
Date: March 27, 2022  
Vehicle: Cessna 172F, N8431U  
Investigator: Millicent Hill

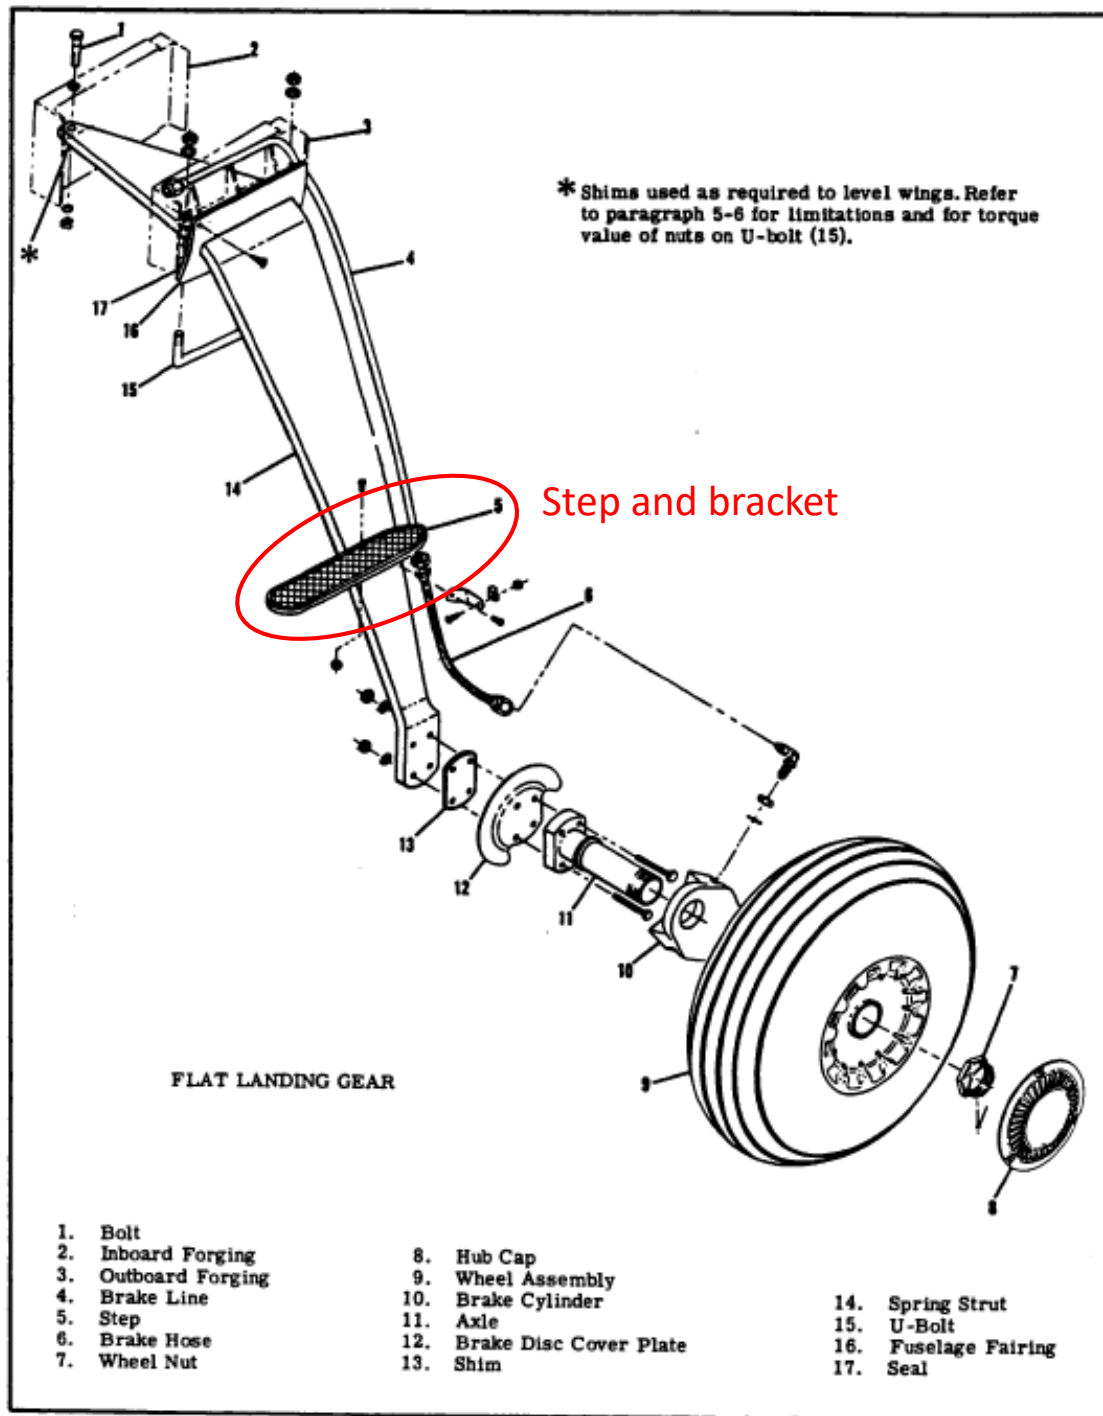
Figure 5-1. Main Gear Installation (Sheet 1 of 2)

The submitted left main landing gear items are shown in in Figure 1 with key pieces identified. For reference, an image of the landing gear spring strut with step and bracket from the Cessna Model 172 Service Manual is shown in Figure 2<sup>1</sup>.

**Figure 2.** Image of the main landing gear spring strut and step assembly from the Service Manual—1969 thru 1976 Model 172 Skyhawk Series.
