# NTSB MEMORANDUM FOR RECORD

**Date: 5/5/2022**  
**Person Contacted: GARY ANKNEY (FAA INSPECTOR)**  
**NTSB Accident Number: ERA22LA215**

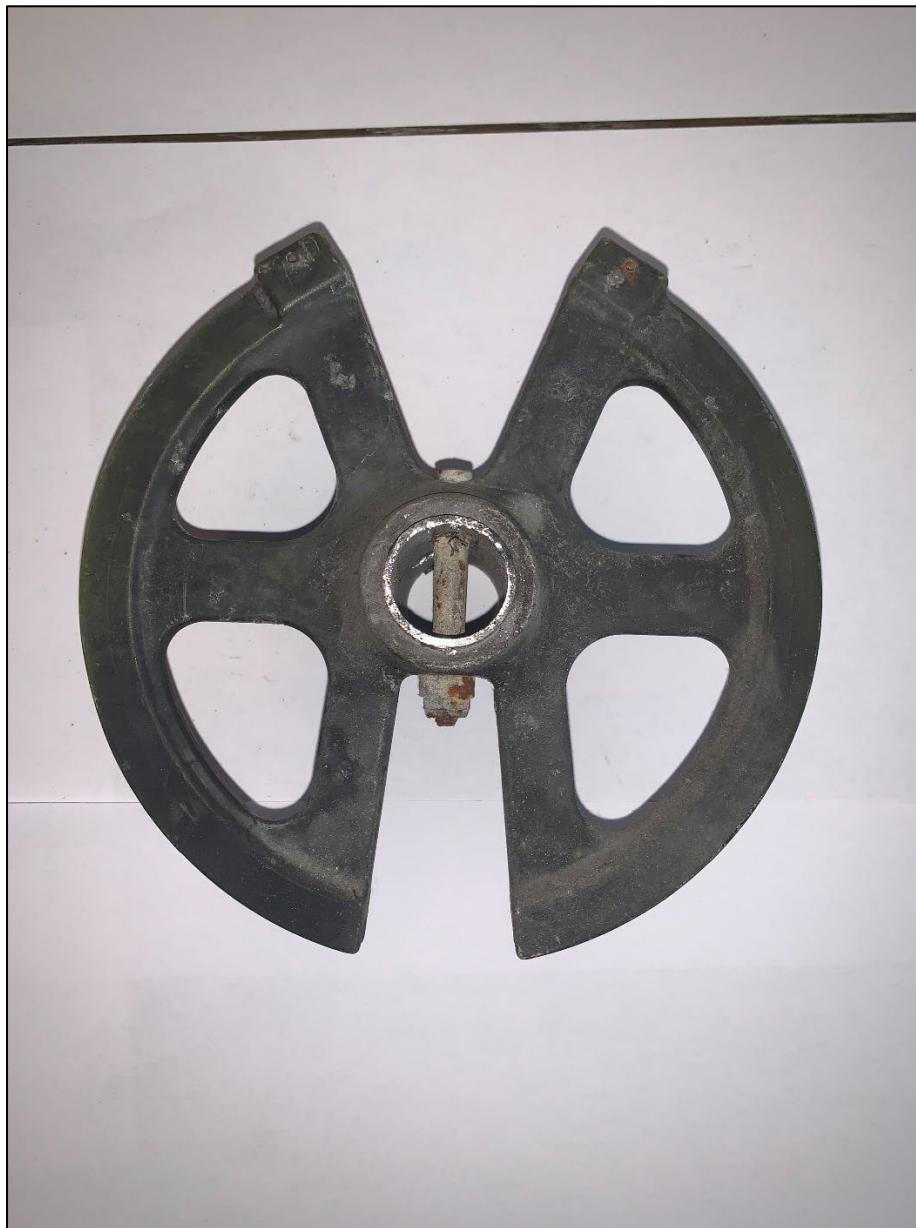
Figure 11: Overview of the elevator bellcrank.

- He observed scratches on the elevator bell crank.
- The Garmin 530 did not have rear or side straps securing the unit to a support structure in the airplane.
- The KX-155 avionics tray had one strap on its left side, but it was not connected to a structural member of the airframe. There was no strap on the right side of the lowest tray.
- The flight controls operated with a full range of motion once the KX-155 avionics tray had been moved away from the elevator bell crank.
- The operator had a sister Cessna 414 with similar avionics. The distance from the lower avionics tray to the elevator bell crank was measured to be one inch of clearance. The airplane's avionics possessed metal strapping connected to structural elements.
