# NATIONAL TRANSPORTATION SAFETY BOARD

## MATERIALS LABORATORY FACTUAL REPORT

Report No. 22-050

Place : North Myrtle Beach, South Carolina  
Date : 05/26/2022  
Vehicle : Robinson Helicopters R44  
NTSB No. : ERA22LA256  
Investigator : Brian Rayner

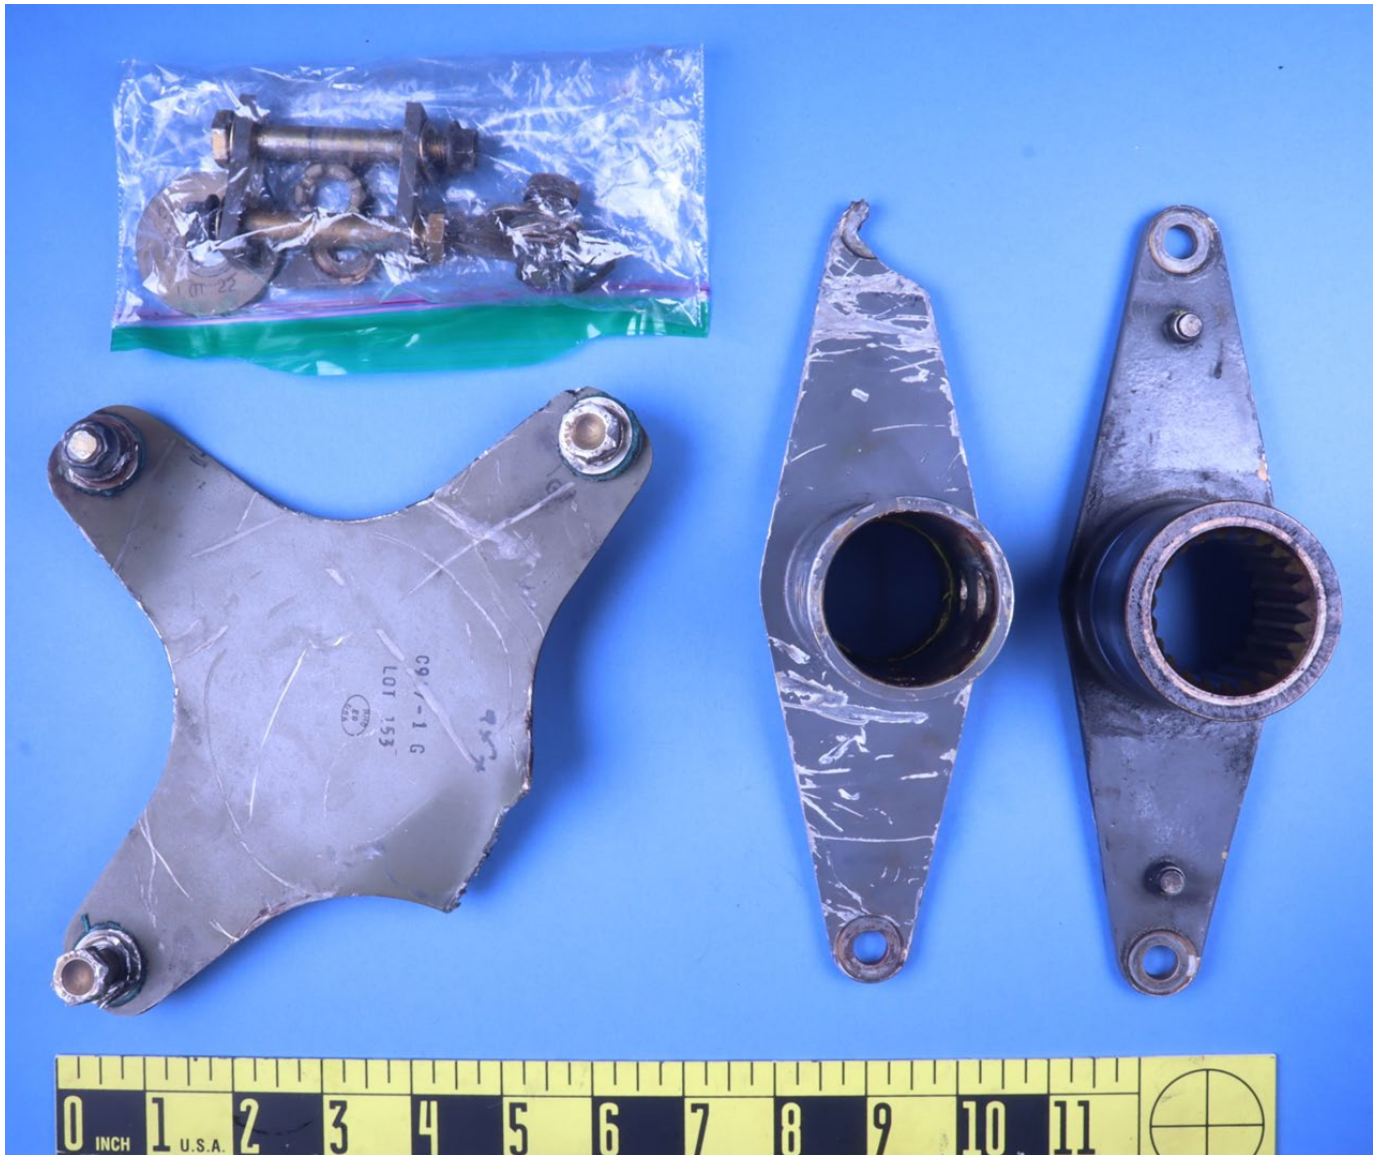
The as-received evidence is shown in Figures 1 and 2, with key components annotated in Figure 2.

Figure 1 Image of the as-received evidence.

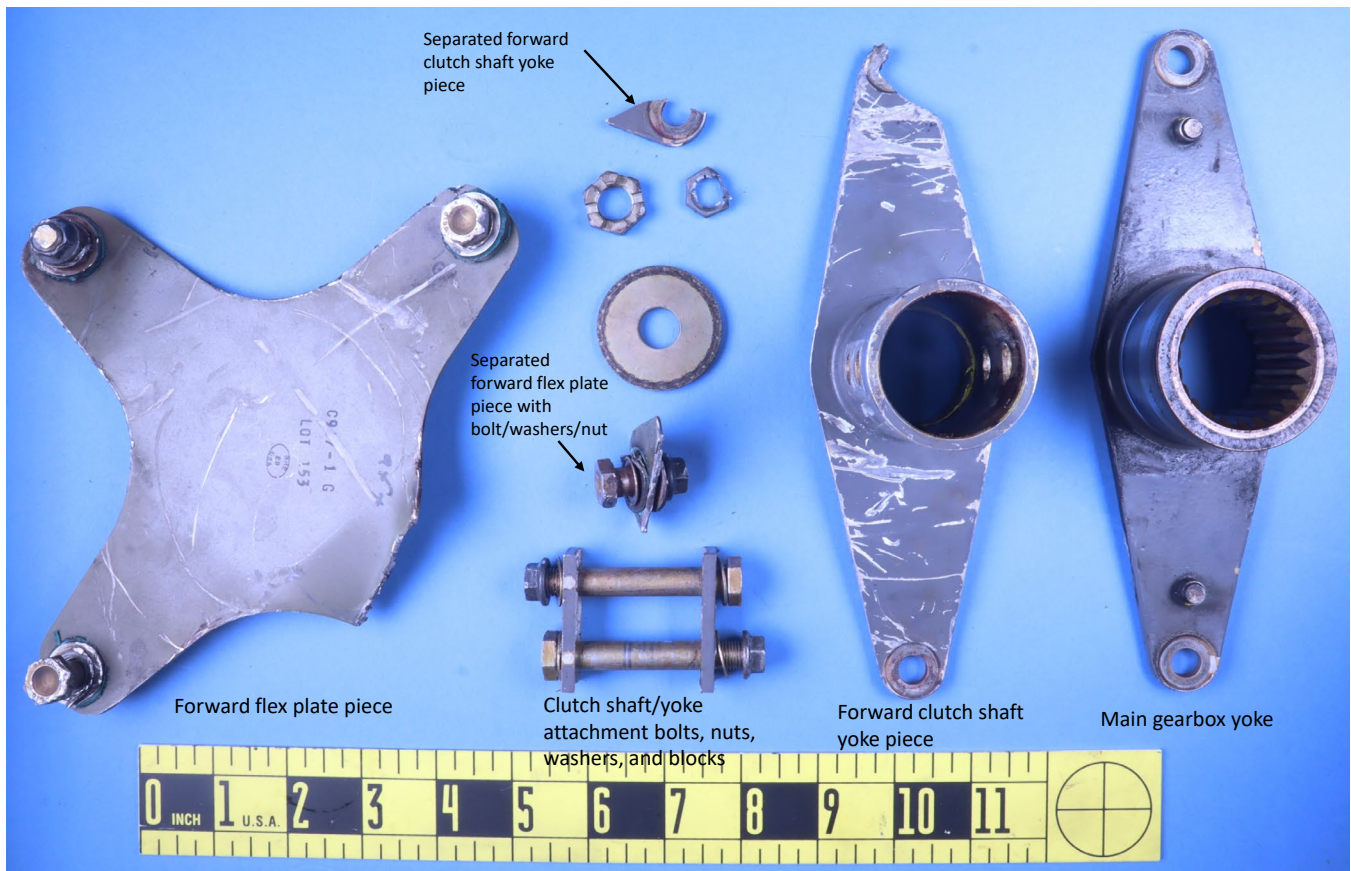
Figure 2 Image of the as-received evidence with key pieces identified.
