# National Transportation Safety Board

ERA22LA274

## **ONBOARD IMAGE RECORDER**

Location: Brevard, NC  
Date: June 16, 2022  
Time: 17:45 EDT  
Airplane: Cessna 172M, N5064H

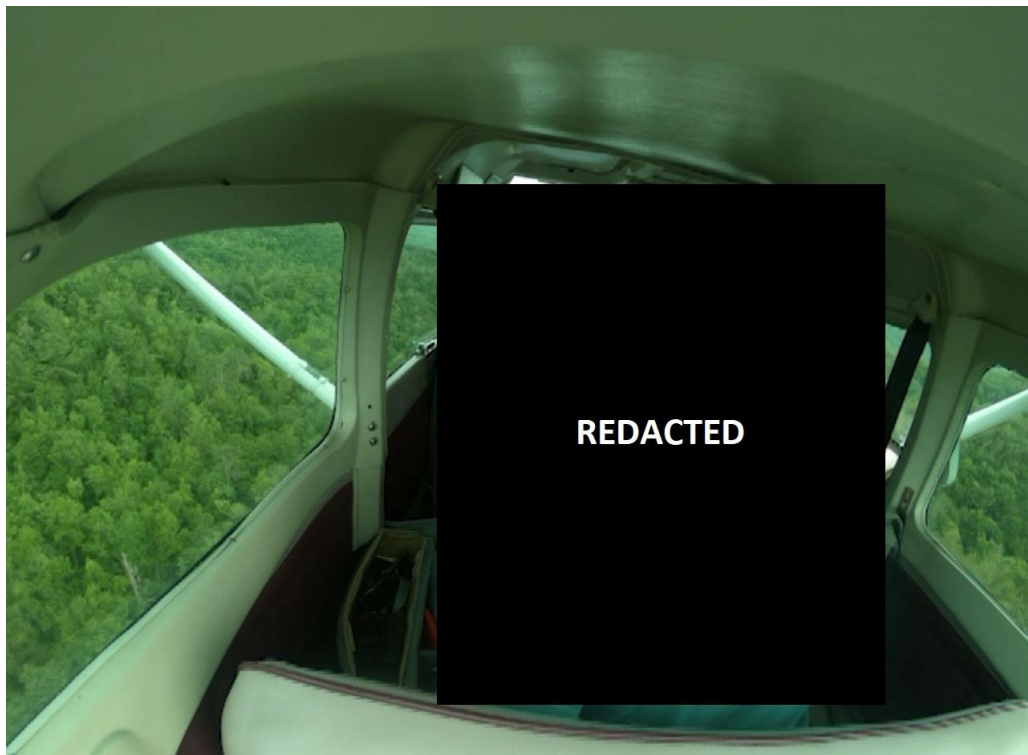
The point of view of the GoPro camera at the time it recorded the accident sequence is shown below in figure 2. Occupants of the accident aircraft have been redacted. This camera position remained unchanged until the aircraft's impact with terrain.

**Figure 2.** Image showing camera view with the occupants redacted.
