# National Transportation Safety Board

ERA22LA312

## VIDEO STUDY

Location: Russell, Pennsylvania  
Date: July 14, 2022  
Time: 1940 eastern daylight time (EDT)  
Aircraft: Flightstar II-SC, N6116U

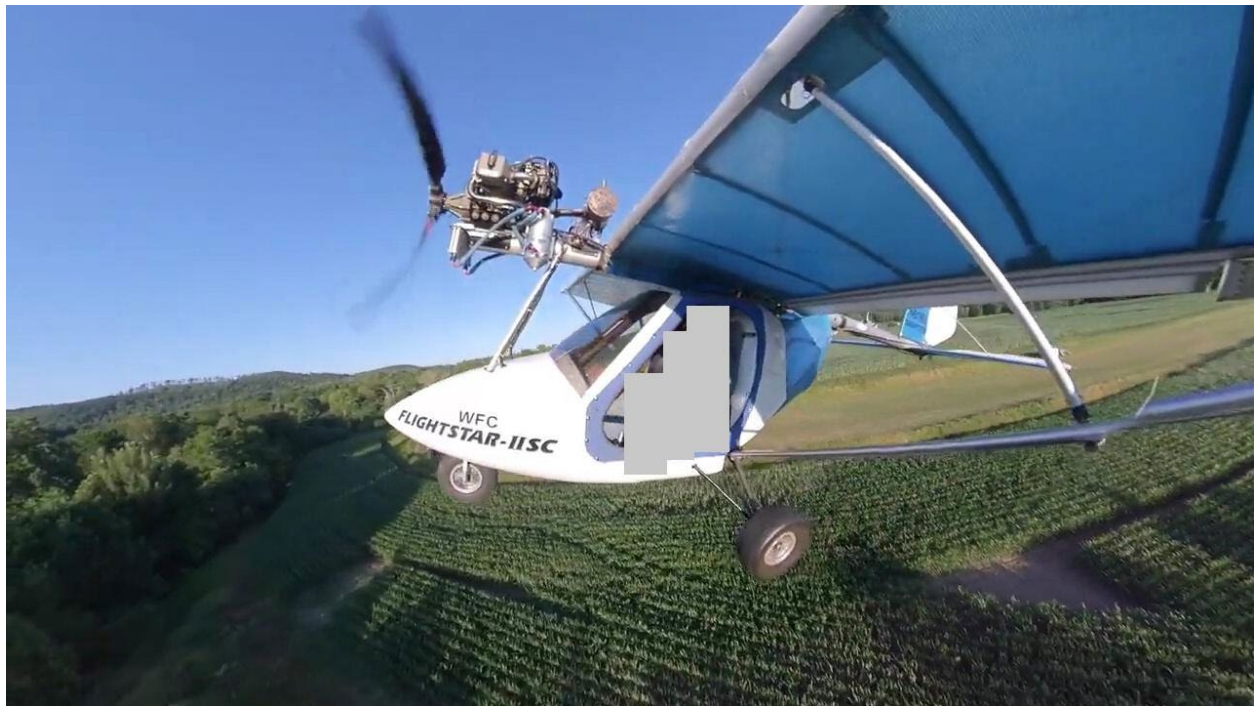
**Figure 2.** Frame from the analyzed video

Figure 1 shows a frame from the analyzed video. The gray rectangles in the figure mask the images of the pilot and the passenger. A GPS device in the airplane recorded the ground track of the airplane and its altitude during the flight at the rate of once per second. The camera and the GPS device were not time-synchronized. Figure 2 shows the ground track of the airplane superimposed on an aerial image of
