Subject: Witness statement to hard landing/incident of N160TH, BO-105CBS-4  
Helicopter on June 30, 2022, 06:42 hours

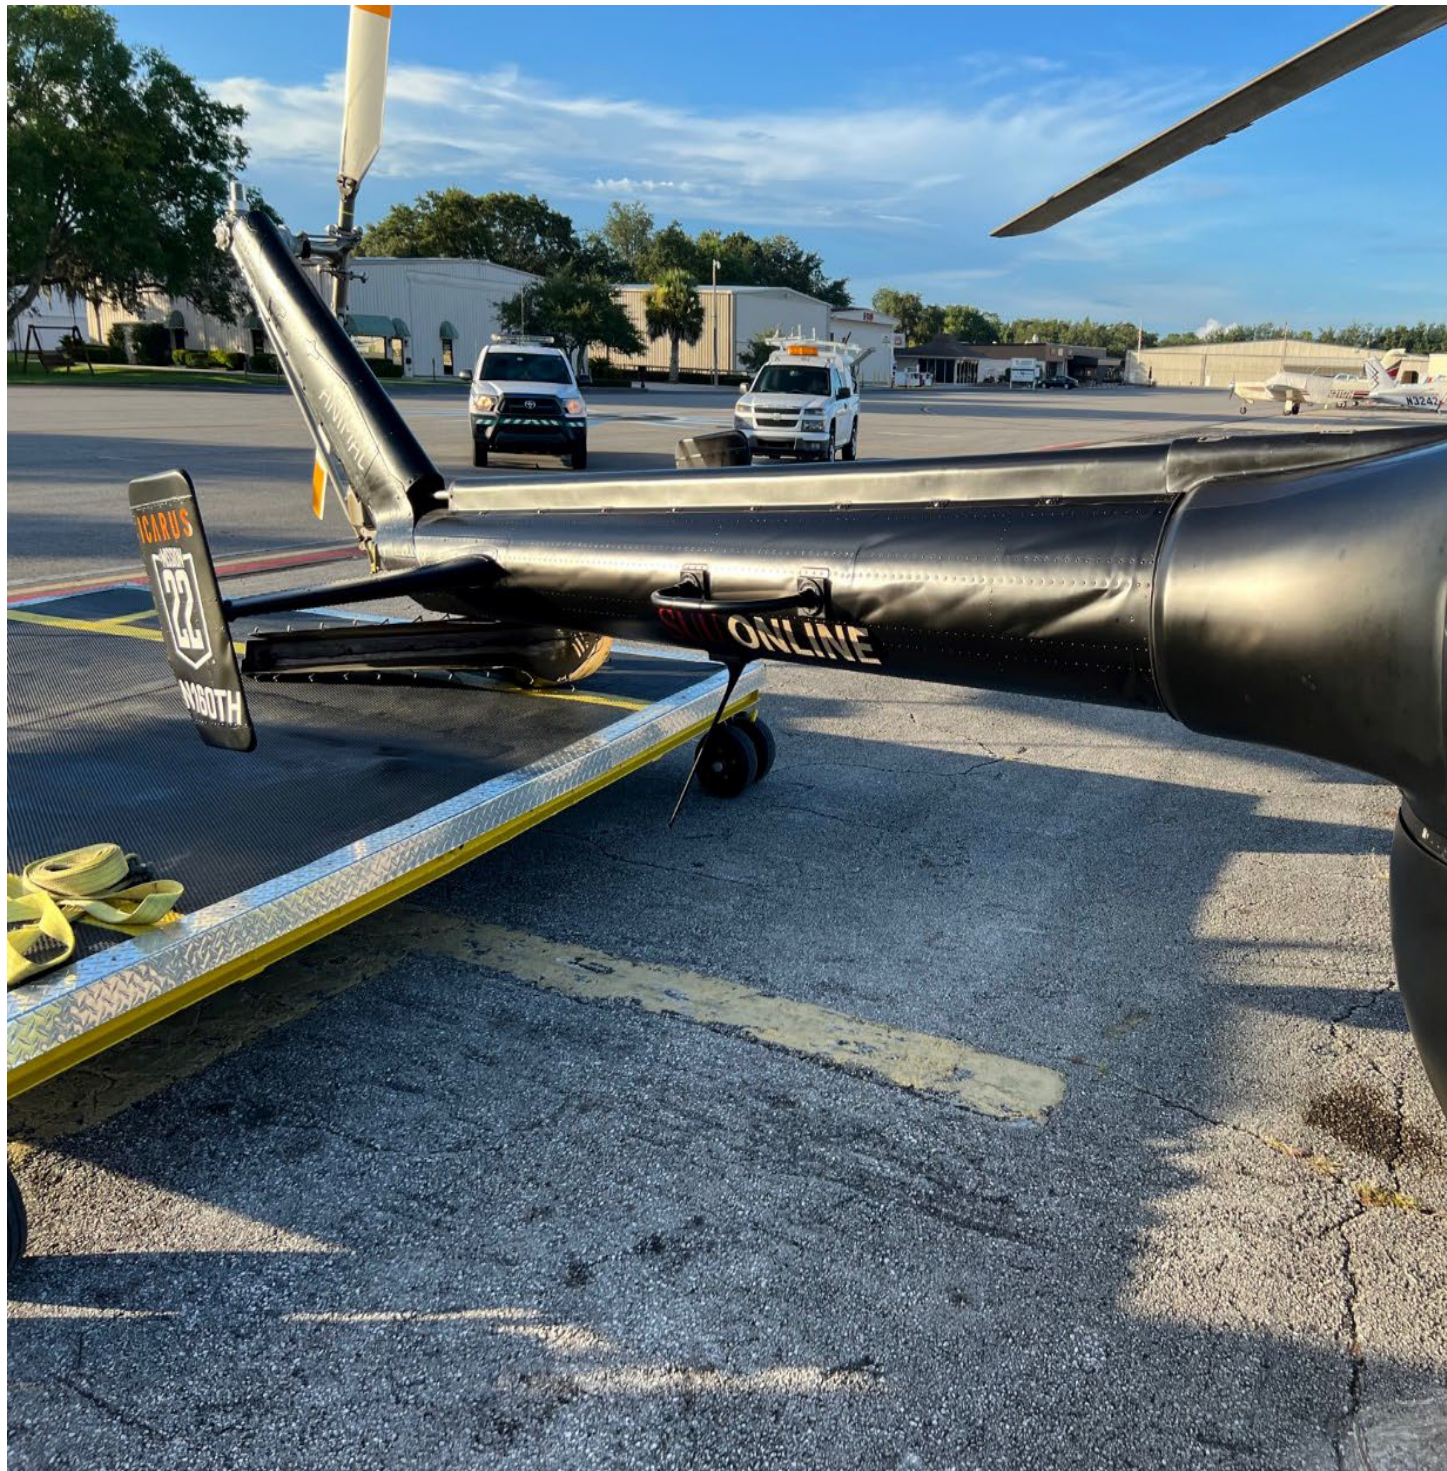
Note the ground scratching from skids, which is indication of a left pedal control input in a counterclockwise rotation/spin.
