# National Transportation Safety Board

ERA22LA410

## **MATERIALS LABORATORY**

Factual Report 23-098

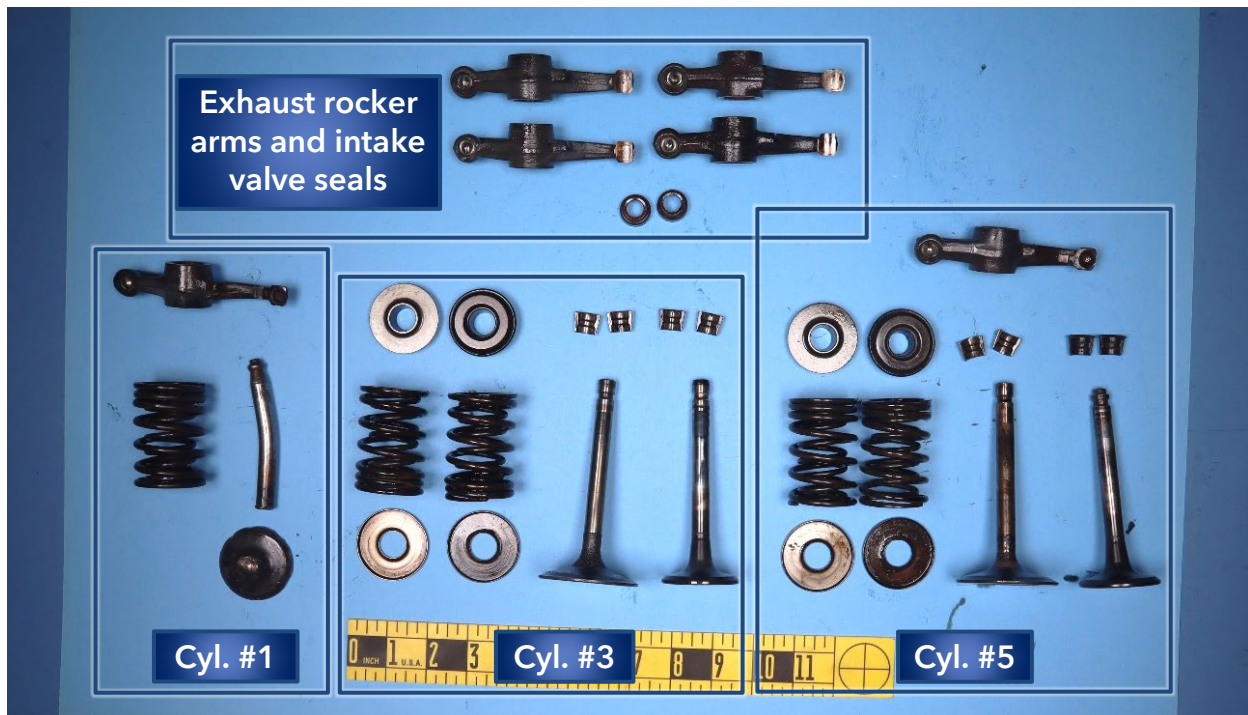
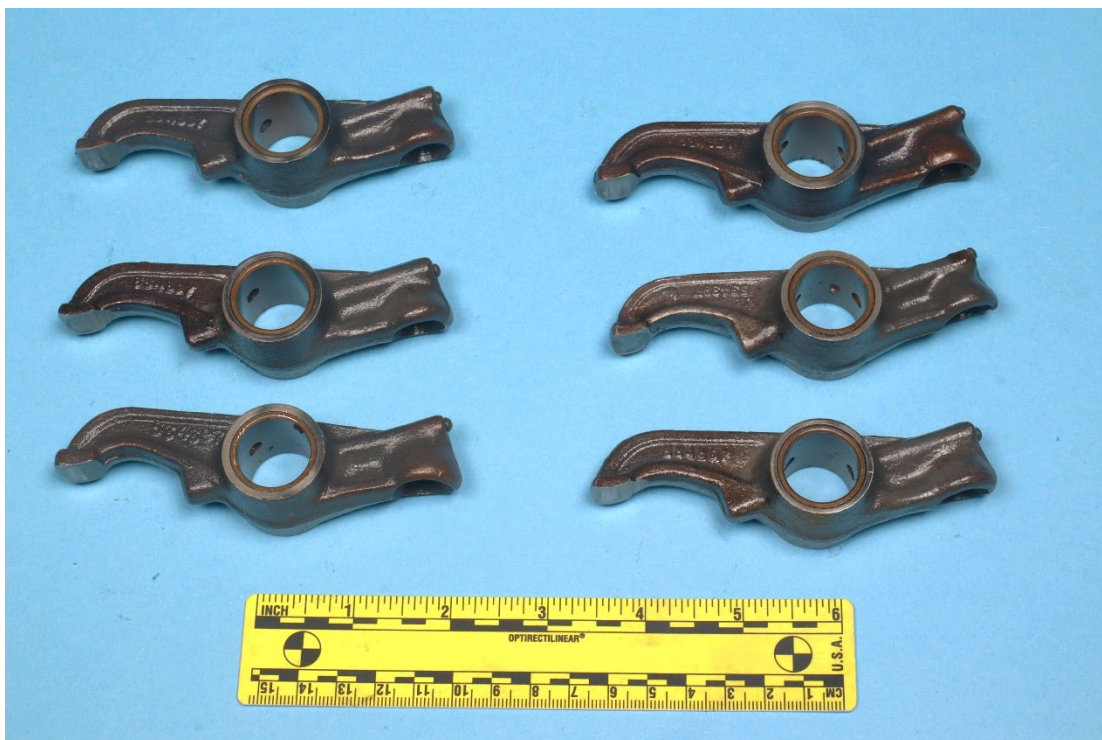
An overall view of the submitted components are shown in figure 1. Most of the parts were received in bags labeled by cylinder number as indicated in figure 1. Exhaust rocker arms from cylinders 1 and 5 were associated with the cylinders as identified from photographs taken during the engine teardown examination. The remaining four exhaust rocker arms and the intake valve stem seals shown at the top of the upper image in figure 1 were not labeled to allow association with a particular cylinder. The intake rocker arms shown in the lower image were received in a later shipment and also were not labeled by cylinder number. For the components from cylinders 3 and 5, the exhaust valve is shown to the right of the intake valve, and the exhaust valve springs and seats are shown to the right of the intake valve springs and seats. For cylinder 1, the exhaust valve and exhaust valve springs are shown in figure 1 with the associated rocker arm.

**Figure 1.** Overall view of the submitted components from cylinder numbers 1, 3, and 5 and exhaust rocker arms from all 6 cylinders as received (upper image) and a view of the 6 intake rocker arms as received in a subsequent shipment (lower image).

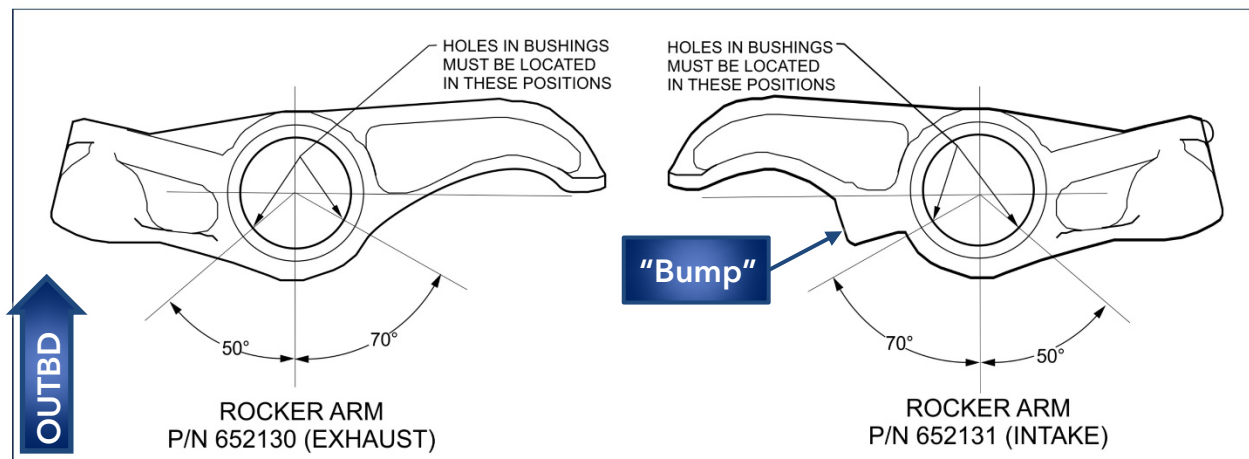
Technologies. A table in the SPMM lists exhaust and intake rocker arm assembly part numbers 652130 and 652131, respectively, for use in engines including the Continental IO-550-A, B, and C engines.<sup>1</sup> A drawing of these rocker arms as illustrated in the SPMM is shown in figure 15. Since part numbers can fade or become illegible over time, the SPMM provides diagrams for identifying distinguishing features associated with parts currently in use. The drawing for the intake rocker arm (part number 652131) notes a “bump” on the inboard side of the valve arm as noted in figure 15. In contrast, the drawing for the exhaust rocker arm (part number 652130) does not show a bump.

The single bushings for the part numbers 652130 and 652131 intake and exhaust rocker arms contained two oil passage holes. As shown in figure 15, the bushings are to be installed with the oil passage holes located at the inboard side of the rocker arm at specific angles relative to the transverse plane. Additionally, the hole centers are offset from the midpoint between the two end faces of the bushing, and the SPMM provides a diagram of the rocker arms viewed looking inboard showing correct positioning of the offset relative to each rocker arm’s longitudinal axis. A warning in the SPMM states, “Incorrectly positioned bushing oil passages will result in a loss of rocker arm shaft lubrication, severe wear of the rocker arm bushing, shaft, and valve guide and possible engine failure.”

An overall view of the intake rocker arms is shown again for reference in figure 18. Unlabeled arrows in figure 18 point to locations of oil passage holes in the installed bushings. None of the oil holes were located in the positions described in the SPMM or as shown in figure 15. The oil holes in all 6 intake rocker arms were similarly located outboard of the bushing centerline. Additionally, the oil hole positions were offset to the incorrect side of the longitudinal centerline in 4 of the 6 arms.

**Figure 15.** Rocker assembly drawings for the intake and exhaust rocker arms for engines including the Continental IO-550-A, -B, and -C engines as shown in the Continental Standard Practice Maintenance Manual. (Courtesy Continental Aerospace Technologies)
