# National Transportation Safety Board

ERA23FA025

## **MATERIALS LABORATORY**

Factual Report 23-066

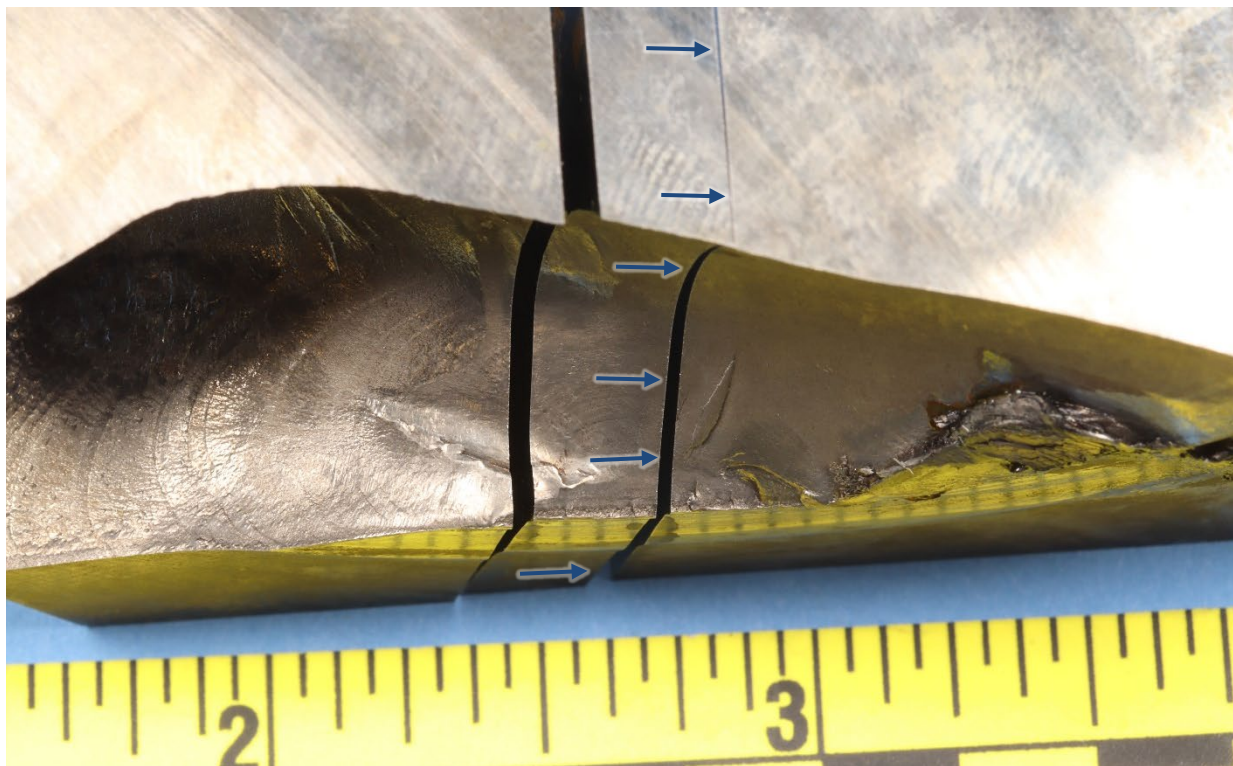
A piece of the crankshaft was cut from the origin area to facilitate a metallographic examination. The sectioned piece is shown in figure 15 after the cuts were made, and unlabeled arrows point to the cut surface that was polished and etched using 2% nital etchant. A metallographic image of the typical core

**Figure 15.** View of the fracture surface after sectioning for metallographic examination. Arrows point to the prepared surface.

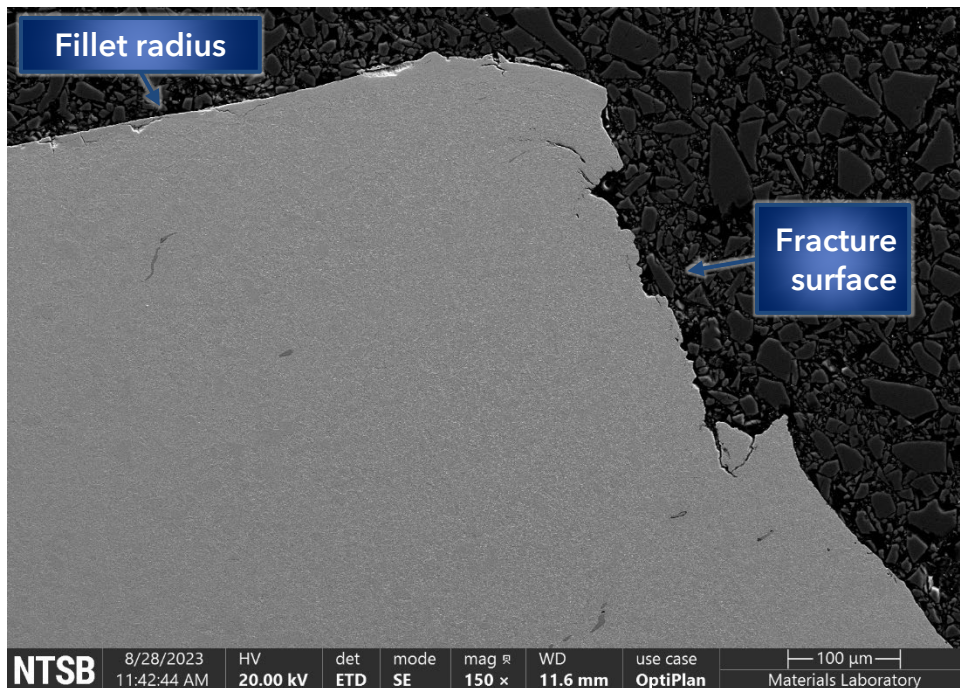
Next, the metallographic mount was sputter coated with a thin layer of a gold/palladium alloy to facilitate an SEM examination of the sample. Note that the SEM images are mirror images of optical images taken with the inverted metallograph as presented in figures 16 through 19. An SEM image of the fatigue origin area is shown in figure 20, and views of the secondary crack are shown in figure 21. Near the surface, both the fracture surface and the secondary crack showed crack paths along prior austenite grain boundaries.

**Figure 20.** SEM image of the metallographic section through the fracture origin area. Etched with 2% nital.

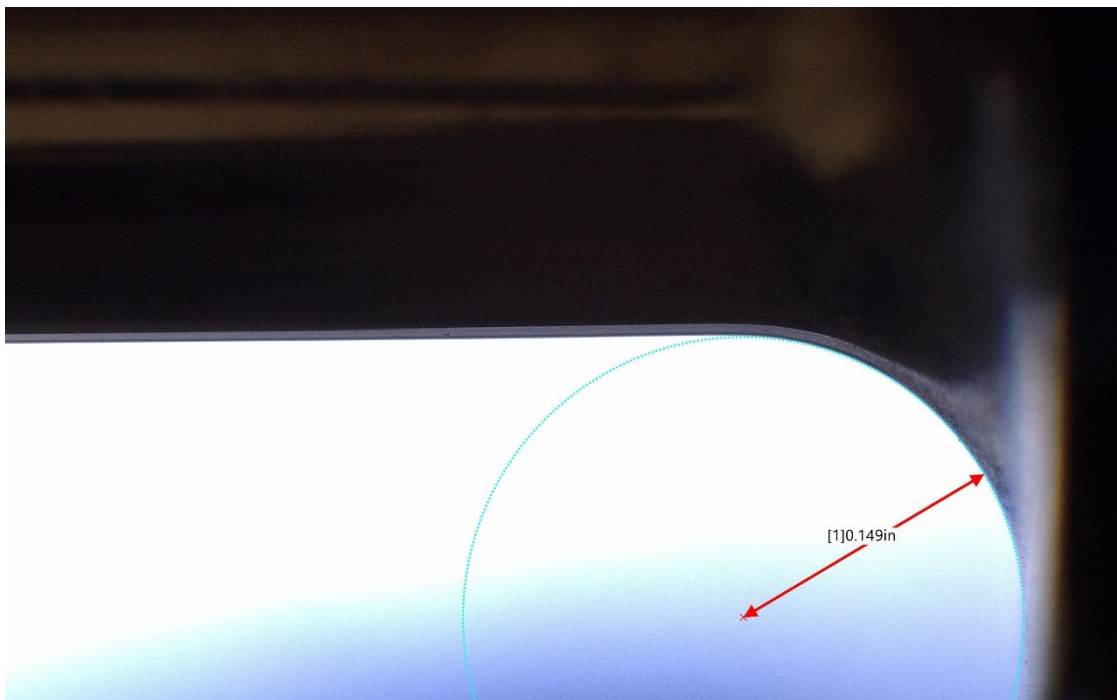
The fillet profile at the aft end of connecting rod journal 5 was examined using a backlit optical image as shown in figure 29. The fillet had smooth transitions to the journal and cheek surfaces. The fillet radius measured 0.149 inch, which is within the specified range of 0.140 inch to 0.156 inch.

**Figure 29.** Number 5 connecting rod journal aft fillet radius measurement.
