# National Transportation Safety Board

ERA23FA047

## **G-1000 SD CARD**

Specialist's Factual Report

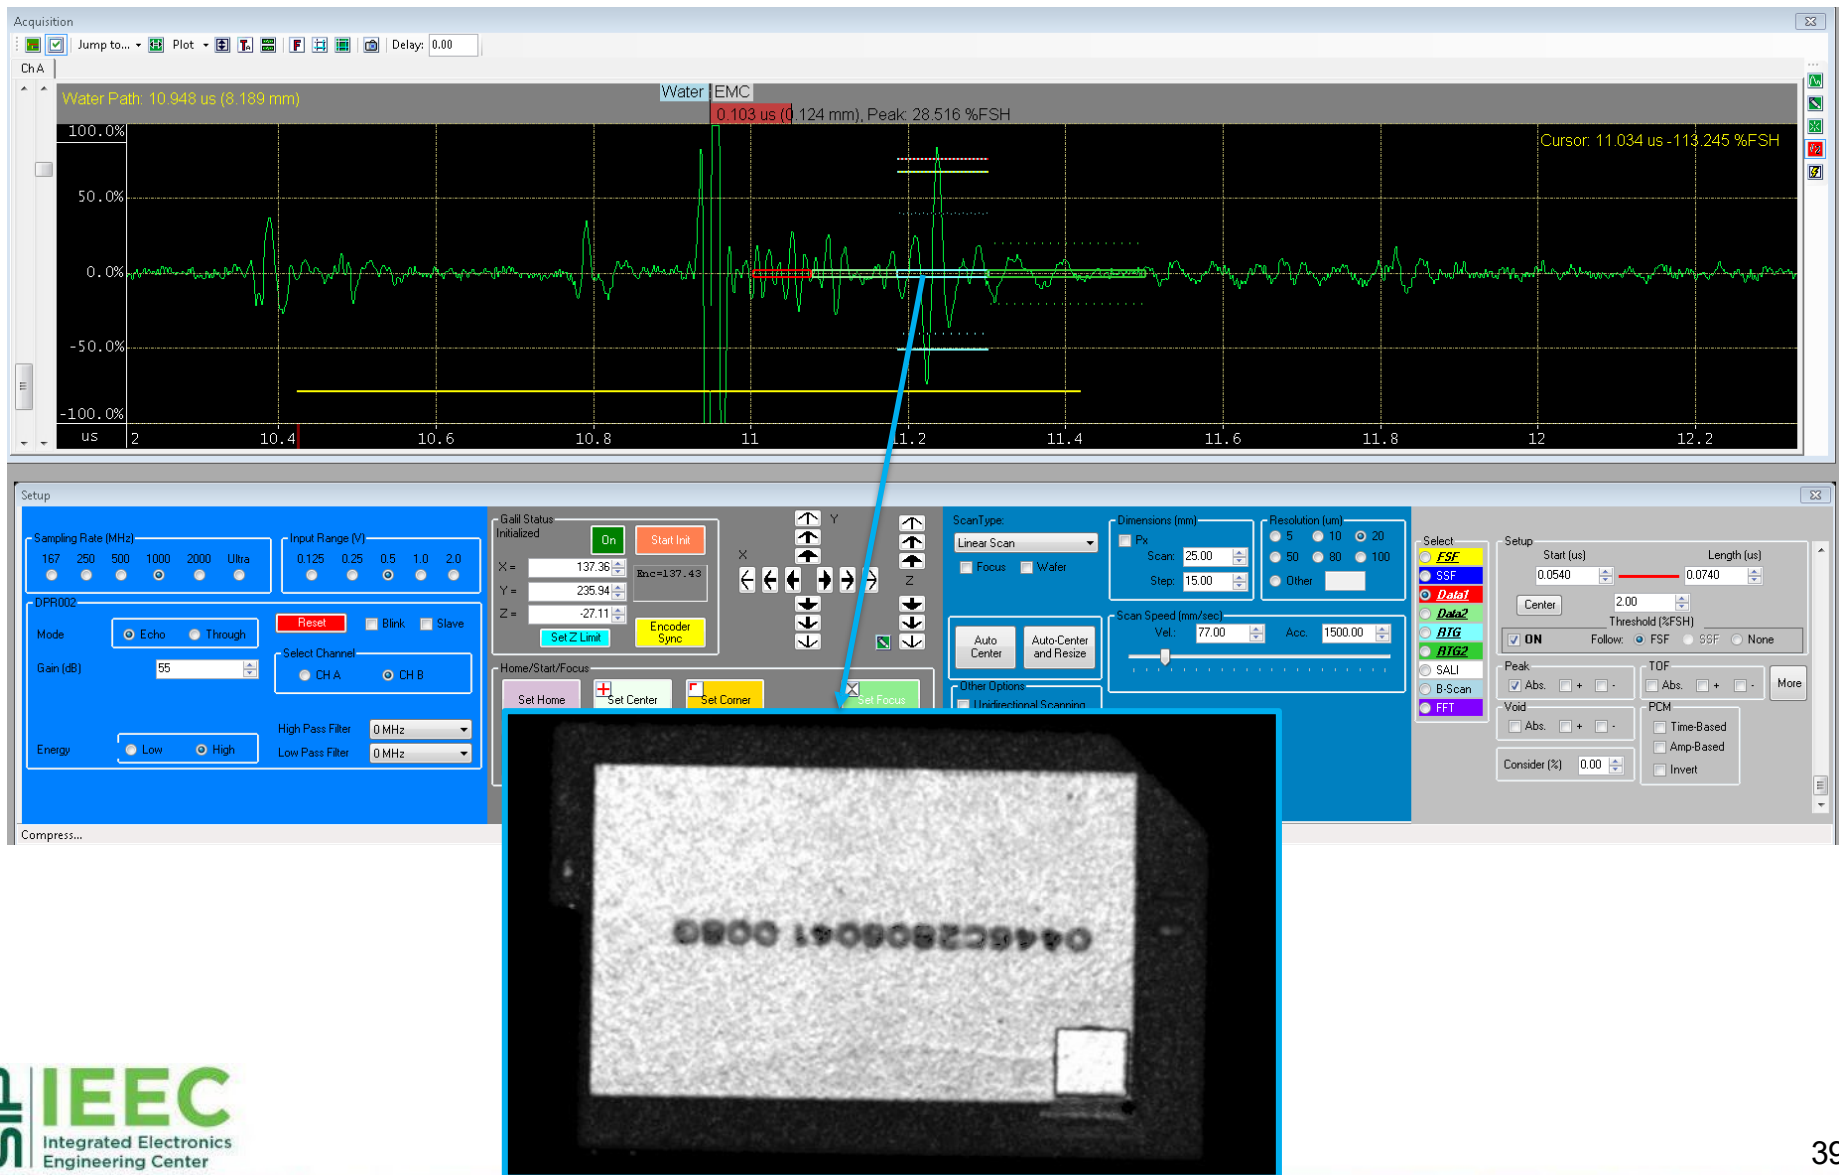
# Examination of the Lower Chip with a Higher Frequency Transducer (150 MHz)

- Horizontal streaks in the area of the lower chip are readily seen
- Unclear if these streaks indicate mechanical damage (hence likely damage to the chip), or if they are simply due to nonuniformities in the chip adhesive

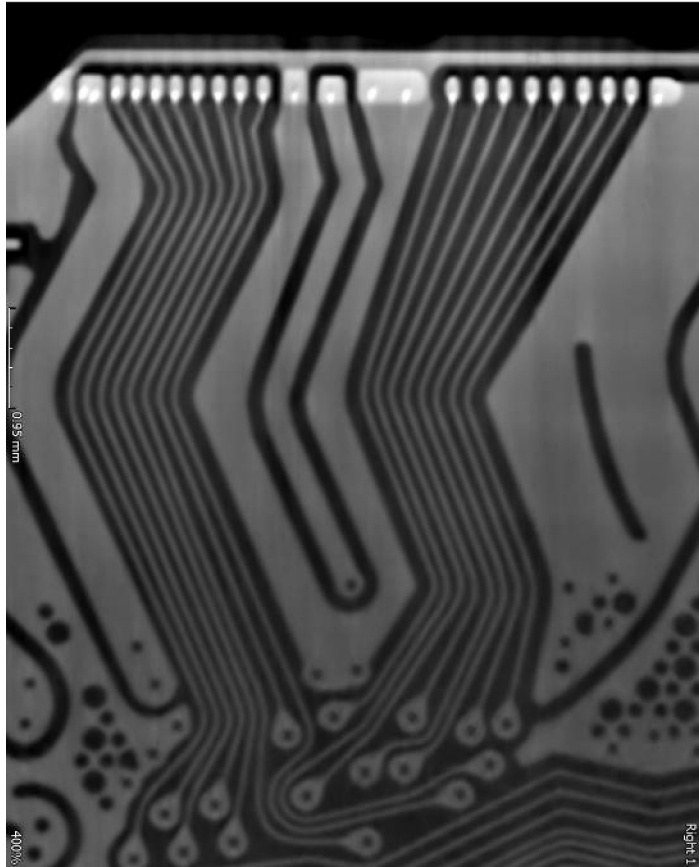
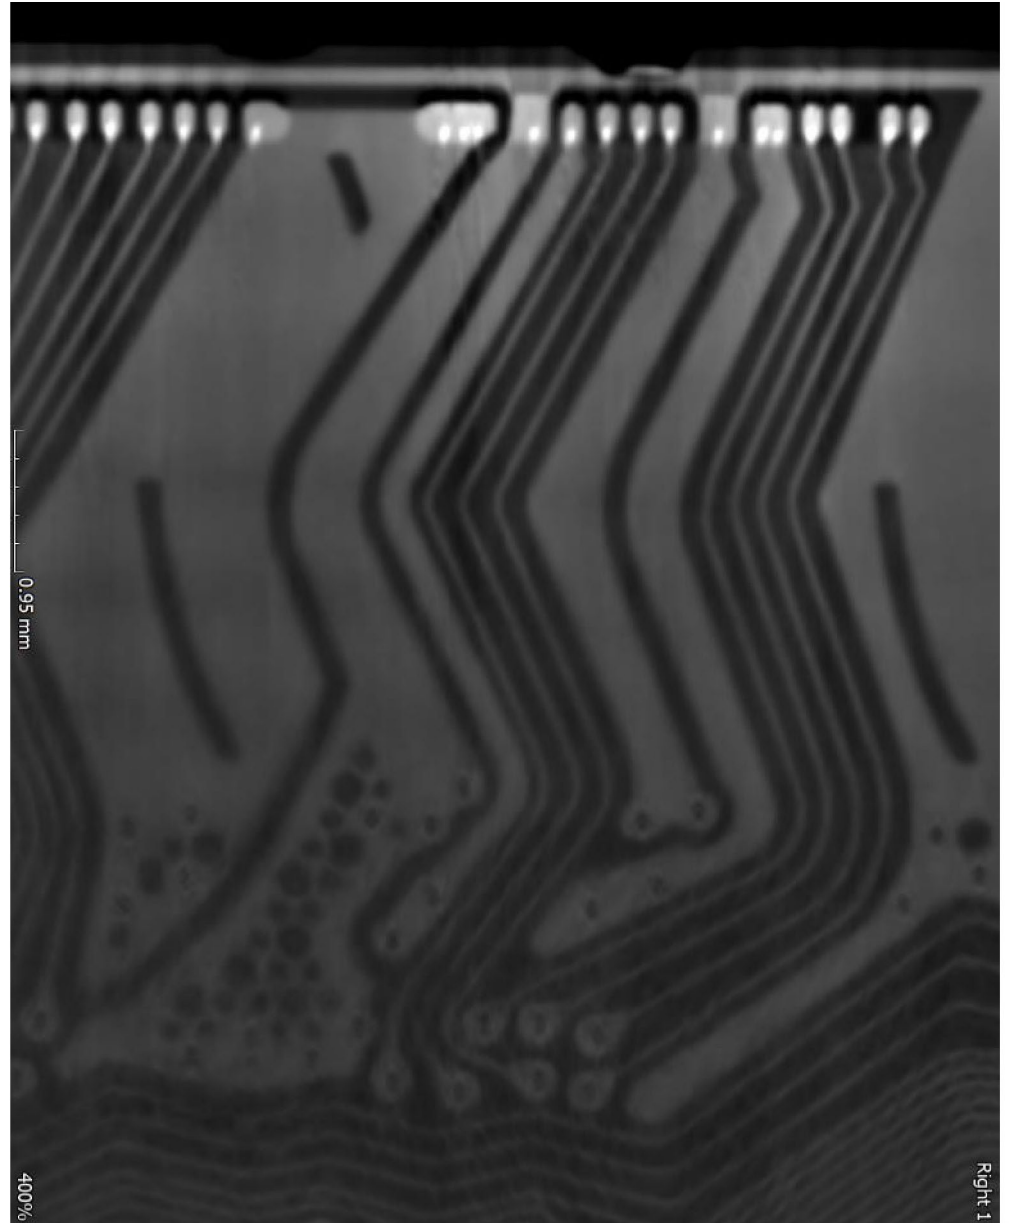
# Large die wirebonds

Separation between the damaged area and wirebonds is  $< 300\mu\text{m}$ - there is a possibility that some wirebonds may have lifted up- hard to detect through X-ray or C-SAM
