# National Transportation Safety Board

ERA23FA070

Group Chair's Factual Report

Location: Charlotte, NC  
Date: November 22, 2022  
Time: 1219 EST  
1719 UTC  
Helicopter: Robinson R44 / N7094J

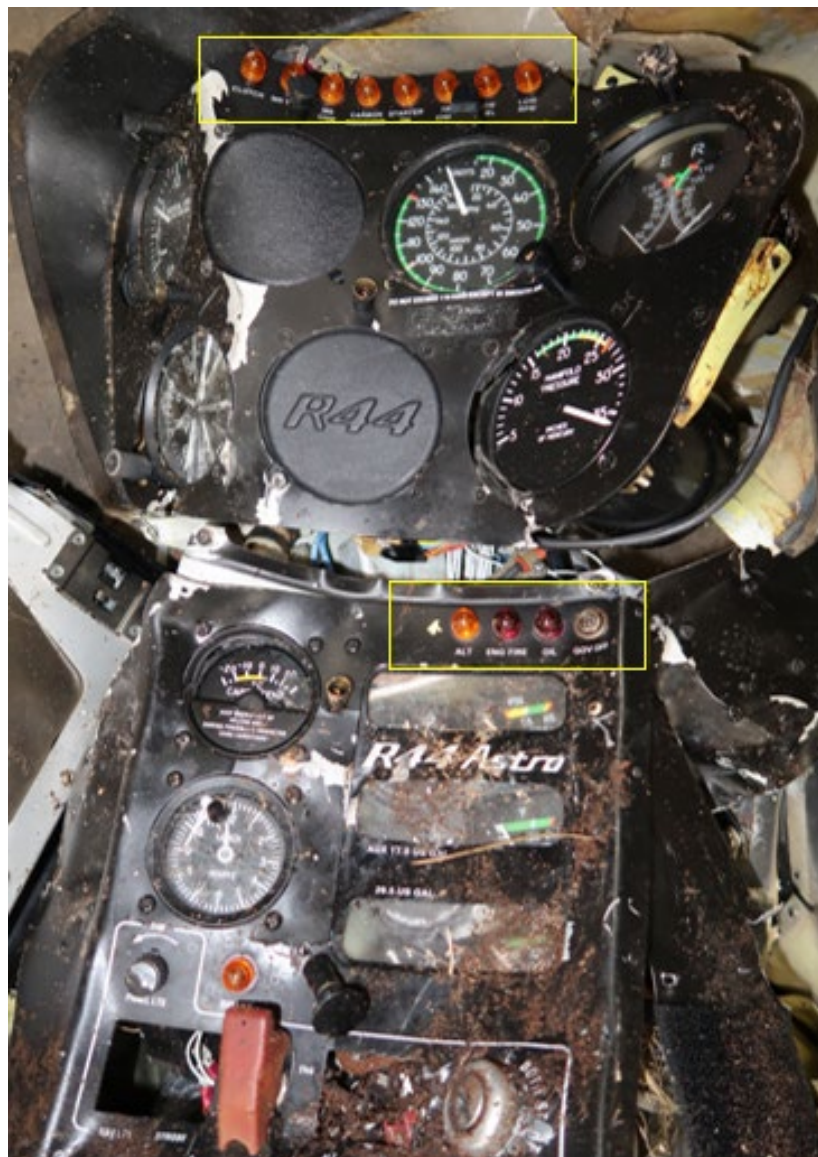
**Figure 9.** Caution and warning lights identified in yellow boxes.

The light bulbs of all the caution/warning lights (Figure 9) were removed and submitted to the NTSB Materials Laboratory for examination. A normal light bulb filament is considered a filament resting in the support saddles with a slight curve of the filament between the supports. The following lights were examined by x-ray to determine filaments status. The status of each filament is listed in Table 4. Radiographs of selected light bulbs are included in this section (Figures 10, 11, and 12).
