# National Transportation Safety Board

ERA23FA113

## **ENGINE HISTORY AND NO. 4 CYLINDER SPARK PLUG EXAMINATION SUMMARY**

Location: North Castle, New York  
Date: January 19, 2023  
Time: 1729 EST  
2229 Coordinated Universal Time (UTC)  
Airplane: N19MT, Beech A36

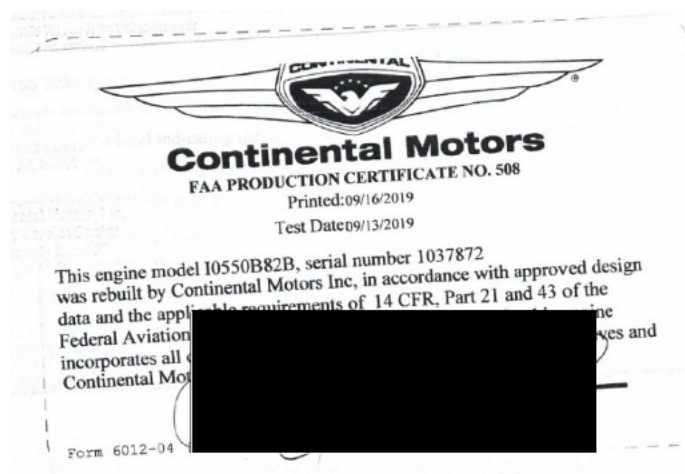
**Figure 5 Engine Rebuilt Entry**

According to provided logbook information, the engine was "rebuilt" by Continental Aerospace Technologies and was tested on September 13, 2019 (Figure 5).

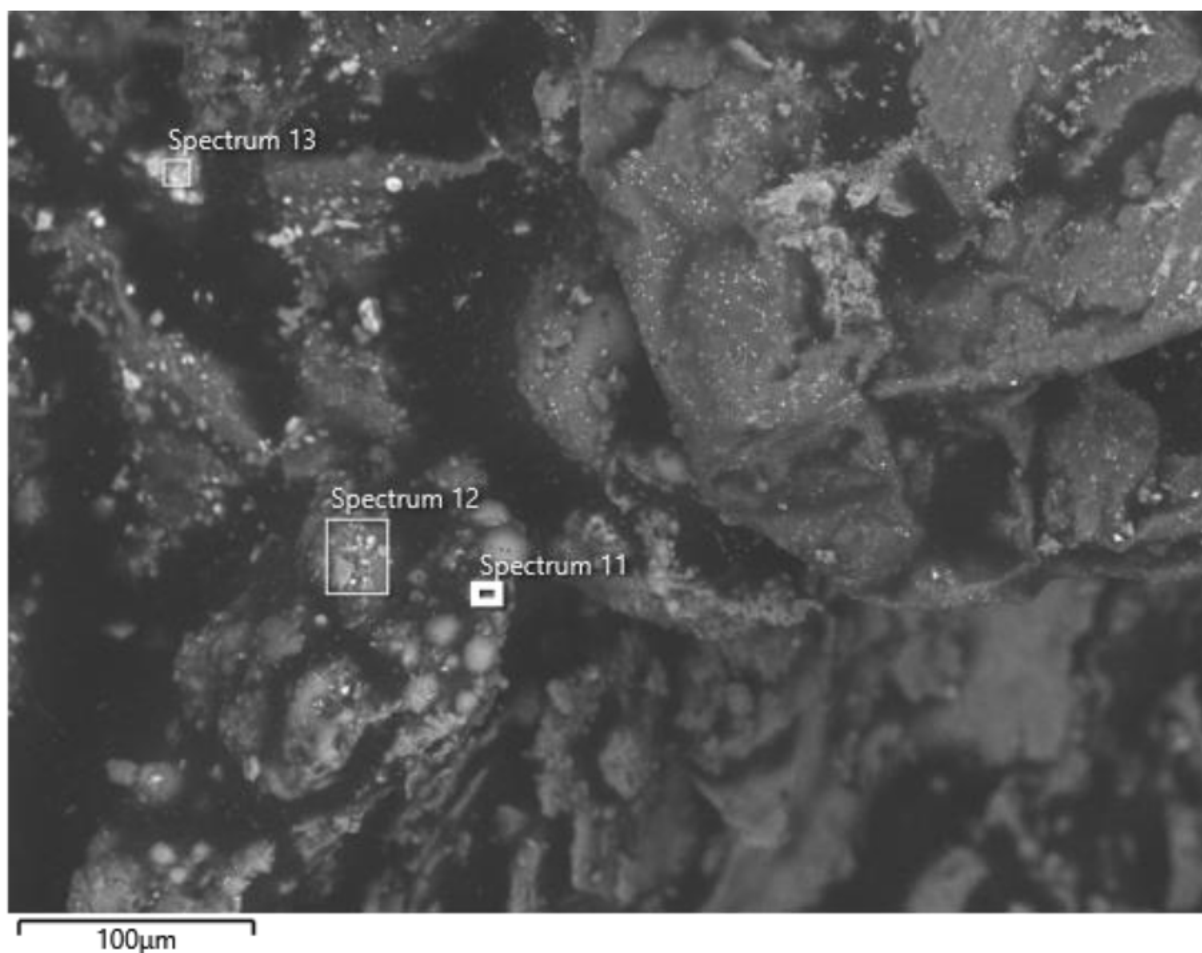
**Figure 5. Typical SEM photomicrograph and EDX analysis for 4B Surface Deposit Ground Electrode, 100X magnification**

Figures 5 through 8 present typical SEM photomicrographs and corresponding EDX analyses of the 4B surface deposit on the ground electrode.
