# National Transportation Safety Board

ERA23FA113

## **ENGINE INFORMATION AND EXAMINATION SUMMARY**

Location: North Castle, New York  
Date: January 19, 2023  
Time: 1729 EST  
2229 coordinated universal time (UTC)  
Airplane: N19MT, Beech A36

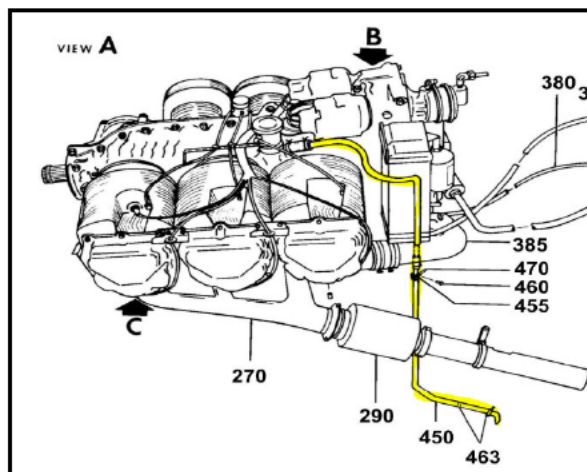
The engine was equipped with a crankcase ventilation system consisting of a flexible hose that connected the breather assembly - oil filler to an upper section of an aluminum tube. The upper section of aluminum tube transitioned slightly down and aft. A flexible hose connected the upper aluminum tube to a lower aluminum tube that transitioned the left side of the engine firewall near the left cowl flap and extended into the slipstream below the fuselage. (Figures 5 and 6).

**Figure 5 Highlighted Path of Crankcase Ventilation System Components**

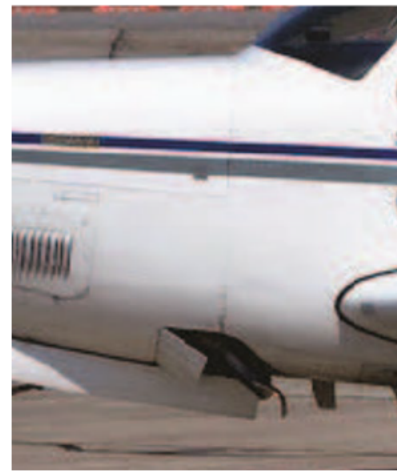
**Figure 6 Left Side View of the Airplane From Internet Depicting the Crankcase Breather line Extending by Left Cowl Flap and Below the Fuselage Bottom**

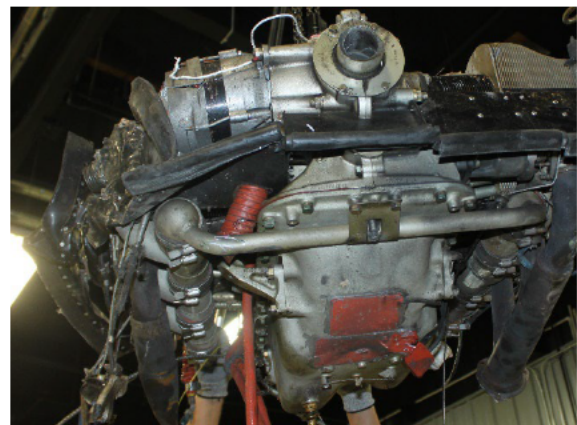
**Figure 18 View Taken Below Engine  
At Start of Examination**

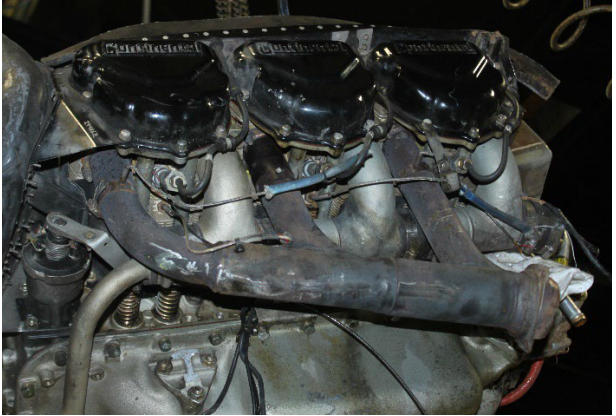
Inspection of the air induction for the Nos. 1, 3, and 5 cylinders revealed it was installed properly, and all flexible ducts were in place and tightly clamped. Impact damage was noted to the No 5 cylinder induction tube at the cylinder attach location. The balance tube remained connected at both sides but exhibited an impact scratch on the right side. Inspection of the air induction for the Nos. 2, 4, and 6 cylinders revealed it was also installed properly, and all flexible ducts were in place and tightly clamped (Figure 25). The intake hose between the Nos. 2 and 4 cylinders exhibited an area of abrasion in the area where the aft clamp was located. There were no stains on the flange of the intake elbow tube for the No. 4 cylinder (Figure 26).

**Figure 25 View of the Air Induction and Exhaust Systems of the Nos. 2, 4, and 6 Cylinders**

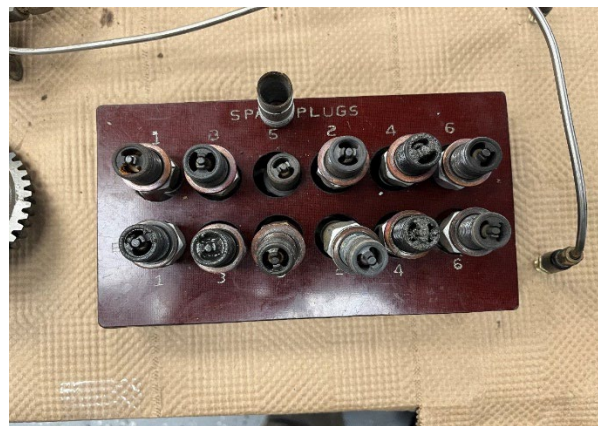
The upper and lower Champion RHB32E spark plugs from the No. 4 cylinder both exhibited re-solidified material (Figure 32). The condition of the center electrode of the Nos. 4B and 4T plugs could not be reliably determined. Inspection of the remaining plugs revealed all but Nos. 1B, 2B, and 5T center electrodes were football shaped and all plugs exhibited a slightly dark color (Figure 33). The No. 1B plug contained contaminant in the center well and the No. 3B plug was oil soaked.

**Figure 33 View of All Spark Plugs**

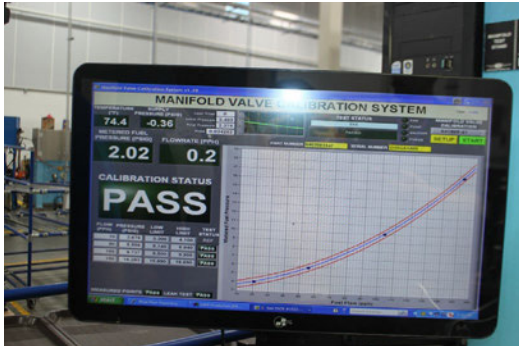
Operational testing of the manifold valve with fuel injector lines and nozzles was performed to production standards. For testing, the impact damaged No. 5 fuel injector nozzle was replaced with an exemplar unit. The assembly passed all test points (Figure 37) and the pattern from all nozzles was good with no issues noted (Figure 38).

**Figure 37 View of the Test Results of the Manifold Valve, Injector Lines and Injector Nozzles Operational Testing**

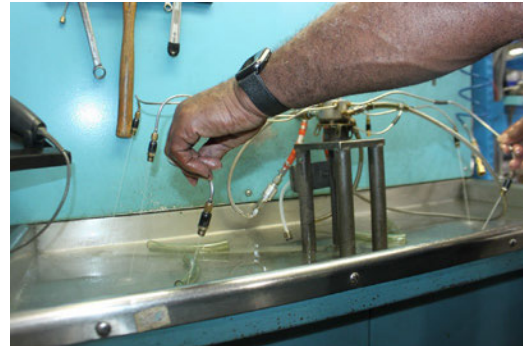
**Figure 38 View of the Spray Pattern of the Fuel Injector Nozzles During Operational Testing**

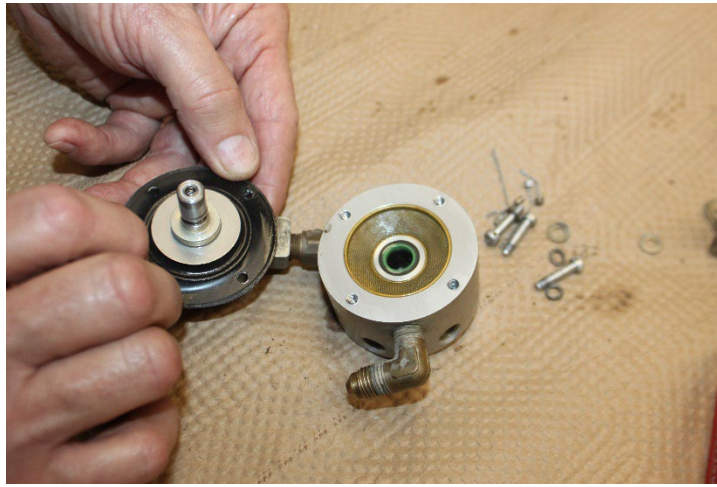
Disassembly examination of the manifold valve following operational testing revealed the screen was clean (Figure 39) with only 1 very small spec of black colored material on the bottom side of the screen. The hole on the pilot

valve was clear and all injector line openings were free of obstructions. The valve was partially reassembled and not retained.

**Figure 39 View of the Screen of the Manifold Valve.**

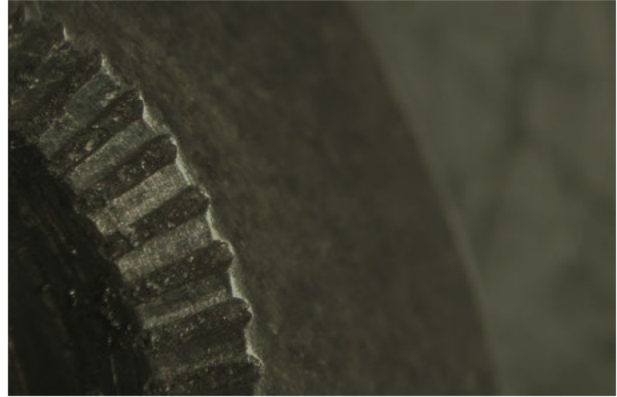
Examination of the impact separated throttle body and metering valve<sup>4</sup> revealed the throttle and mixture control levers remained attached. The throttle lever was tightly installed onto the shaft and was secured by a metal locking nut and a palnut. Movement of the stainless-steel throttle lever resulted in movement of the throttle shaft and valve. The throttle lever was removed for operational testing. Movement of the stainless-steel mixture control lever did not result in rotation of the mixture control shaft. Inspection of the mixture control lever revealed it was attached by 2 nuts and was not deformed when compared with an exemplar unit. Both nuts remained threaded onto the shaft. Removal of the metal locking nut by hand revealed it was semi-tight against the lever and exhibited normal tare torque during removal. Following removal of the mixture control lever, the top of the serrations on the shaft and the lever appeared damaged (Figures 40 and 41). The throttle linkage exhibited bending overload failure (Figure 42). The fuel inlet screen was clean. Further inspection of the throttle body and metering valve revealed the mixture return and outlet fittings were fractured. The fractured fittings were removed and replaced with exemplar fittings for operational testing.

**Figure 41 View of the Serrations of the Mixture Control Lever**

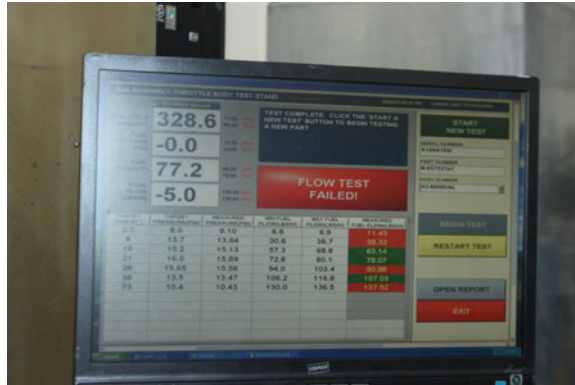
Operational testing of the throttle body and metering valve with the exemplar throttle linkage set to the accident length was performed to production standards. The unit passed three test points and failed four test points (Figure 43). The last test point which was at 73° angle of the throttle valve shaft, or full open revealed it flowed 1.02 pounds-per-hour (PPH) greater than the specified maximum limit. No adjustments were made to the accident unit, but the engine manufacturer representative reported that with adjustments the unit could be made to fall within limits at the out of tolerance test points.

**Figure 43 View of the Results of the Throttle Body and Metering Valve Operational Testing**

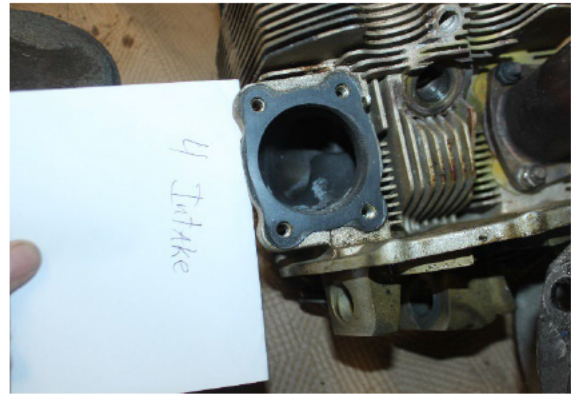
No. 4 - Had resolidified aluminum material inside the cylinder head near both spark plug holes and on both valves. The Cylinder skirt was damaged. The bottom of the piston was damaged. The piston exhibited erosion circumferentially with a visible gap in the piston extending from the dome past both compression rings and the oil control ring (Figure 45). The intake gasket remained installed on the cylinder and there were no cuts or visible damage (Figure 46). The debris by both spark plug holes was removed and both spark

**Figure 46 View of the No. 4 Cylinder Intake Port**
