Timothy W. Monville  
Sr. Air Safety Investigator  
OAS-Eastern Region Aviation

**Subject:** ERA23FA138, Record of Conversation/Interview

**Contact:** Aamro Aviation Personnel

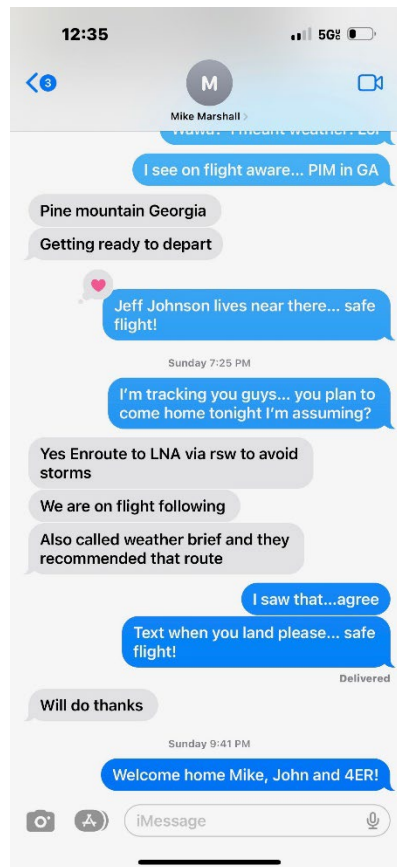
Two. Messrs. West and Reiter. Mr. Loomis had someone track the flight progress of the airplane that night. Mr. Loomis was also tracking the flight progress of the airplane that day (Figures 3 and 4). Mr. Loomis received a call from Mr. Reiter telling him about the crash.

Figure 3: Screenshot of Text messages To and From Mr. Loomis and Mr. Marshall, Jr.

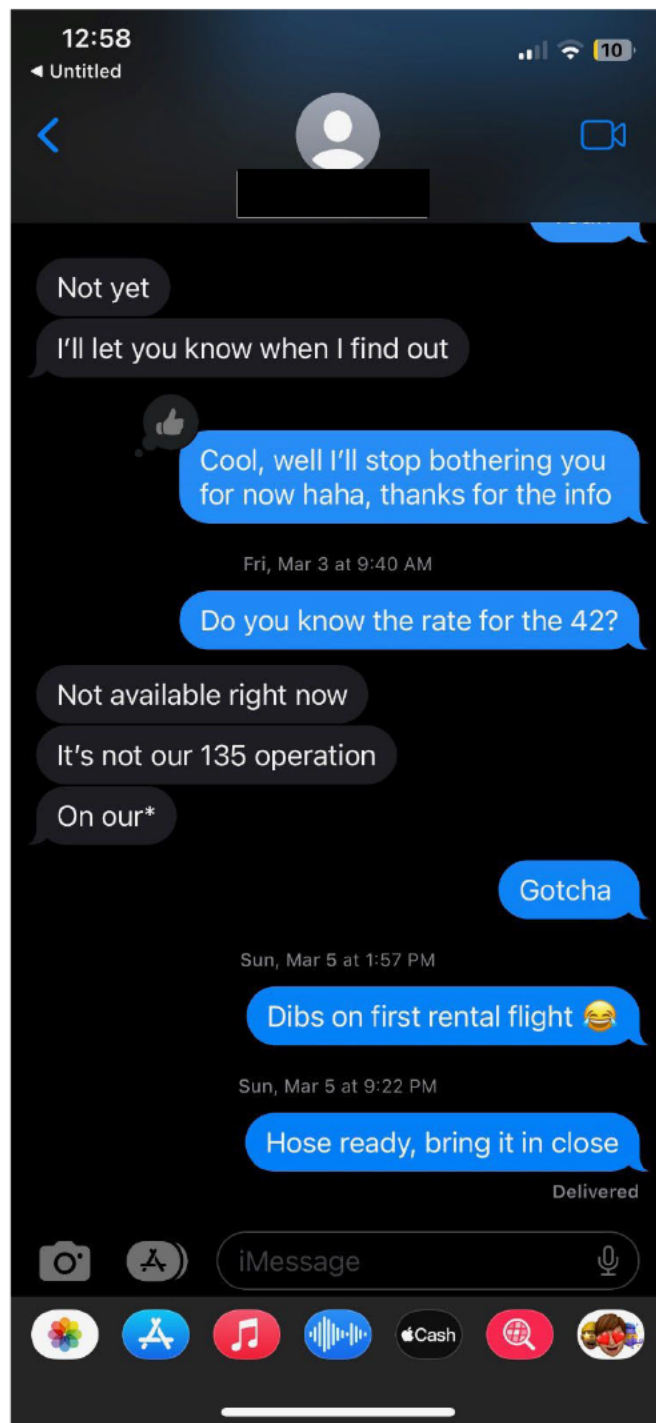
Yes, earlier he texted Mr. Marshall twice (Figure 1). The first text was at “1:57 pm” and the second text was at “9:22 pm” but he did not respond to either text message. Mr. Reiter did text one of the occupants<sup>5</sup>.

Figure 1: Screenshot of Text Messages On Mr. West's Phone to and From Mr. Marshall, Jr.
